Home Report

Survey Report on:

Property Address	42 Shore Street Nairn IV12 4PX	
------------------	--------------------------------------	--

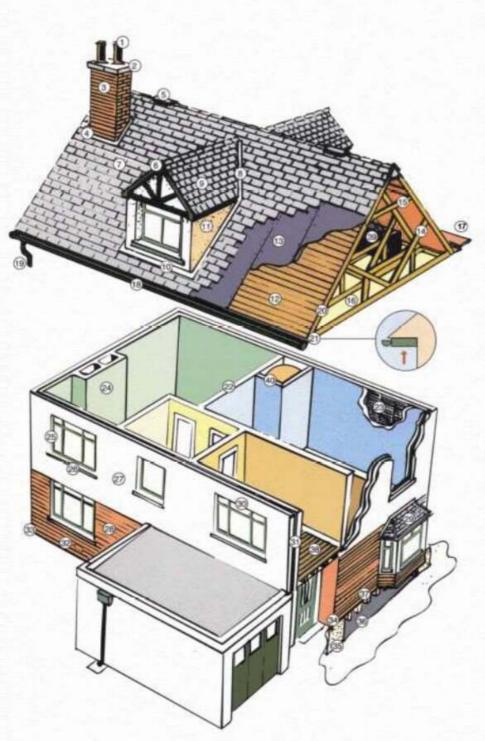
Sectional Diagram showing elements of a typical house

Reference may be made in this report to some or all of the above component parts of the property. This diagram may assist you in locating and understanding these items.

0	Chimney pots
2	Coping stone
3	Chimney head
1	Flashing
5	Ridge ventilation
6	Ridge board
1	Slates / tiles
8	Valley guttering
9	Dormer projection
10	Dormer flashing
1	Dormer cheeks
12	Sarking
13	Roof felt
14	Trusses
15	Collar
16	Insulation
Ī	Parapet gutter
18	Eaves guttering
19	Rainwater downpipe
20	Verge boards /skews
21	Soffit boards
22	Partition wall
23	Lath / plaster
24	Chimney breast
25	Window pointing
26	Window sills
27	Rendering
28	Brickwork / pointing
29	Bay window projection
30	Lintels
31	Cavity walls / wall ties
32	Subfloor ventilator
	Damp proof course
34	Base course
35	Foundations
36	Solum
37	Floor joists
38	Floorboards
39	Water tank
(40)	Hot water tank
