HOME REPORT

98 HARBOUR STREET
NAIRN
IV12 4PH

Energy Performance Certificate (EPC)

Single Survey

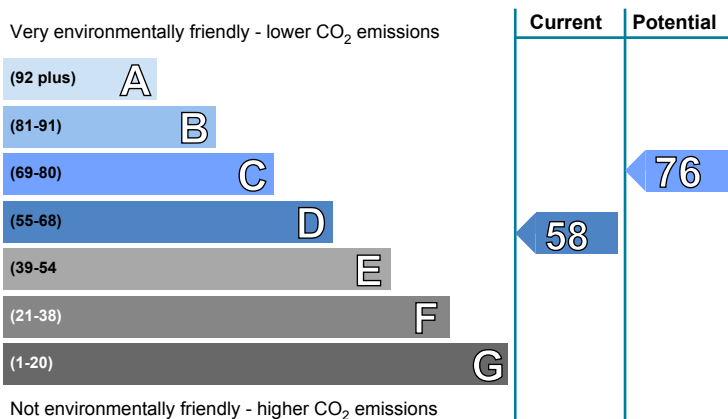
Environmental Impact (CO₂) Rating

This graph shows the effect of your home on the environment in terms of carbon dioxide (CO₂) emissions. The higher the rating, the less impact it has on the environment.

Your current rating is **band D (58)**. The average rating for EPCs in Scotland is **band D (59)**.

The potential rating shows the effect of undertaking all of the improvement measures listed within your recommendations report.
