HOME REPORT

SKENE MEADOWS RAFFORD

ENERGY PERFORMANCE CERTIFICATE

Single Survey

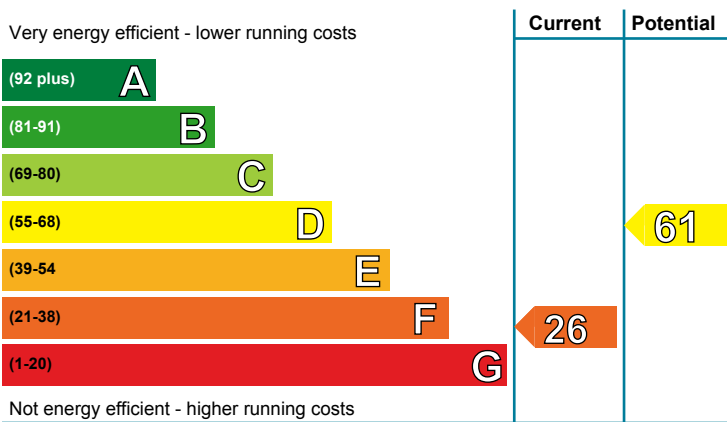
Energy Efficiency Rating

This graph shows the current efficiency of your home, taking into account both energy efficiency and fuel costs. The higher this rating, the lower your fuel bills are likely to be.

Your current rating is **band F (26)**. The average rating for EPCs in Scotland is **band D (61)**.

The potential rating shows the effect of undertaking all of the improvement measures listed within your recommendations report.

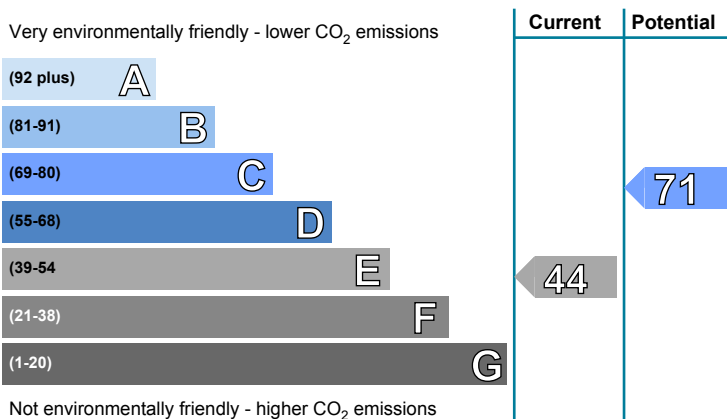
Environmental Impact (CO₂) Rating

This graph shows the effect of your home on the environment in terms of carbon dioxide (CO₂) emissions. The higher the rating, the less impact it has on the environment.

Your current rating is **band E (44)**. The average rating for EPCs in Scotland is **band D (59)**.

The potential rating shows the effect of undertaking all of the improvement measures listed within your recommendations report.
