# HOME REPORT

EMERALD BANK OLD ROAD

RAFFORD  
FORRES  
IV36 2PT

# ENERGY PERFORMANCE CERTIFICATE

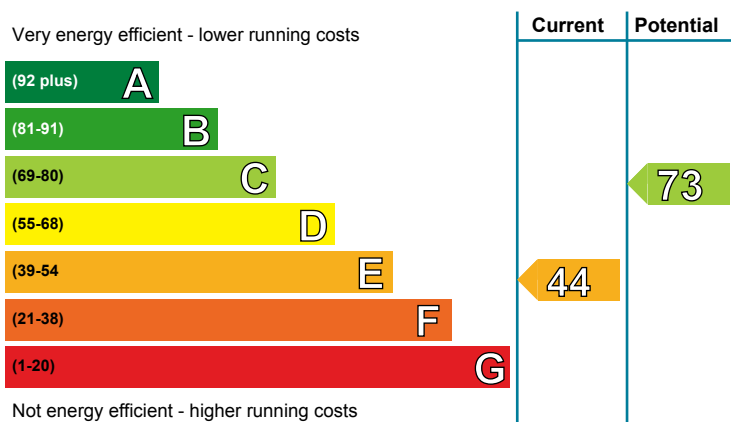
## Energy Efficiency Rating

This graph shows the current efficiency of your home, taking into account both energy efficiency and fuel costs. The higher this rating, the lower your fuel bills are likely to be.

Your current rating is **band E (44)**. The average rating for EPCs in Scotland is **band D (61)**.

The potential rating shows the effect of undertaking all of the improvement measures listed within your recommendations report.

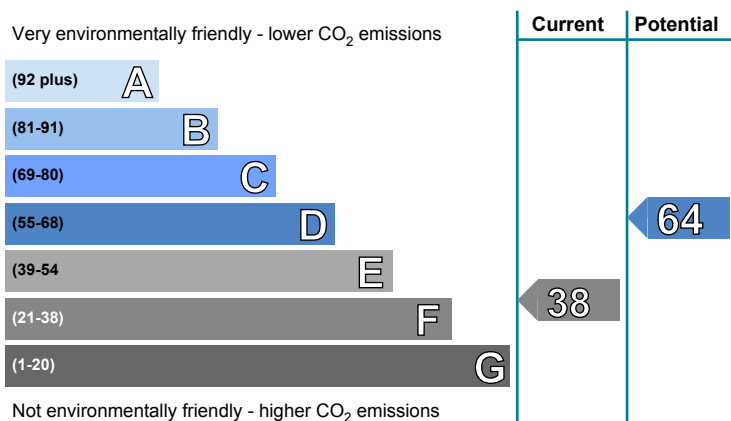
## Environmental Impact (CO<sub>2</sub>) Rating

This graph shows the effect of your home on the environment in terms of carbon dioxide (CO<sub>2</sub>) emissions. The higher the rating, the less impact it has on the environment.

Your current rating is **band F (38)**. The average rating for EPCs in Scotland is **band D (59)**.

The potential rating shows the effect of undertaking all of the improvement measures listed within your recommendations report.
