HOME REPORT

**12 ARMOUR GROVE
MUIRHOUSE
MOTHERWELL
ML1 2ER**

DM HALL
CHARTERED SURVEYORS

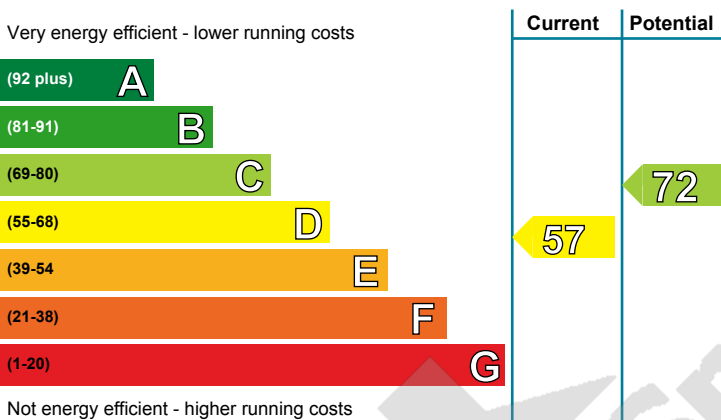
Energy Efficiency Rating

This graph shows the current efficiency of your home, taking into account both energy efficiency and fuel costs. The higher this rating, the lower your fuel bills are likely to be.

Your current rating is **band D (57)**. The average rating for EPCs in Scotland is **band D (61)**.

The potential rating shows the effect of undertaking all of the improvement measures listed within your recommendations report.

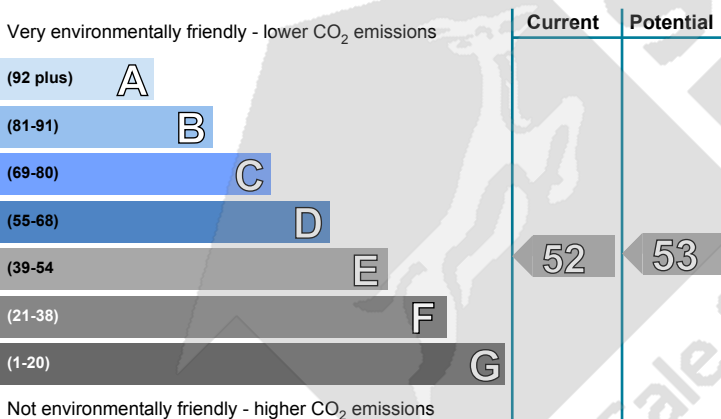
Environmental Impact (CO₂) Rating

This graph shows the effect of your home on the environment in terms of carbon dioxide (CO₂) emissions. The higher the rating, the less impact it has on the environment.

The potential rating shows the effect of undertaking all of the improvement measures listed within your recommendations report.

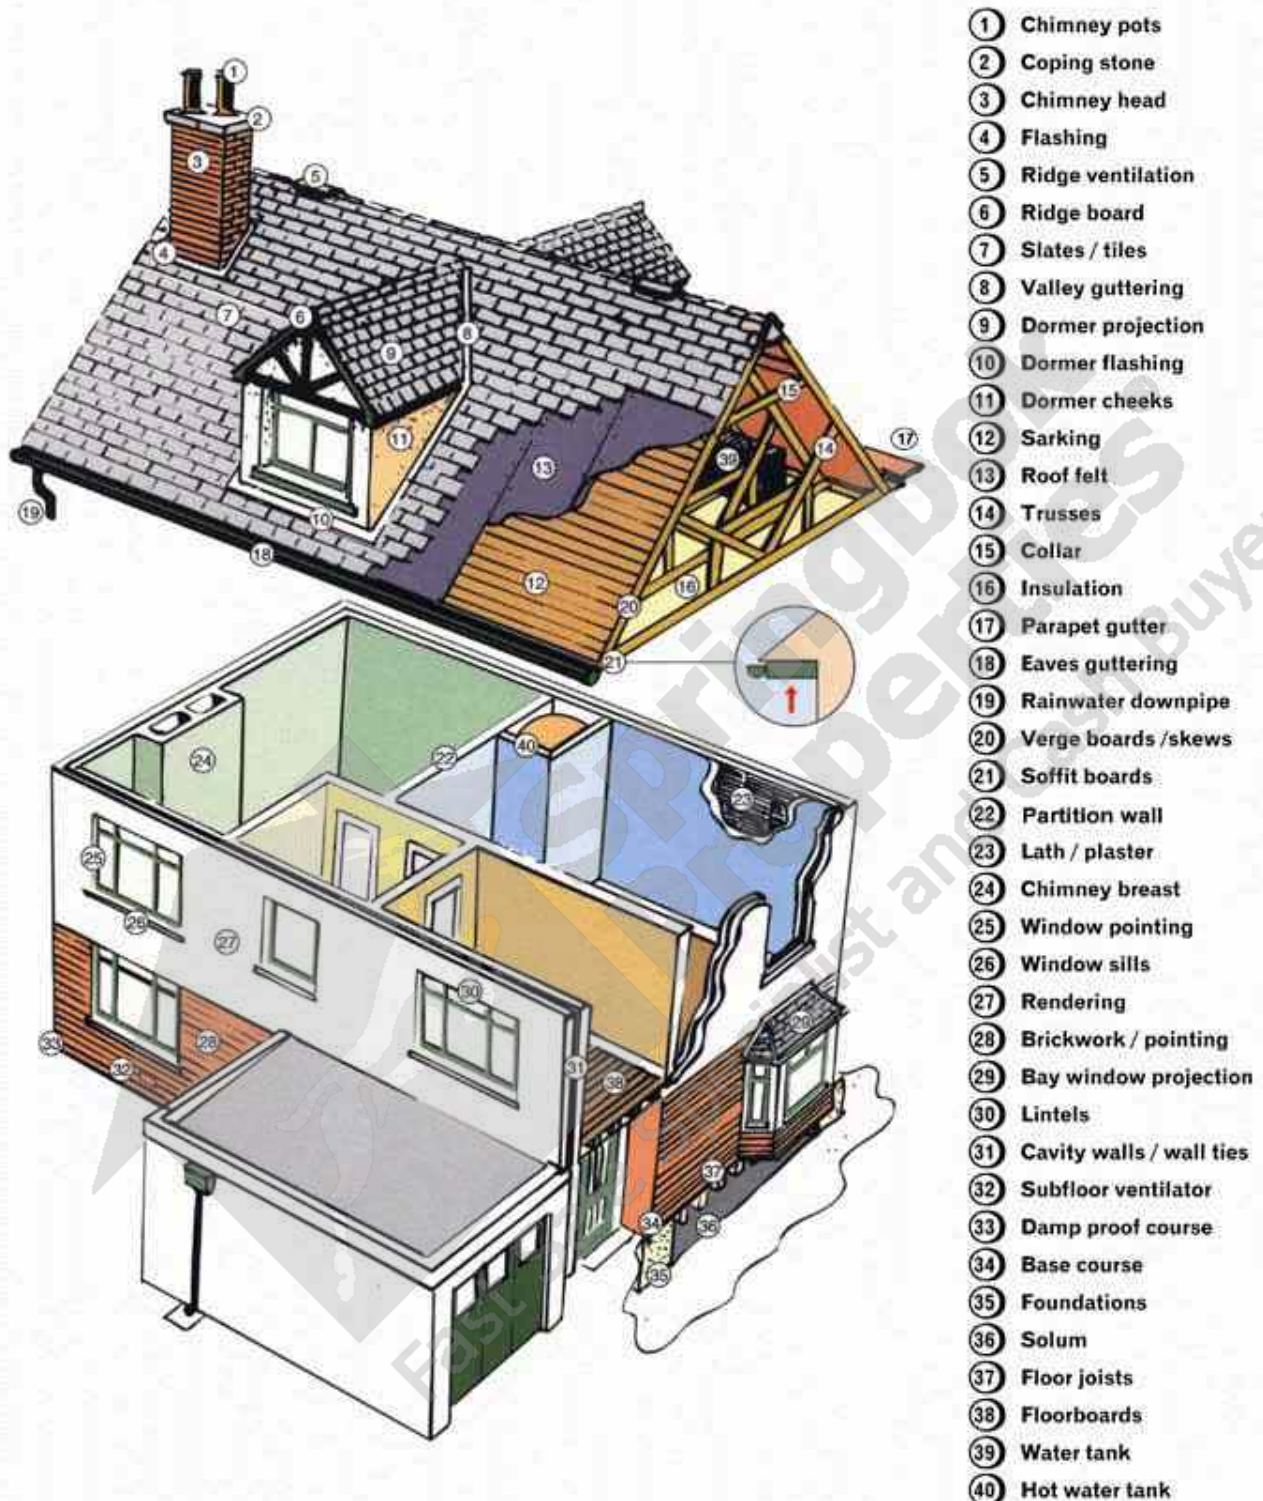
Sectional Diagram showing elements of a typical house

Reference may be made in this report to some or all of the above component parts of the property. This diagram may assist you in locating and understanding these items.
