YOUR ONESURVEY
HOME REPORT

21 The Loaning
Douglas, Lanark
ML11 0QE

SINGLE SURVEY

Single Survey

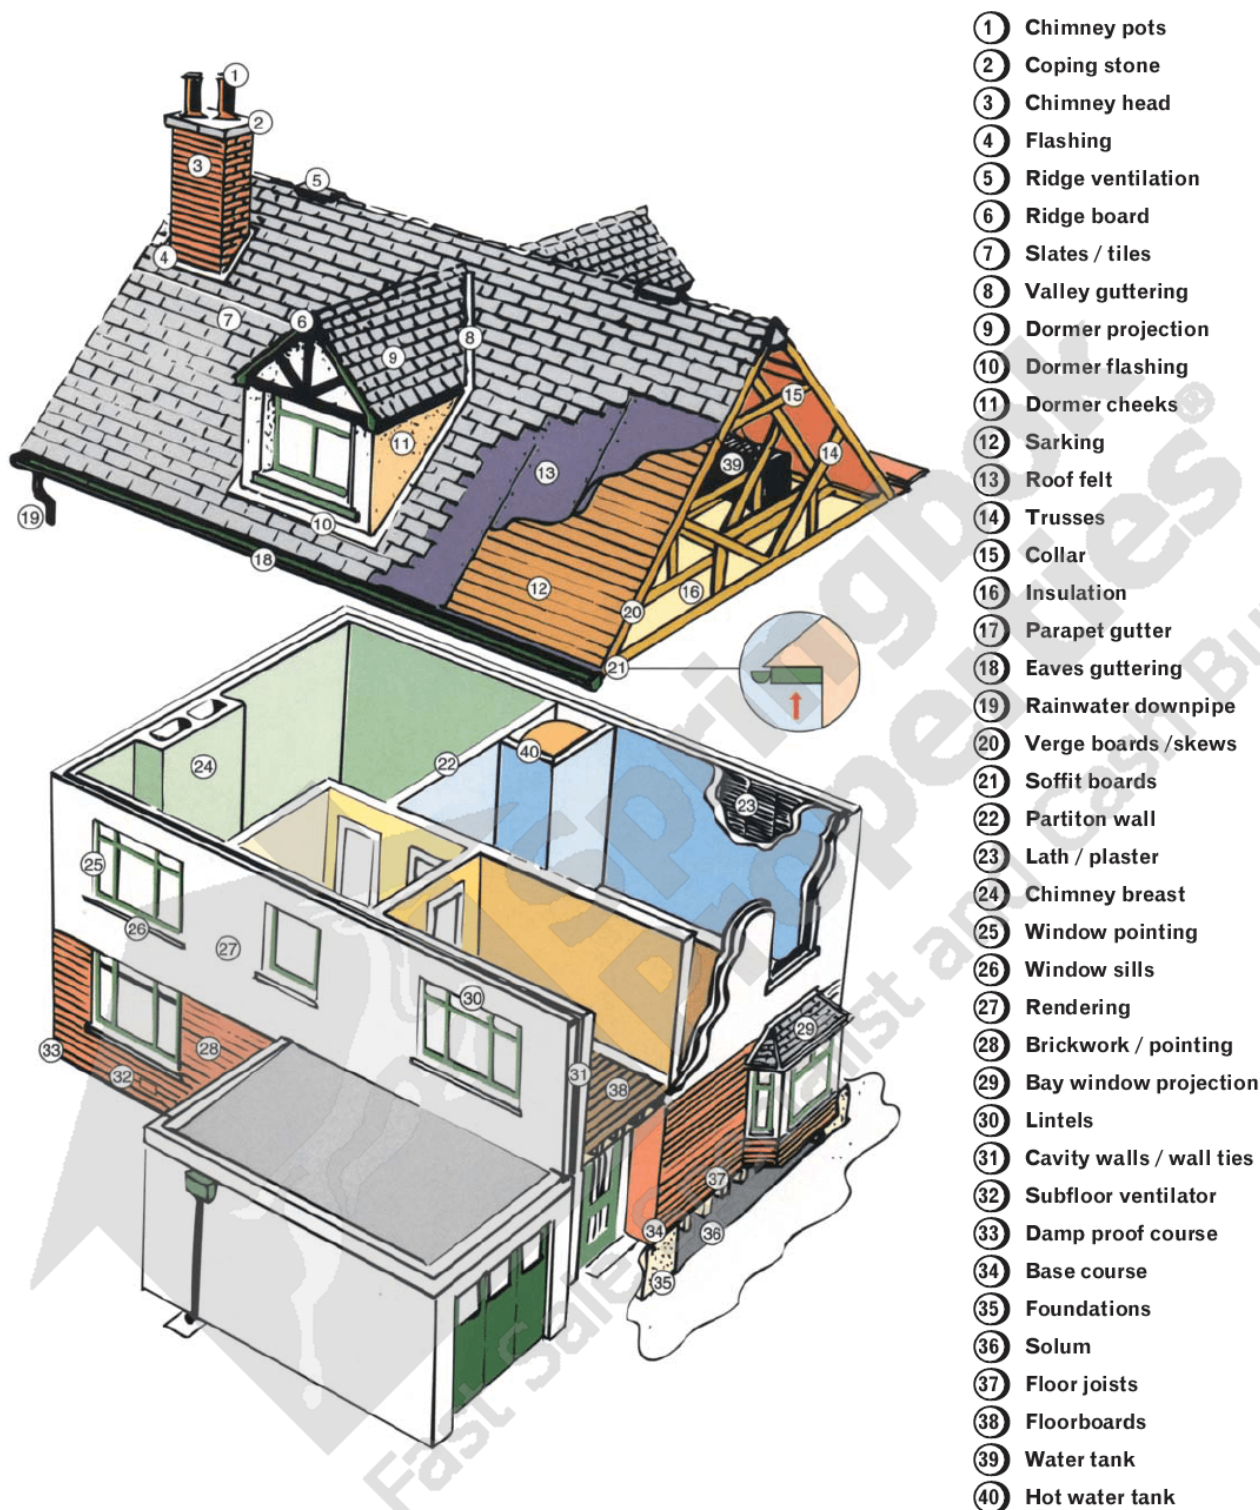
Sectional Diagram showing elements of a typical house

- ① Chimney pots
- ② Coping stone
- ③ Chimney head
- ④ Flashing
- ⑤ Ridge ventilation
- ⑥ Ridge board
- ⑦ Slates / tiles
- ⑧ Valley guttering
- ⑨ Dormer projection
- ⑩ Dormer flashing
- ⑪ Dormer cheeks
- ⑫ Sarking
- ⑬ Roof felt
- ⑭ Trusses
- ⑮ Collar
- ⑯ Insulation
- ⑰ Parapet gutter
- ⑱ Eaves guttering
- ⑲ Rainwater downpipe
- ⑳ Verge boards /skews
- ㉑ Soffit boards
- ㉒ Partiton wall
- ㉓ Lath / plaster
- ㉔ Chimney breast
- ㉕ Window pointing
- ㉖ Window sills
- ㉗ Rendering
- ㉘ Brickwork / pointing
- ㉙ Bay window projection
- ㉚ Lintels
- ㉛ Cavity walls / wall ties
- ㉜ Subfloor ventilator
- ㉝ Damp proof course
- ㉞ Base course
- ㉟ Foundations
- ㊱ Solum
- ㊲ Floor joists
- ㊳ Floorboards
- ㊴ Water tank
- ㊵ Hot water tank

Reference may be made in this report to some or all of the above component parts of the property. This diagram may assist you in locating and understanding these items.

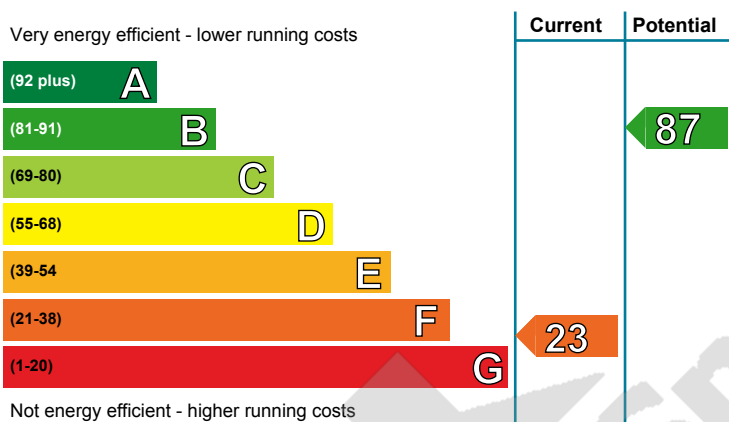
Energy Efficiency Rating

This graph shows the current efficiency of your home, taking into account both energy efficiency and fuel costs. The higher this rating, the lower your fuel bills are likely to be.

Your current rating is **band F (23)**. The average rating for EPCs in Scotland is **band D (61)**.

The potential rating shows the effect of undertaking all of the improvement measures listed within your recommendations report.

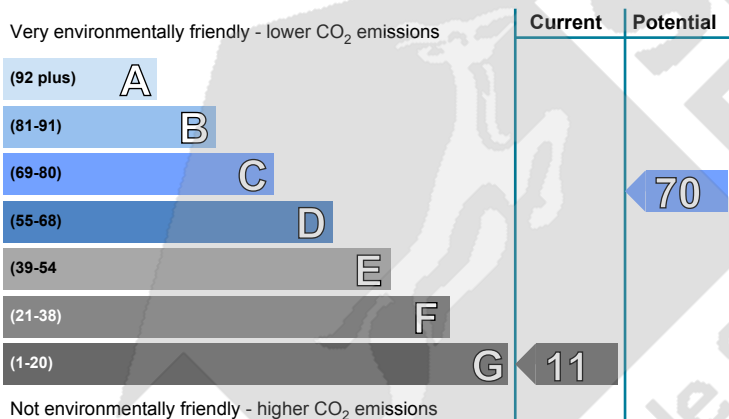
Environmental Impact (CO₂) Rating

This graph shows the effect of your home on the environment in terms of carbon dioxide (CO₂) emissions. The higher the rating, the less impact it has on the environment.
