Home Report

Single Survey

Property address	Flat 5, 3 Wishaw Terrace 3/5 Wishaw Terrace Edinburgh EH7 6AF
Customer	Springbok Properties
Customer address	Flat 5, 3 Wishaw Terrace 3/5 Wishaw Terrace Edinburgh EH7 6AF
Prepared by	Shepherd Chartered Surveyors
Date of inspection	05/12/2023

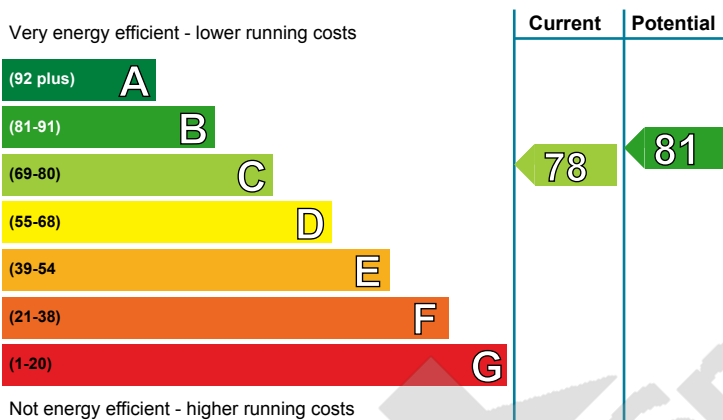
Energy Efficiency Rating

This graph shows the current efficiency of your home, taking into account both energy efficiency and fuel costs. The higher this rating, the lower your fuel bills are likely to be.

Your current rating is **band C (78)**. The average rating for EPCs in Scotland is **band D (61)**.

The potential rating shows the effect of undertaking all of the improvement measures listed within your recommendations report.

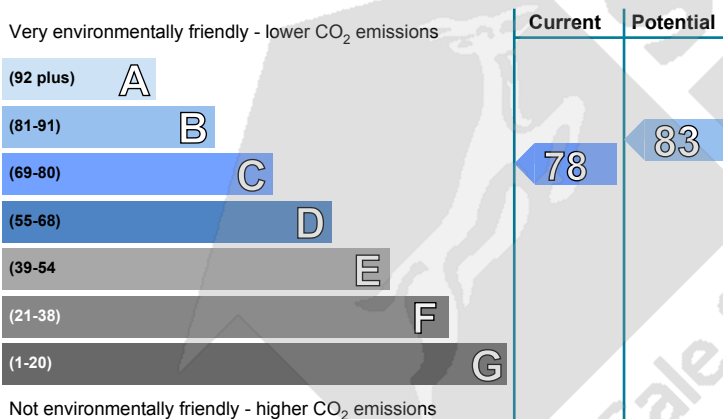
Environmental Impact (CO₂) Rating

This graph shows the effect of your home on the environment in terms of carbon dioxide (CO₂) emissions. The higher the rating, the less impact it has on the environment.
