Home Report

Single Survey

Property address	5 Soyburn Gardens Portsoy Banff AB45 2QG
Customer	Springbok Properties
Customer address	5 Soyburn Gardens Portsoy Banff AB45 2QG
Prepared by	Shepherd Chartered Surveyors
Date of inspection	08/02/2024

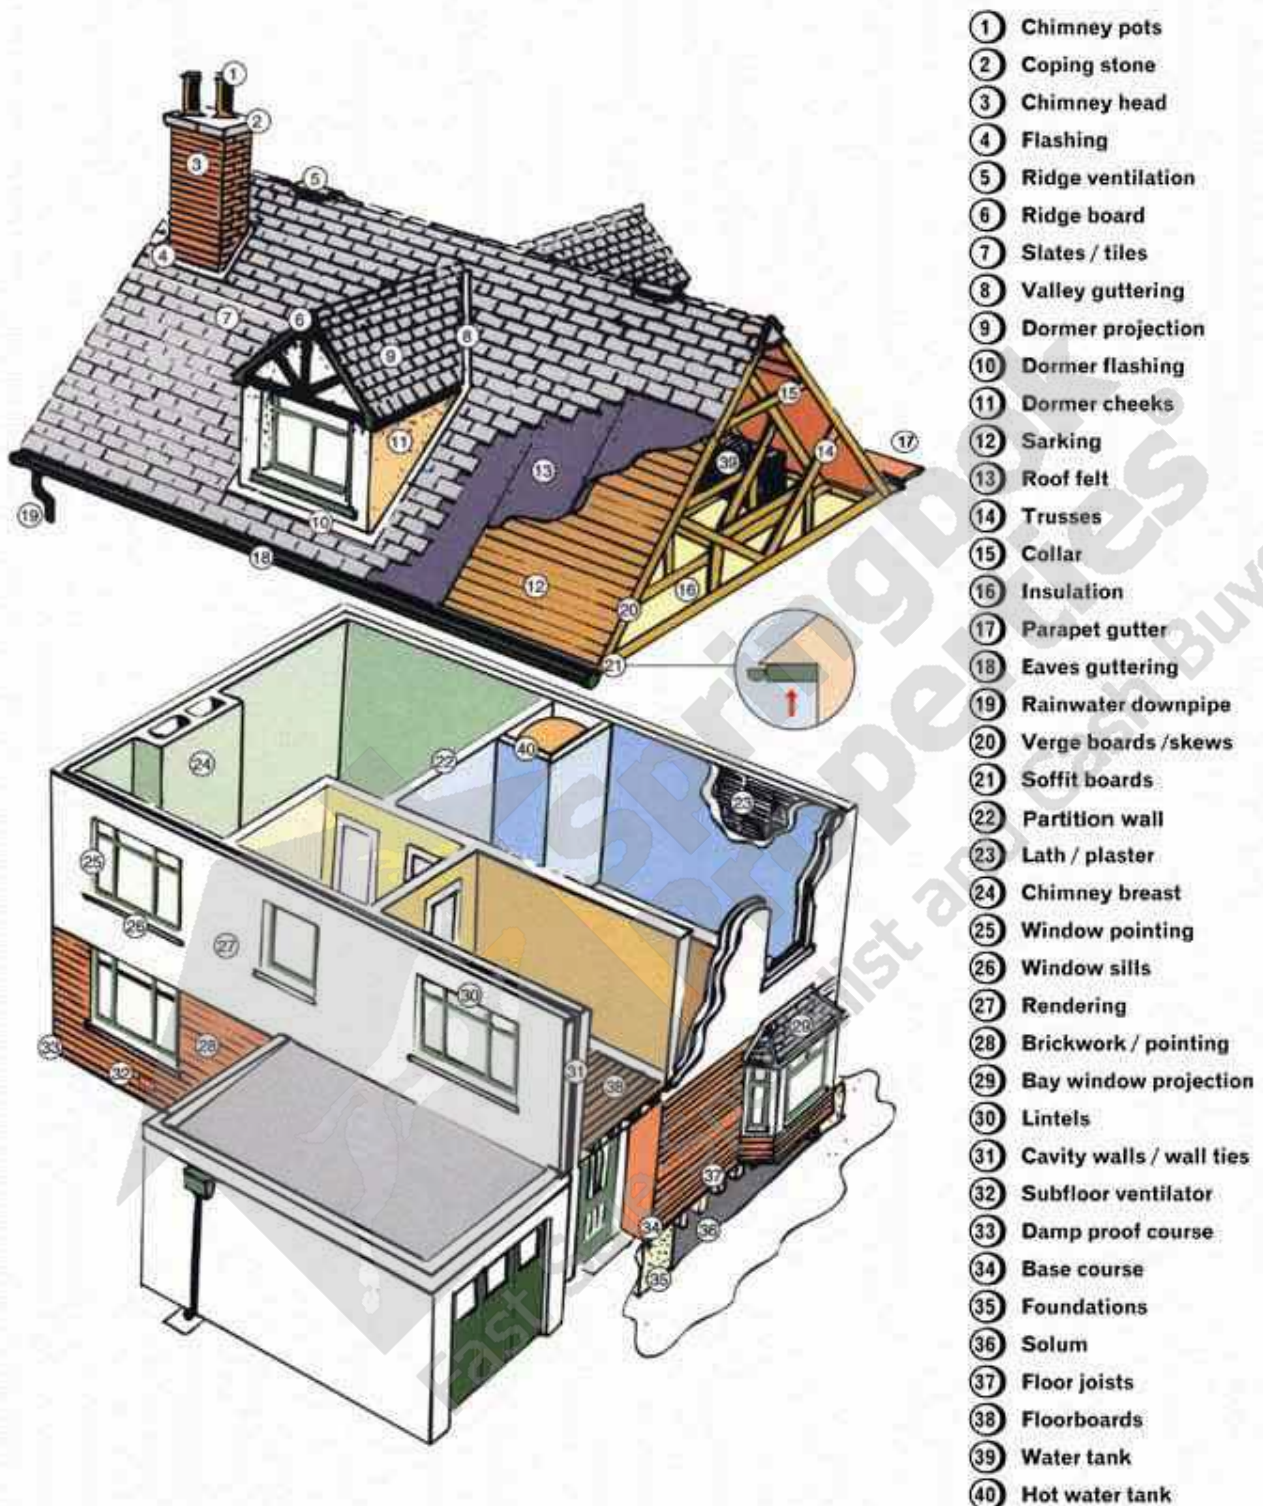
Sectional Diagram showing elements of a typical house

- ① Chimney pots
- ② Coping stone
- ③ Chimney head
- ④ Flashing
- ⑤ Ridge ventilation
- ⑥ Ridge board
- ⑦ Slates / tiles
- ⑧ Valley guttering
- ⑨ Dormer projection
- ⑩ Dormer flashing
- ⑪ Dormer cheeks
- ⑫ Sarking
- ⑬ Roof felt
- ⑭ Trusses
- ⑮ Collar
- ⑯ Insulation
- ⑰ Parapet gutter
- ⑱ Eaves guttering
- ⑲ Rainwater downpipe
- ⑳ Verge boards /skews
- ㉑ Soffit boards
- ㉒ Partition wall
- ㉓ Lath / plaster
- ㉔ Chimney breast
- ㉕ Window pointing
- ㉖ Window sills
- ㉗ Rendering
- ㉘ Brickwork / pointing
- ㉙ Bay window projection
- ㉚ Lintels
- ㉛ Cavity walls / wall ties
- ㉜ Subfloor ventilator
- ㉝ Damp proof course
- ㉞ Base course
- ㉟ Foundations
- ㊱ Solum
- ㊲ Floor joists
- ㊳ Floorboards
- ㊴ Water tank
- ㊵ Hot water tank

Reference may be made in this report to some or all of the above component parts of the property. This diagram may assist you in locating and understanding these items.
