# HOME REPORT

**58 RIGGSIDE ROAD  
GLASGOW  
G33 5PZ**

**DM HALL**  
CHARTERED SURVEYORS

**Dwelling type:** Mid-terrace house  
**Date of assessment:** 21 March 2024  
**Date of certificate:** 22 March 2024  
**Total floor area:** 70 m<sup>2</sup>  
**Primary Energy Indicator:** 263 kWh/m<sup>2</sup>/year

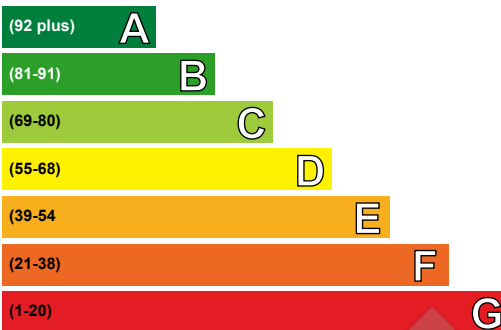
## Energy Efficiency Rating

Current	Potential
70	79

The potential rating shows the effect of undertaking all of the improvement measures listed within your recommendations report.

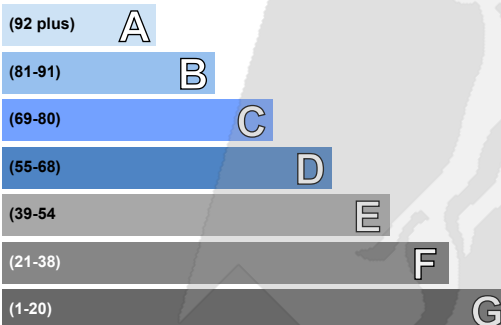
## Environmental Impact (CO<sub>2</sub>) Rating

Current	Potential
67	78

The potential rating shows the effect of undertaking all of the improvement measures listed within your recommendations report.
