Home Report

Scottish Single Survey

Property address	98 Main Street Lochgelly KY5 9AA
Customer	Springbok Properties
Customer address	98 Main Street Lochgelly KY5 9AA
Prepared by	Shepherd Chartered Surveyors
Date of inspection	01/04/2024

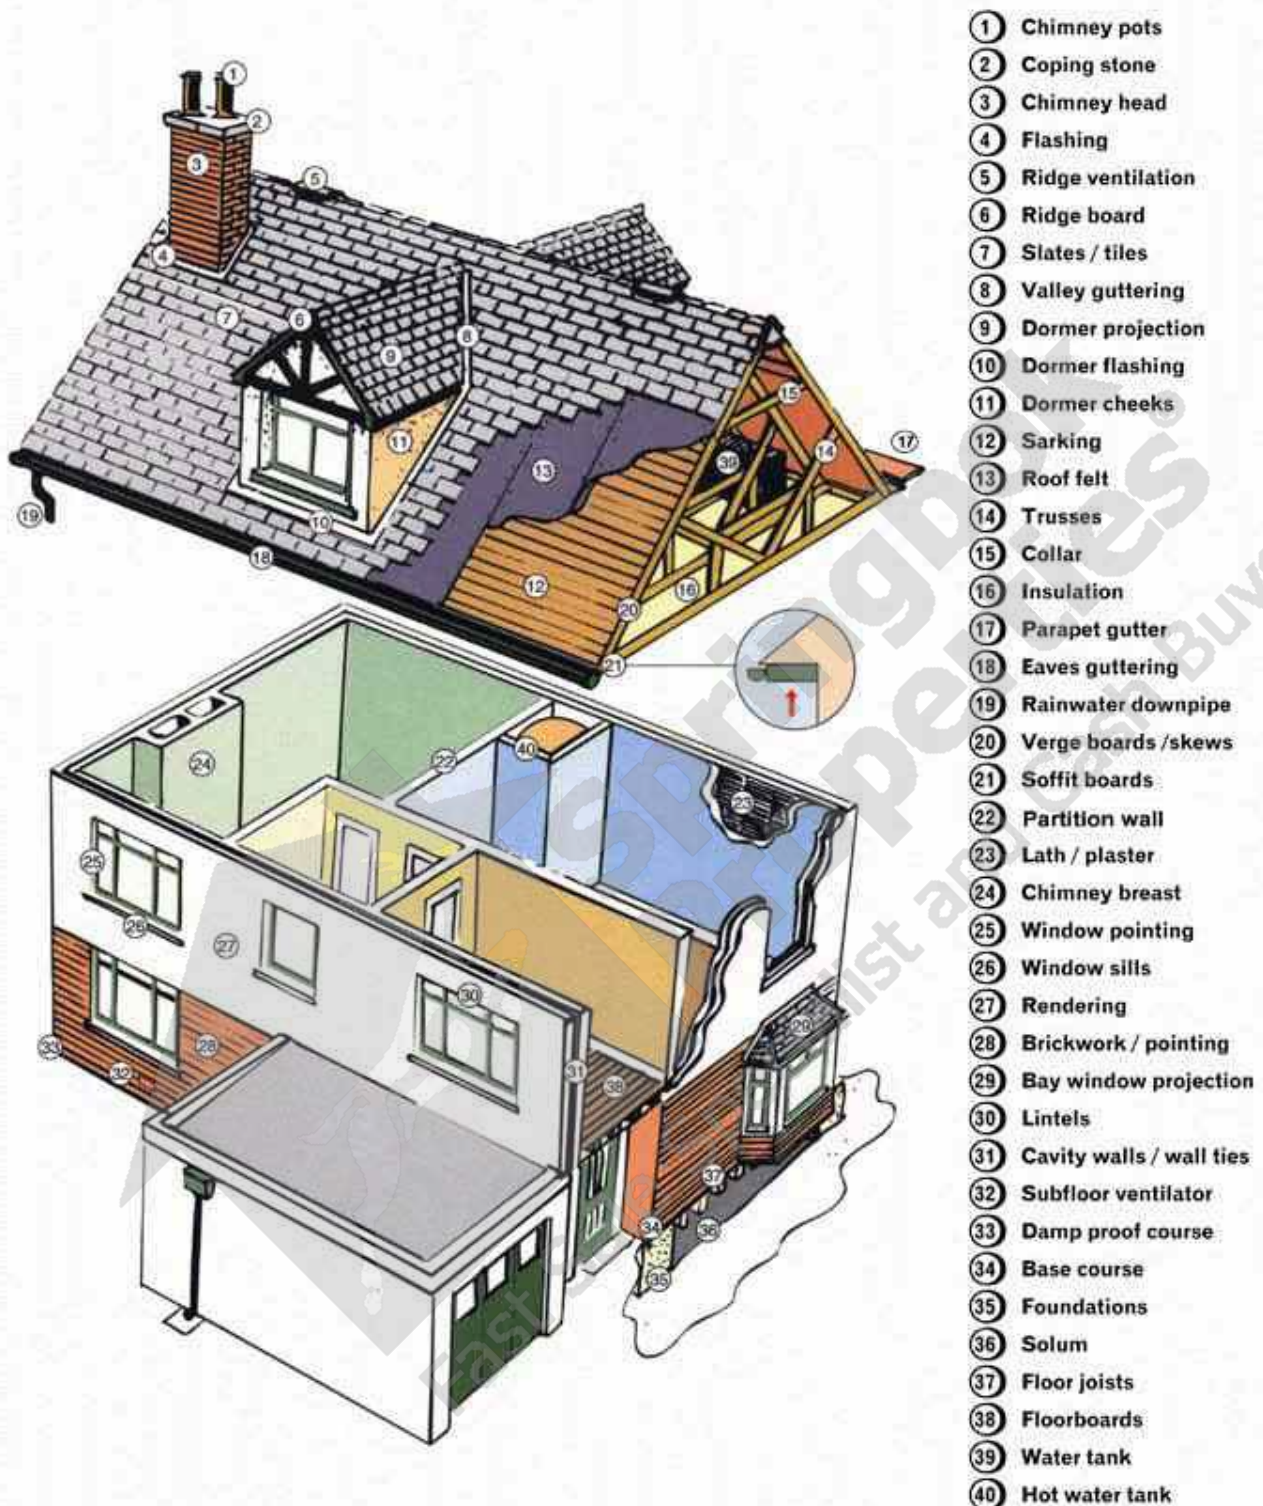
Sectional Diagram showing elements of a typical house

Reference may be made in this report to some or all of the above component parts of the property. This diagram may assist you in locating and understanding these items.

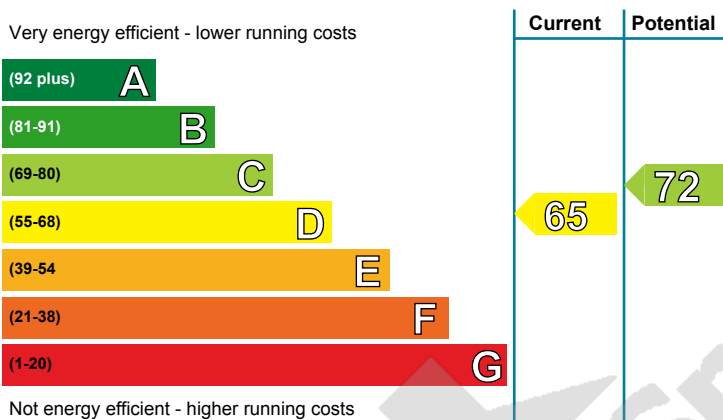
Energy Efficiency Rating

This graph shows the current efficiency of your home, taking into account both energy efficiency and fuel costs. The higher this rating, the lower your fuel bills are likely to be.

Your current rating is **band D (65)**. The average rating for EPCs in Scotland is **band D (61)**.

The potential rating shows the effect of undertaking all of the improvement measures listed within your recommendations report.

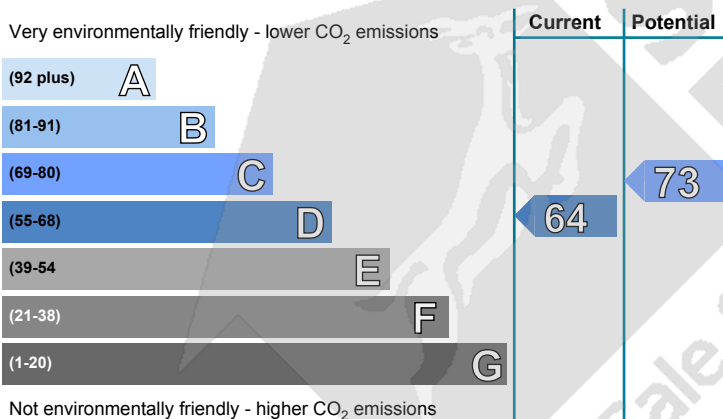
Environmental Impact (CO₂) Rating

This graph shows the effect of your home on the environment in terms of carbon dioxide (CO₂) emissions. The higher the rating, the less impact it has on the environment.
