Home Report

Single Survey

Property address	39 Abergeldie Road Aberdeen AB10 6ED
Customer	Jennifer Wink
Customer address	39 Abergeldie Road Aberdeen AB10 6ED
Prepared by	Shepherd Chartered Surveyors
Date of inspection	30/04/2024

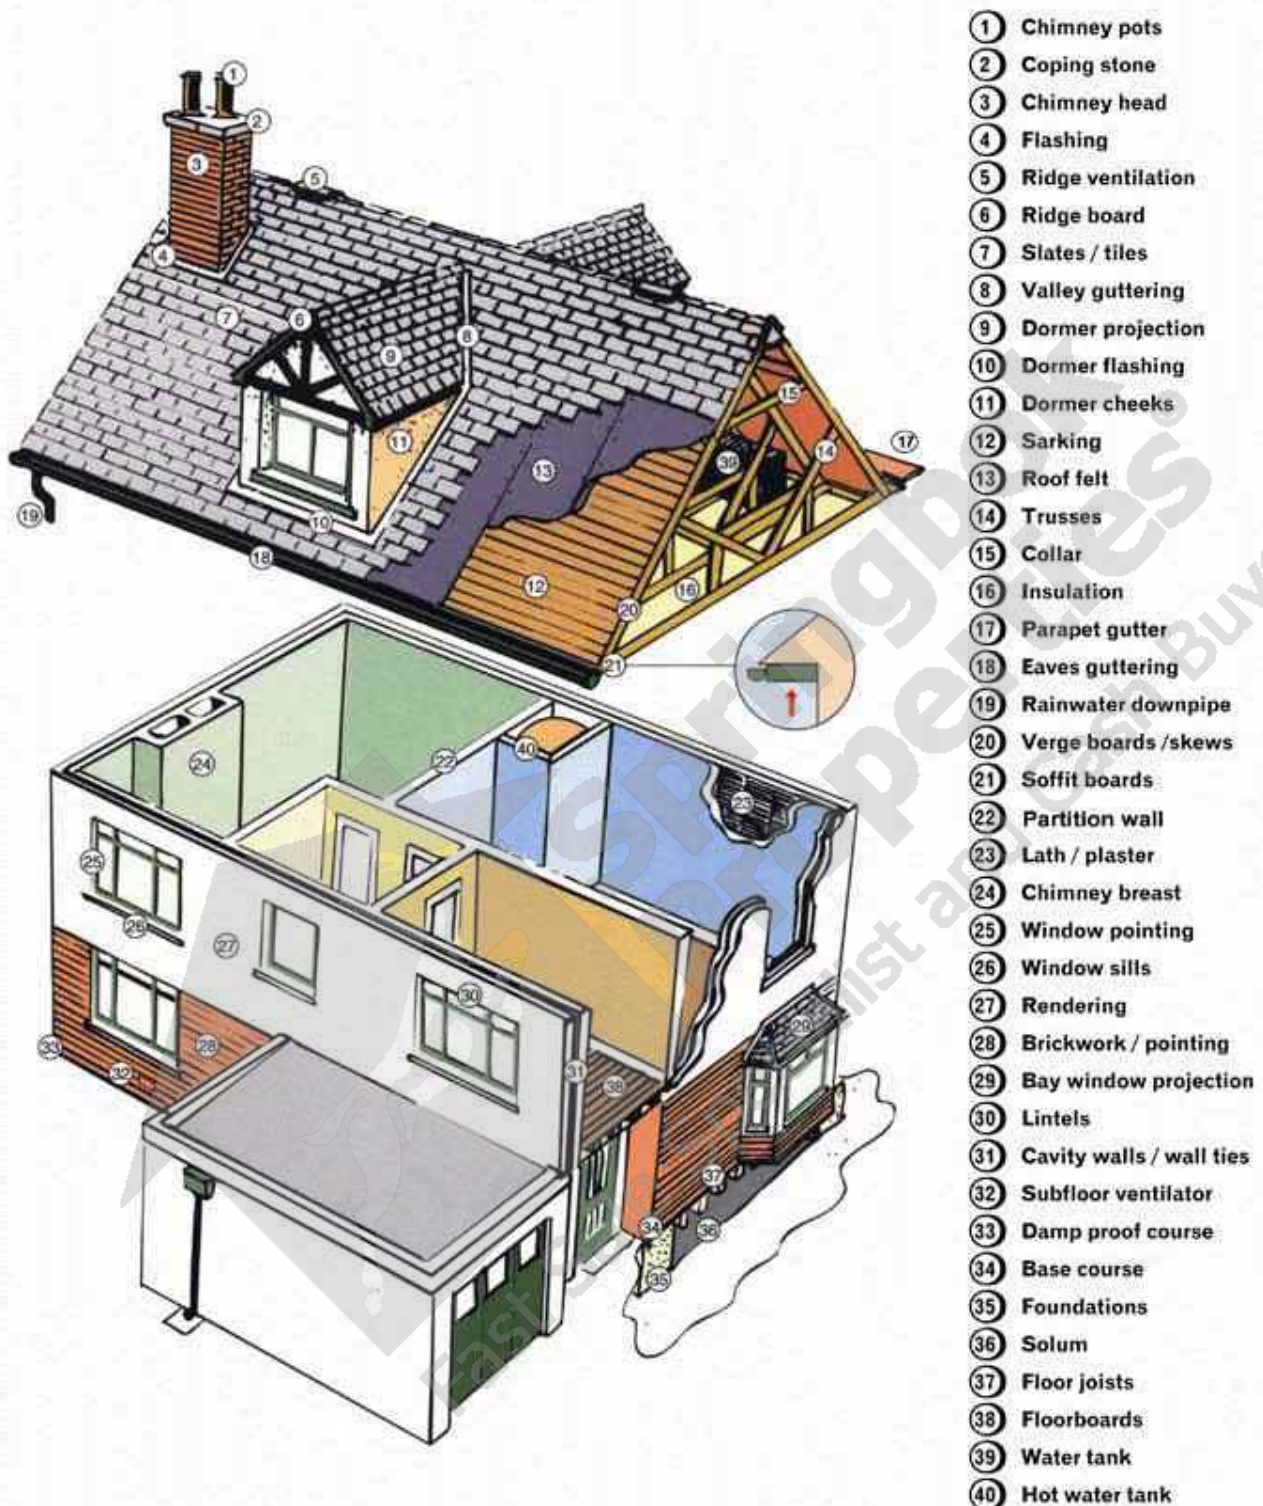
Sectional Diagram showing elements of a typical house

Reference may be made in this report to some or all of the above component parts of the property. This diagram may assist you in locating and understanding these items.
