Home Report

Scottish Single Survey

Property address	Wadesville Brechin Road Montrose DD10 9LE
Customer	Bari And June Islam
Customer address	Wadesville Brechin Road Montrose DD10 9LE
Prepared by	Shepherd Chartered Surveyors
Date of inspection	01/05/2024

Energy Performance Certificate

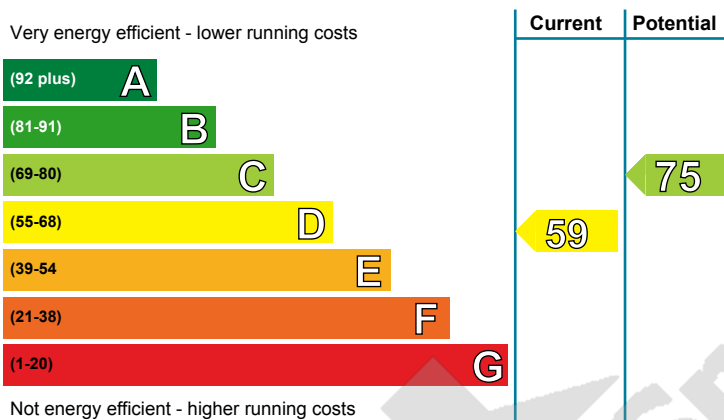
Energy Efficiency Rating

This graph shows the current efficiency of your home, taking into account both energy efficiency and fuel costs. The higher this rating, the lower your fuel bills are likely to be.

Your current rating is **band D (59)**. The average rating for EPCs in Scotland is **band D (61)**.

The potential rating shows the effect of undertaking all of the improvement measures listed within your recommendations report.

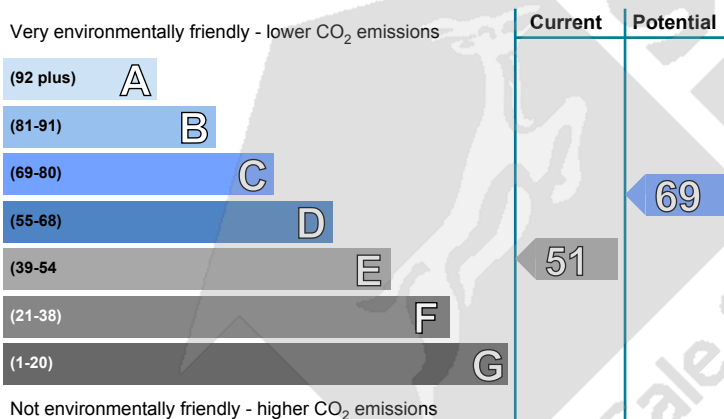
Environmental Impact (CO₂) Rating

This graph shows the effect of your home on the environment in terms of carbon dioxide (CO₂) emissions. The higher the rating, the less impact it has on the environment.
