76 COLLEGE BOUNDS  
FRASERBURGH  
AB43 9QS

# Home Report

# Energy Performance Certificate

# Scottish Single Survey

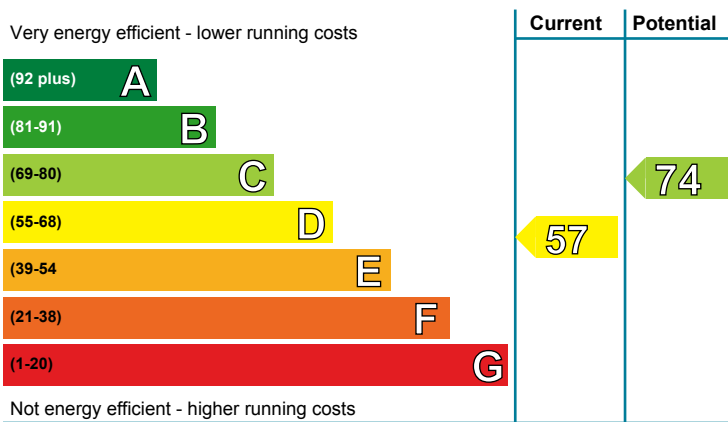
## Energy Efficiency Rating

This graph shows the current efficiency of your home, taking into account both energy efficiency and fuel costs. The higher this rating, the lower your fuel bills are likely to be.

Your current rating is **band D (57)**. The average rating for EPCs in Scotland is **band D (61)**.

The potential rating shows the effect of undertaking all of the improvement measures listed within your recommendations report.

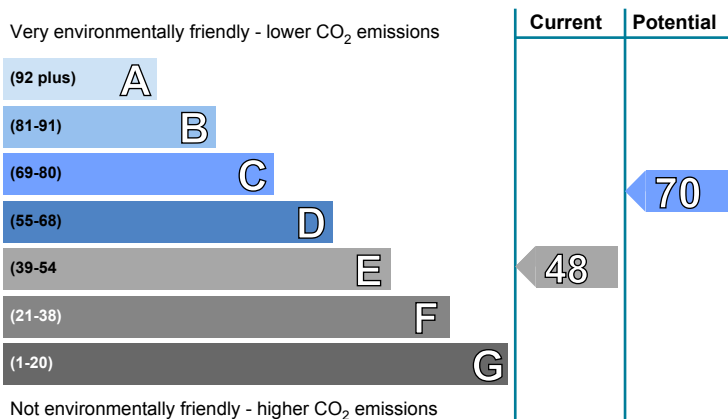
## Environmental Impact (CO<sub>2</sub>) Rating

This graph shows the effect of your home on the environment in terms of carbon dioxide (CO<sub>2</sub>) emissions. The higher the rating, the less impact it has on the environment.

Your current rating is **band E (48)**. The average rating for EPCs in Scotland is **band D (59)**.

The potential rating shows the effect of undertaking all of the improvement measures listed within your recommendations report.

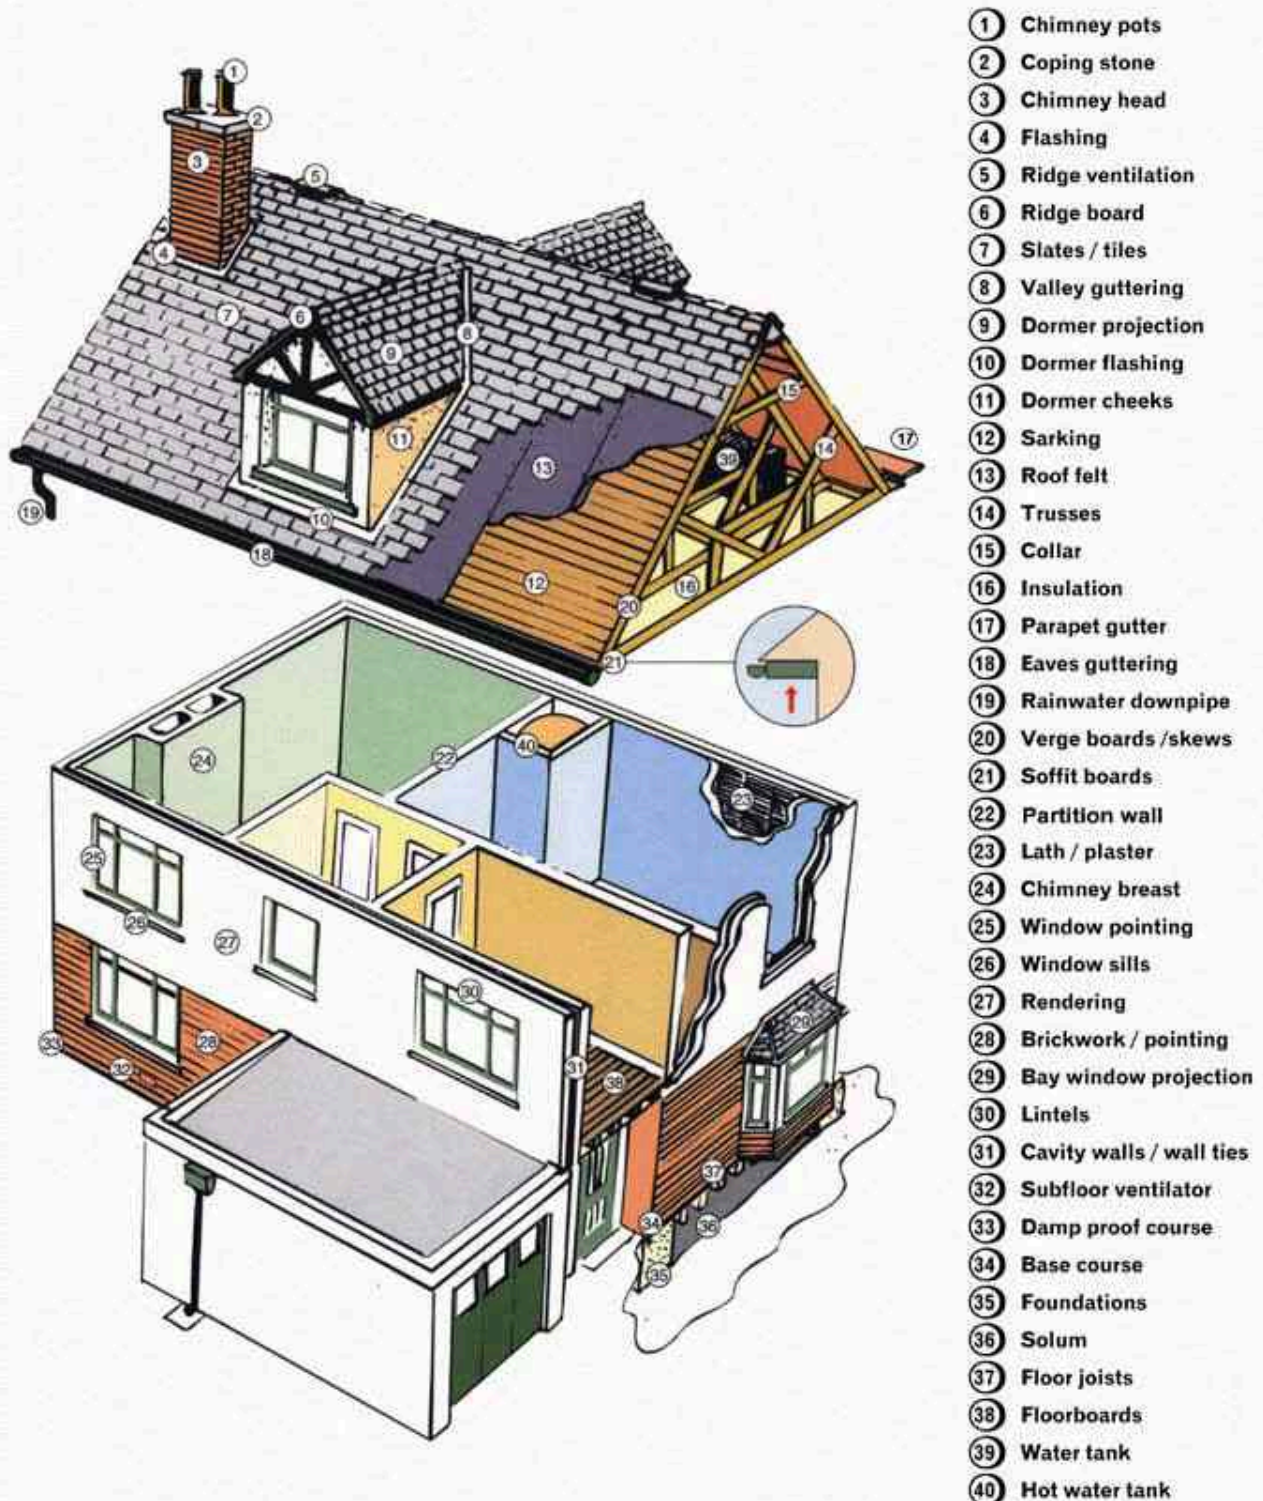
## Sectional Diagram showing elements of a typical house

Reference may be made in this report to some or all of the above component parts of the property. This diagram may assist you in locating and understanding these items.
