YOUR ONESURVEY
HOME REPORT

1 Main Street
Denholm, Hawick
TD9 8NU

SINGLE SURVEY

Single Survey

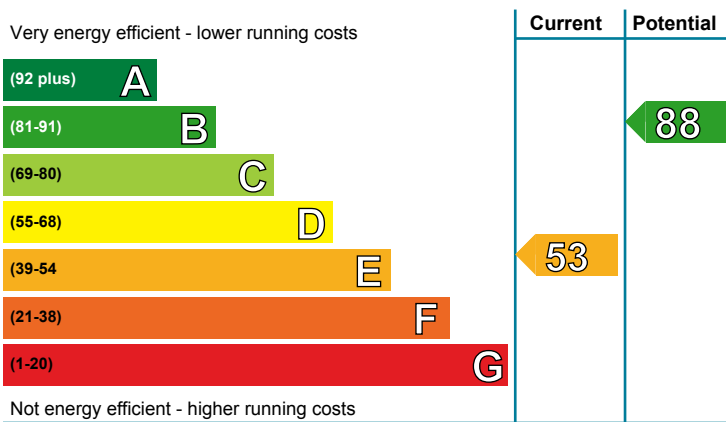
Energy Efficiency Rating

This graph shows the current efficiency of your home, taking into account both energy efficiency and fuel costs. The higher this rating, the lower your fuel bills are likely to be.

Your current rating is **band E (53)**. The average rating for EPCs in Scotland is **band D (61)**.

The potential rating shows the effect of undertaking all of the improvement measures listed within your recommendations report.
