Home Report

Scottish Single Survey

Single Survey

Property address	Flat P 3 St Marys Place Aberdeen AB11 6HL
Customer	Andrew Mitchell-Moore
Customer address	Flat P 3 St Marys Place Aberdeen AB11 6HL
Prepared by	Shepherd Chartered Surveyors
Date of inspection	24/07/2024

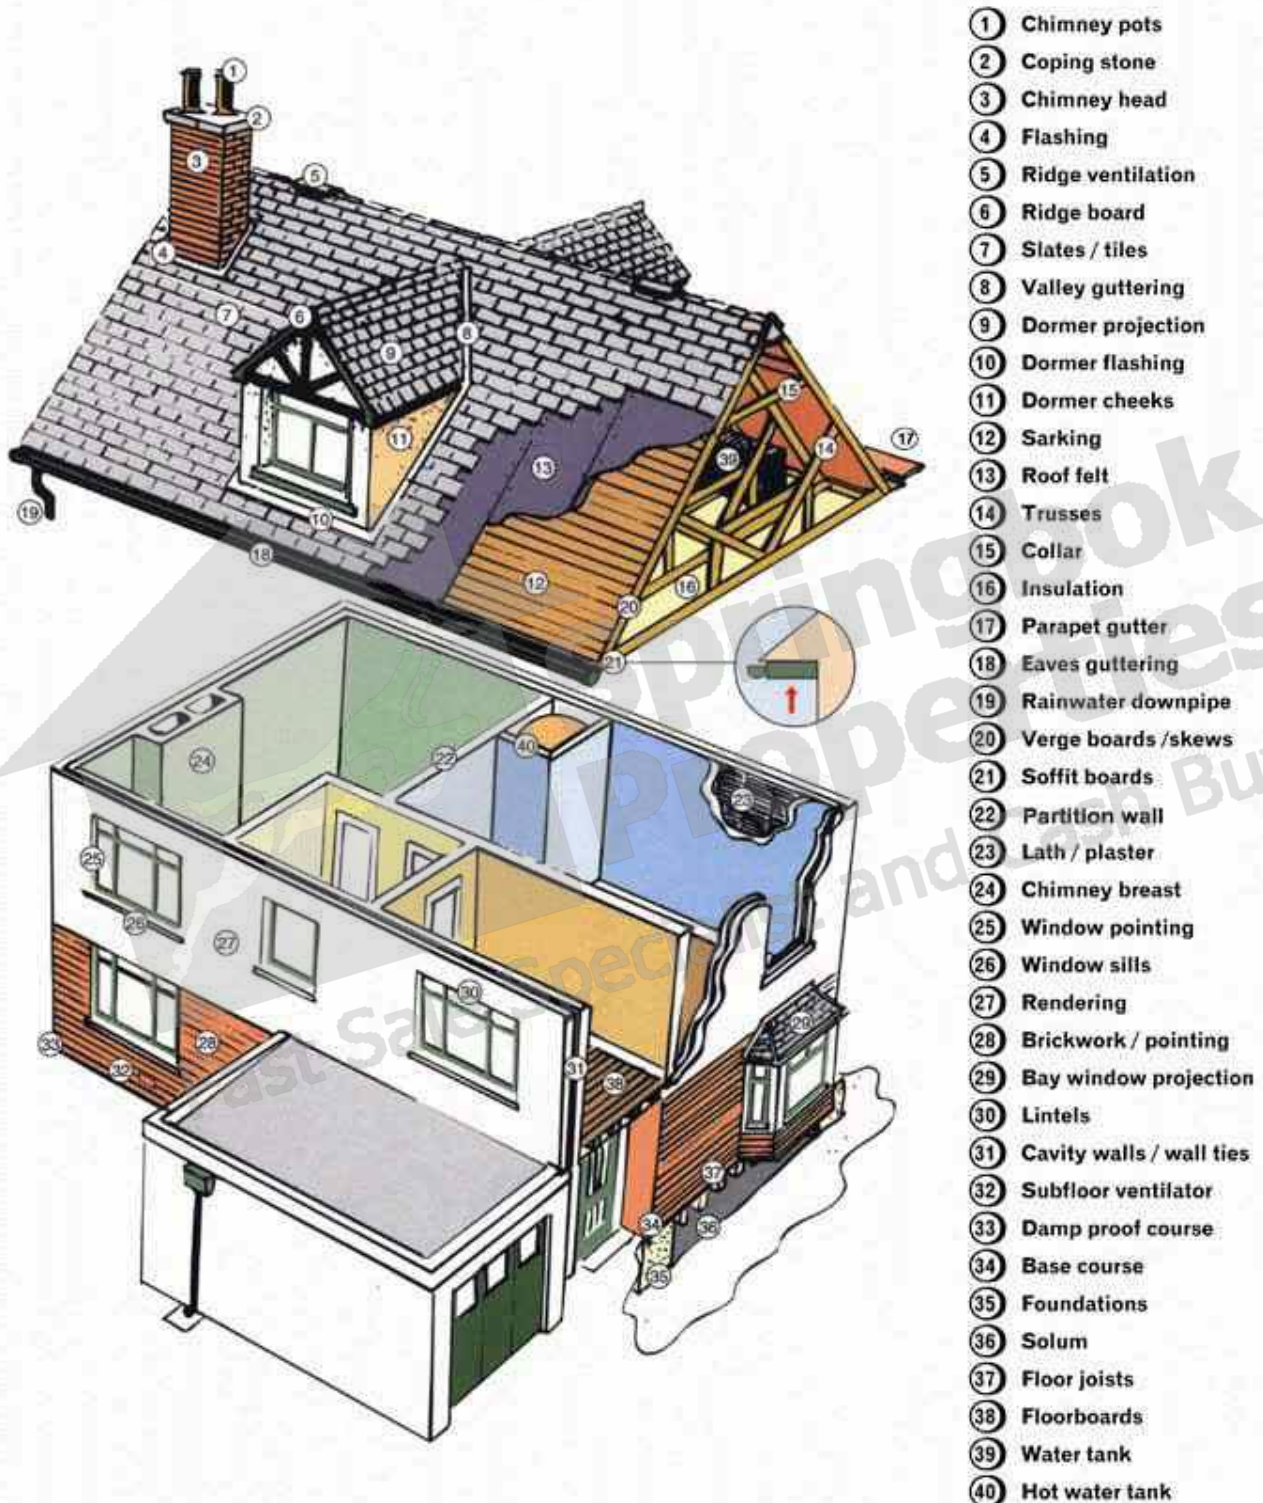
Sectional Diagram showing elements of a typical house

Reference may be made in this report to some or all of the above component parts of the property. This diagram may assist you in locating and understanding these items.
