Home Report

Single Survey

Property address	17 Clifden Blue Court Dundee DD4 0LR
Customer	Mike Barnes
Customer address	17 Clifden Blue Court Dundee DD4 0LR
Prepared by	Shepherd Chartered Surveyors
Date of inspection	26/07/2024

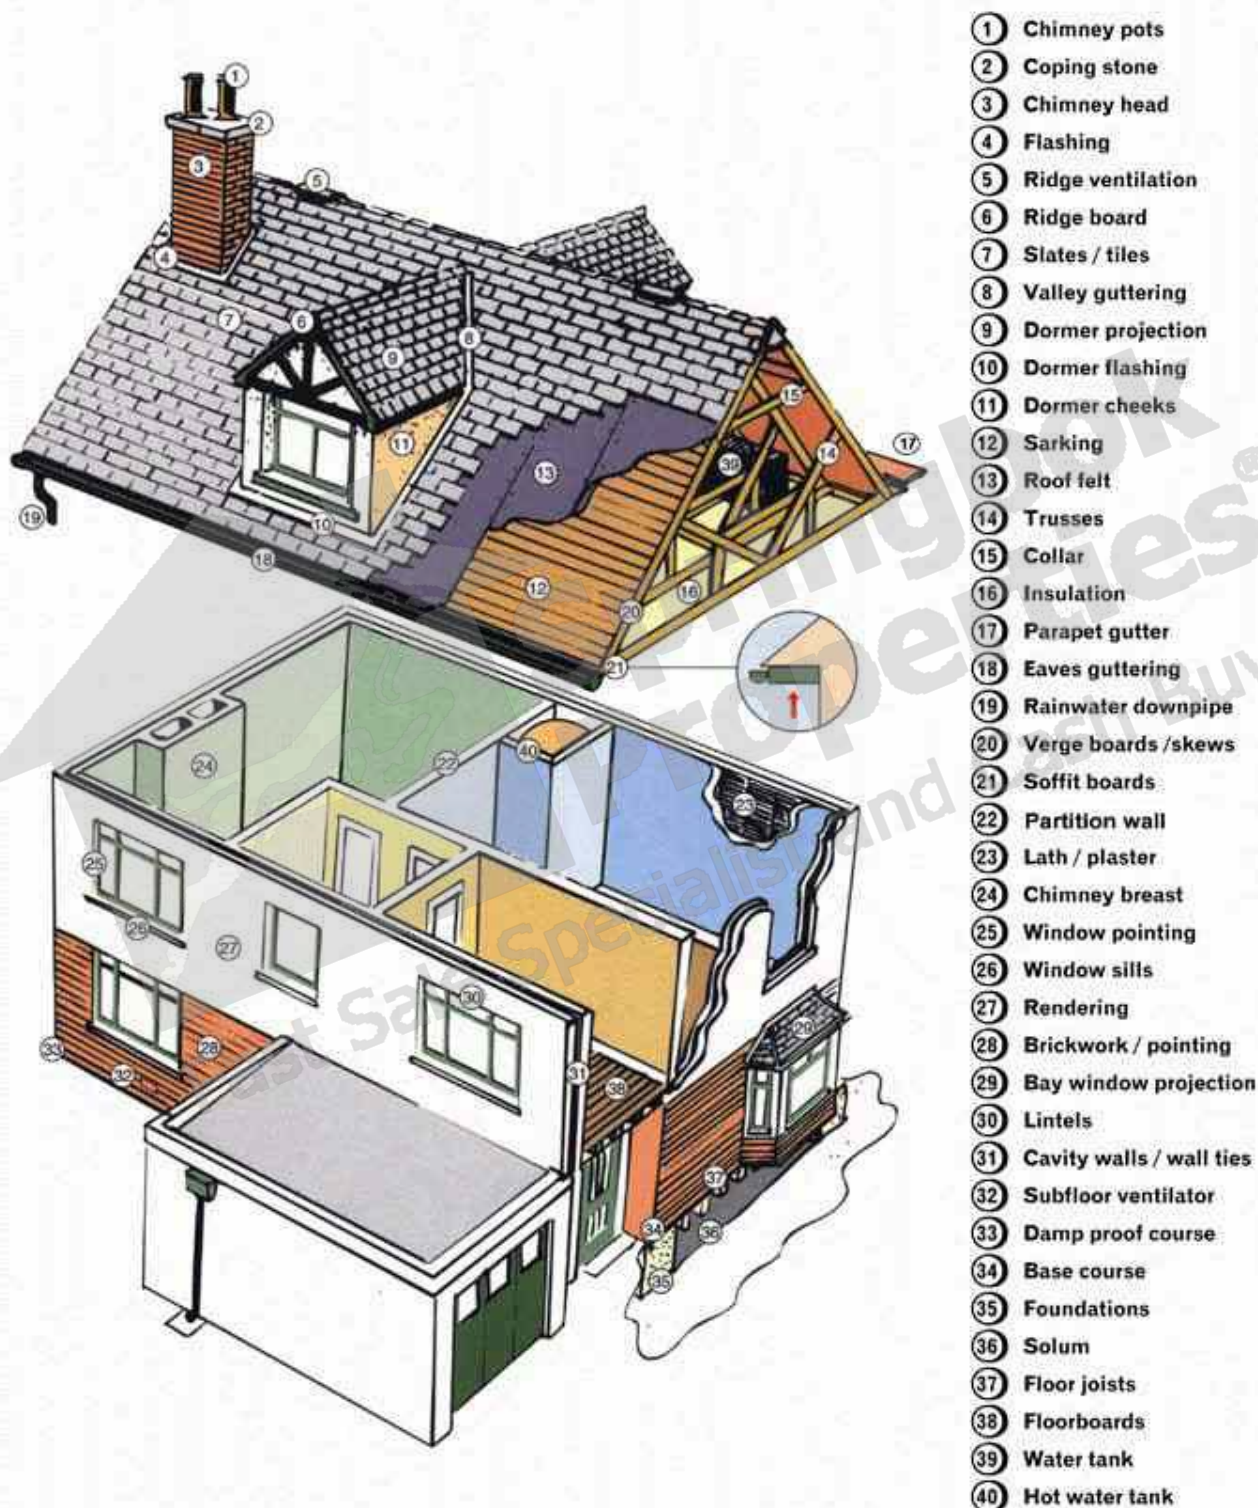
Sectional Diagram showing elements of a typical house

Reference may be made in this report to some or all of the above component parts of the property. This diagram may assist you in locating and understanding these items.

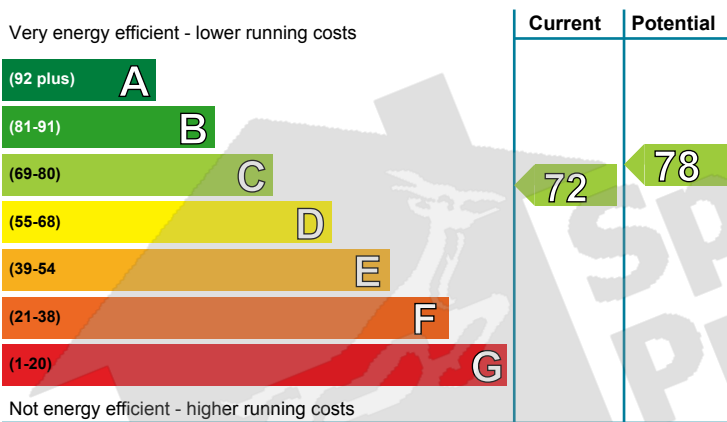
Energy Efficiency Rating

This graph shows the current efficiency of your home, taking into account both energy efficiency and fuel costs. The higher this rating, the lower your fuel bills are likely to be.

Your current rating is **band C (72)**. The average rating for EPCs in Scotland is **band D (61)**.

The potential rating shows the effect of undertaking all of the improvement measures listed within your recommendations report.

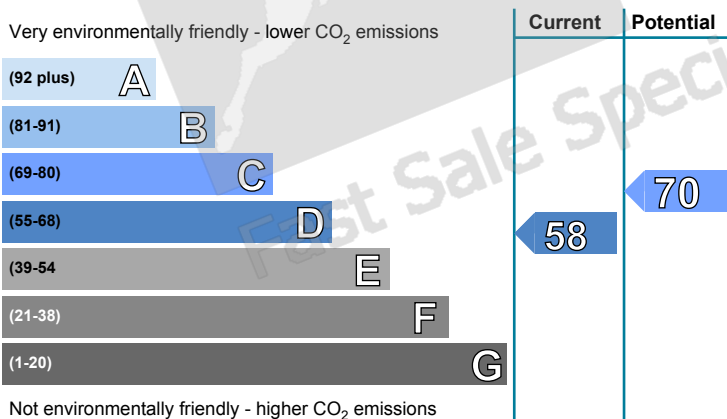
Environmental Impact (CO₂) Rating

This graph shows the effect of your home on the environment in terms of carbon dioxide (CO₂) emissions. The higher the rating, the less impact it has on the environment.
