Home Report

Single Survey

Property address	Roslyn Shanton Road Cove Helensburgh G84 0NW
Customer	Jean David
Customer address	Roslyn Shanton Road Cove Helensburgh G84 0NW
Prepared by	Shepherd Chartered Surveyors
Date of inspection	02/09/2024

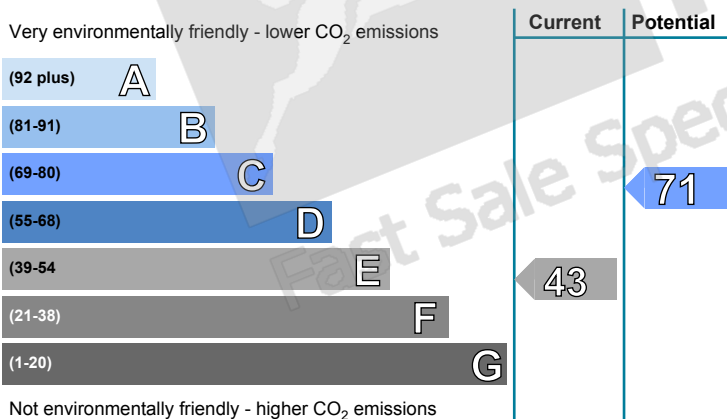
Environmental Impact (CO₂) Rating

This graph shows the effect of your home on the environment in terms of carbon dioxide (CO₂) emissions. The higher the rating, the less impact it has on the environment.
