Home Report

Scottish Single Survey

Single Survey

Property address	14 Eastmill Road Brechin DD9 7EL
Customer	Hayley Pirie
Customer address	14 Eastmill Road Brechin DD9 7EL
Prepared by	Shepherd Chartered Surveyors
Date of inspection	09/09/2024

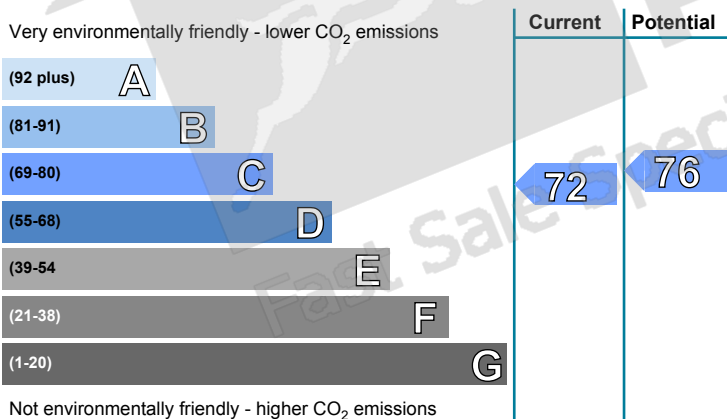
Environmental Impact (CO₂) Rating

This graph shows the effect of your home on the environment in terms of carbon dioxide (CO₂) emissions. The higher the rating, the less impact it has on the environment.
