# Home Report

# Scottish Single Survey

# Single Survey

<b>Property address</b>	The Steading Mill Of Wardes Insch AB52 6LX
<b>Customer</b>	Ms Jennifer Law
<b>Customer address</b>	The Steading Mill Of Wardes Insch AB52 6LX
<b>Prepared by</b>	Shepherd Chartered Surveyors
<b>Date of inspection</b>	01/05/2024

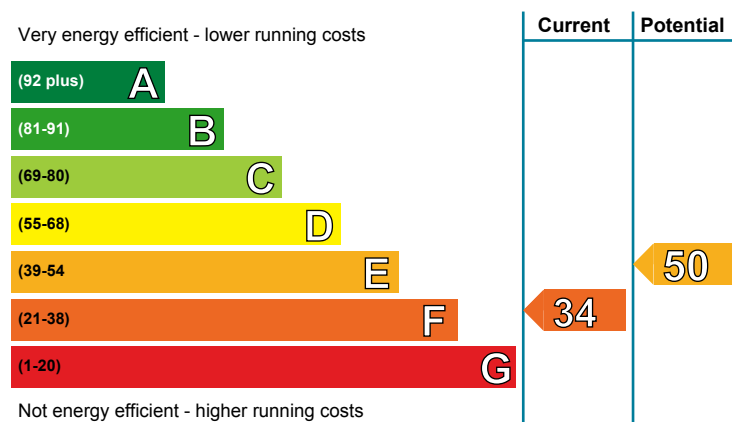
### Energy Efficiency Rating

This graph shows the current efficiency of your home, taking into account both energy efficiency and fuel costs. The higher this rating, the lower your fuel bills are likely to be.

Your current rating is **band F (34)**. The average rating for EPCs in Scotland is **band D (61)**.

The potential rating shows the effect of undertaking all of the improvement measures listed within your recommendations report.

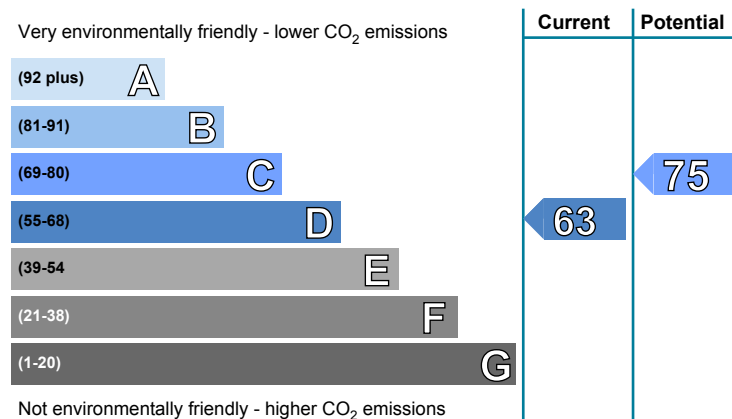
### Environmental Impact (CO<sub>2</sub>) Rating

This graph shows the effect of your home on the environment in terms of carbon dioxide (CO<sub>2</sub>) emissions. The higher the rating, the less impact it has on the environment.
