# Home Report

# Scottish Single Survey

# Single Survey

| Property address | 45A Springbank Terrace<br>Aberdeen<br>AB11 6LR |

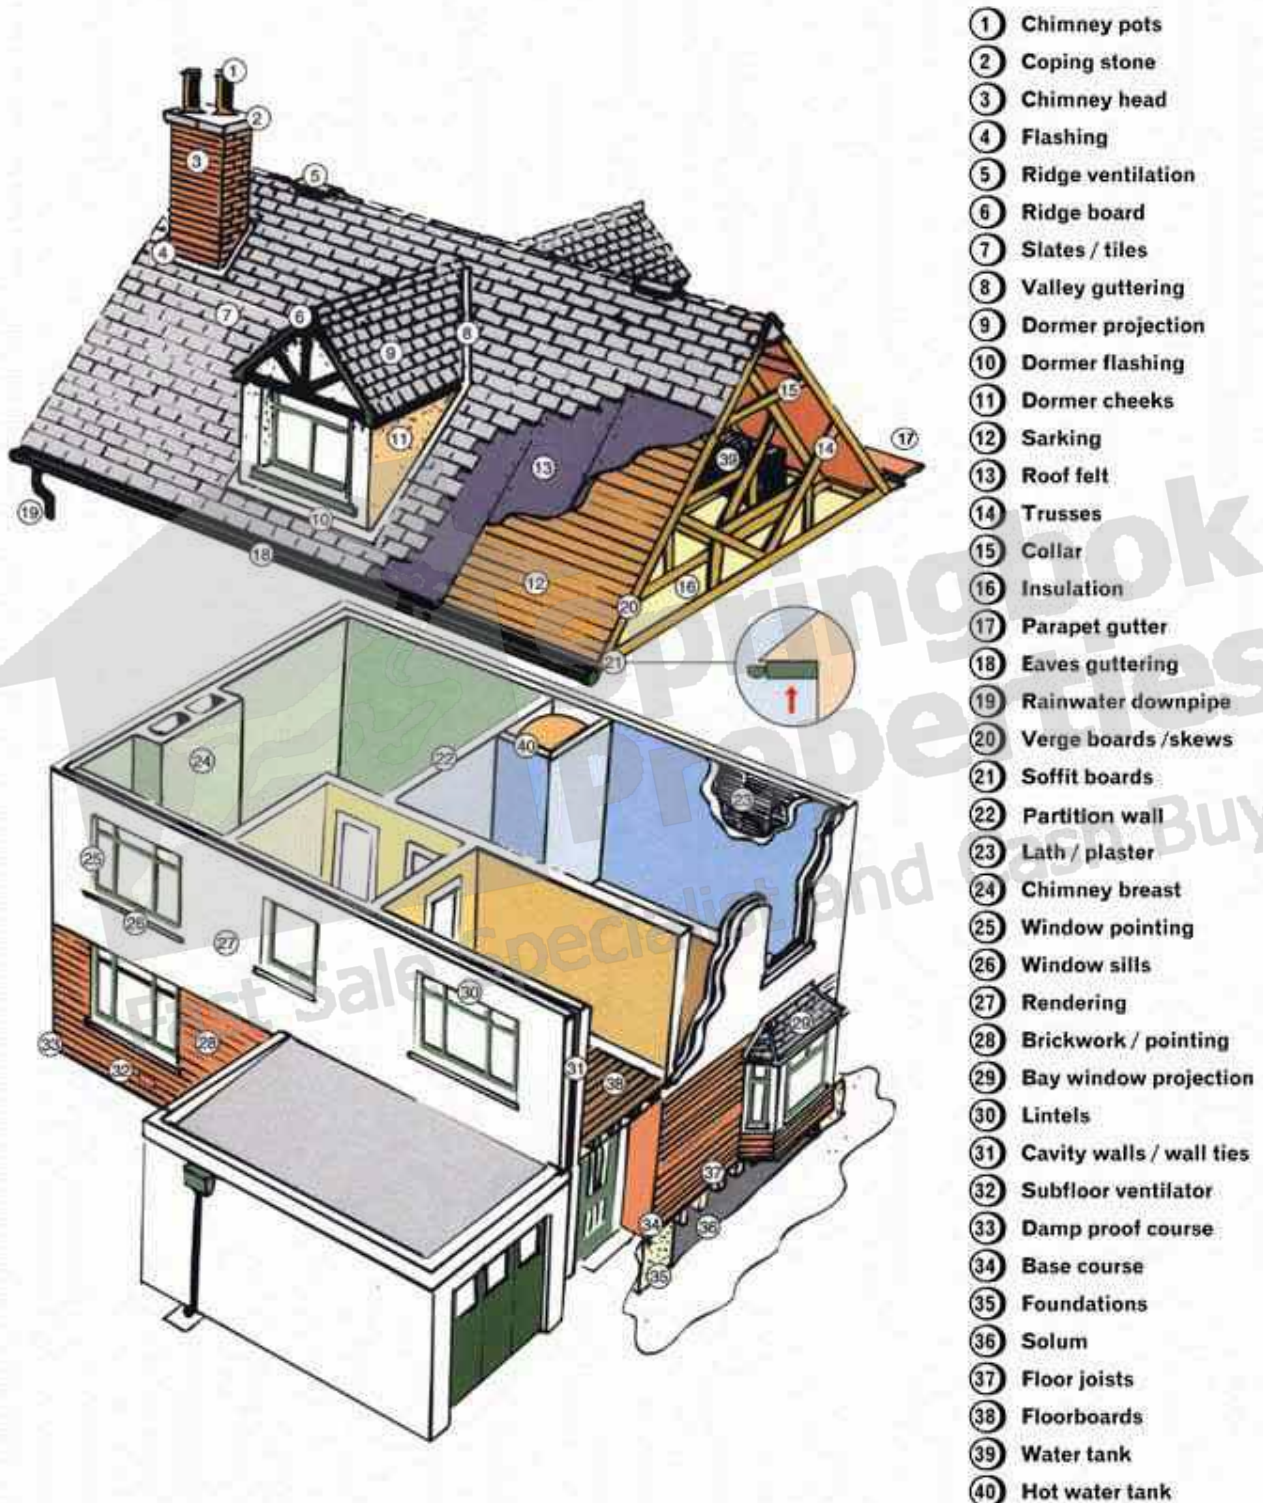
## Sectional Diagram showing elements of a typical house

Reference may be made in this report to some or all of the above component parts of the property. This diagram may assist you in locating and understanding these items.
