HOME REPORT

**200 CLEEVES QUADRANT
GLASGOW
G53 6NR**

Energy Performance Certificate (EPC)

Single Survey

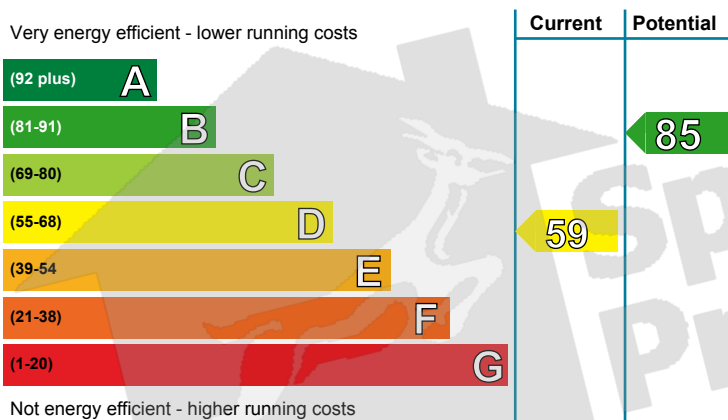
Energy Efficiency Rating

This graph shows the current efficiency of your home, taking into account both energy efficiency and fuel costs. The higher this rating, the lower your fuel bills are likely to be.

Your current rating is **band D (59)**. The average rating for EPCs in Scotland is **band D (61)**.

The potential rating shows the effect of undertaking all of the improvement measures listed within your recommendations report.

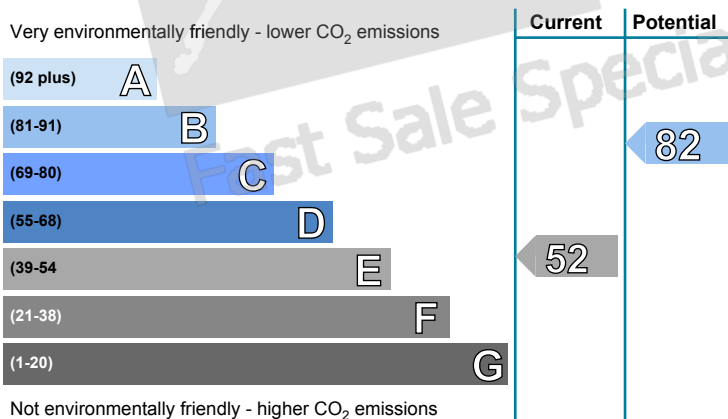
Environmental Impact (CO₂) Rating

This graph shows the effect of your home on the environment in terms of carbon dioxide (CO₂) emissions. The higher the rating, the less impact it has on the environment.

Your current rating is **band E (52)**. The average rating for EPCs in Scotland is **band D (59)**.

The potential rating shows the effect of undertaking all of the improvement measures listed within your recommendations report.

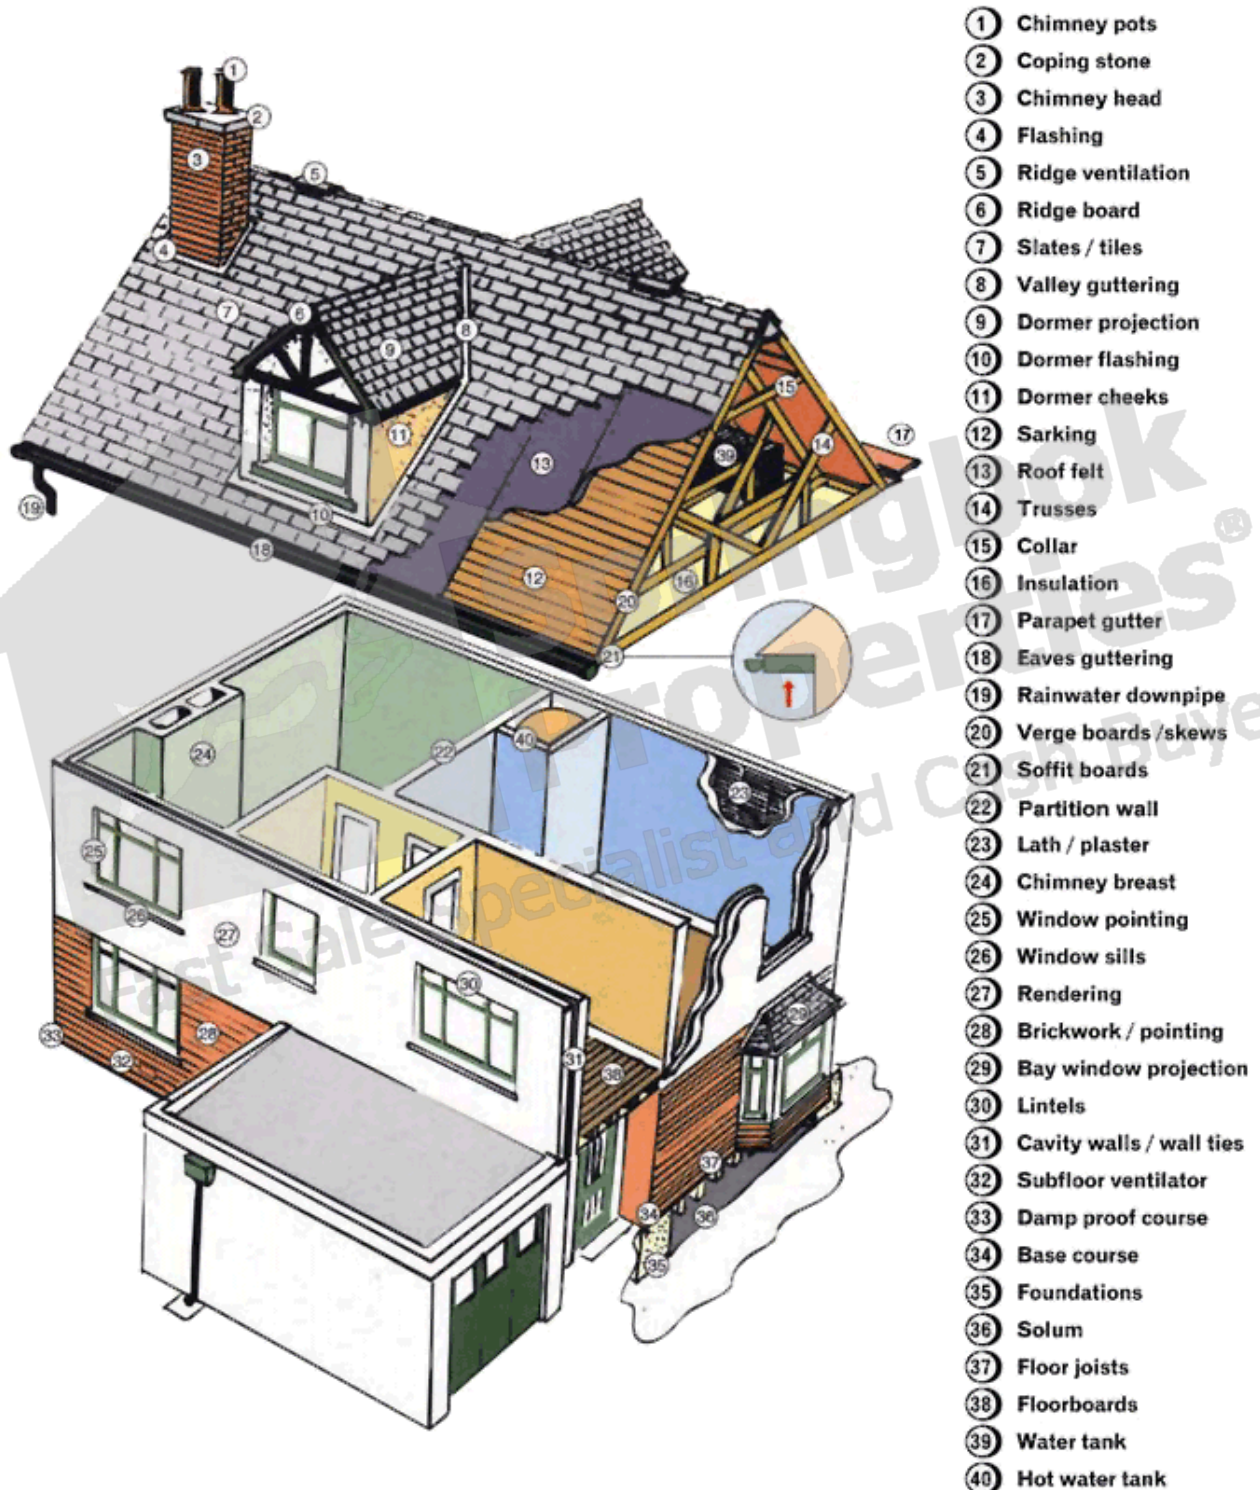
Sectional Diagram showing elements of a typical house

Reference may be made in this report to some or all of the above component parts of the property. This diagram may assist you in locating and understanding these items.
