Single Survey

survey report on:

Property address	18 Mulben Place Glasgow G53 7UQ
Customer	Shoaib Mushtaq
Customer address	18 Mulben Place Glasgow G53 7UQ
Prepared by	Shepherd Chartered Surveyors
Date of inspection	16/04/2025

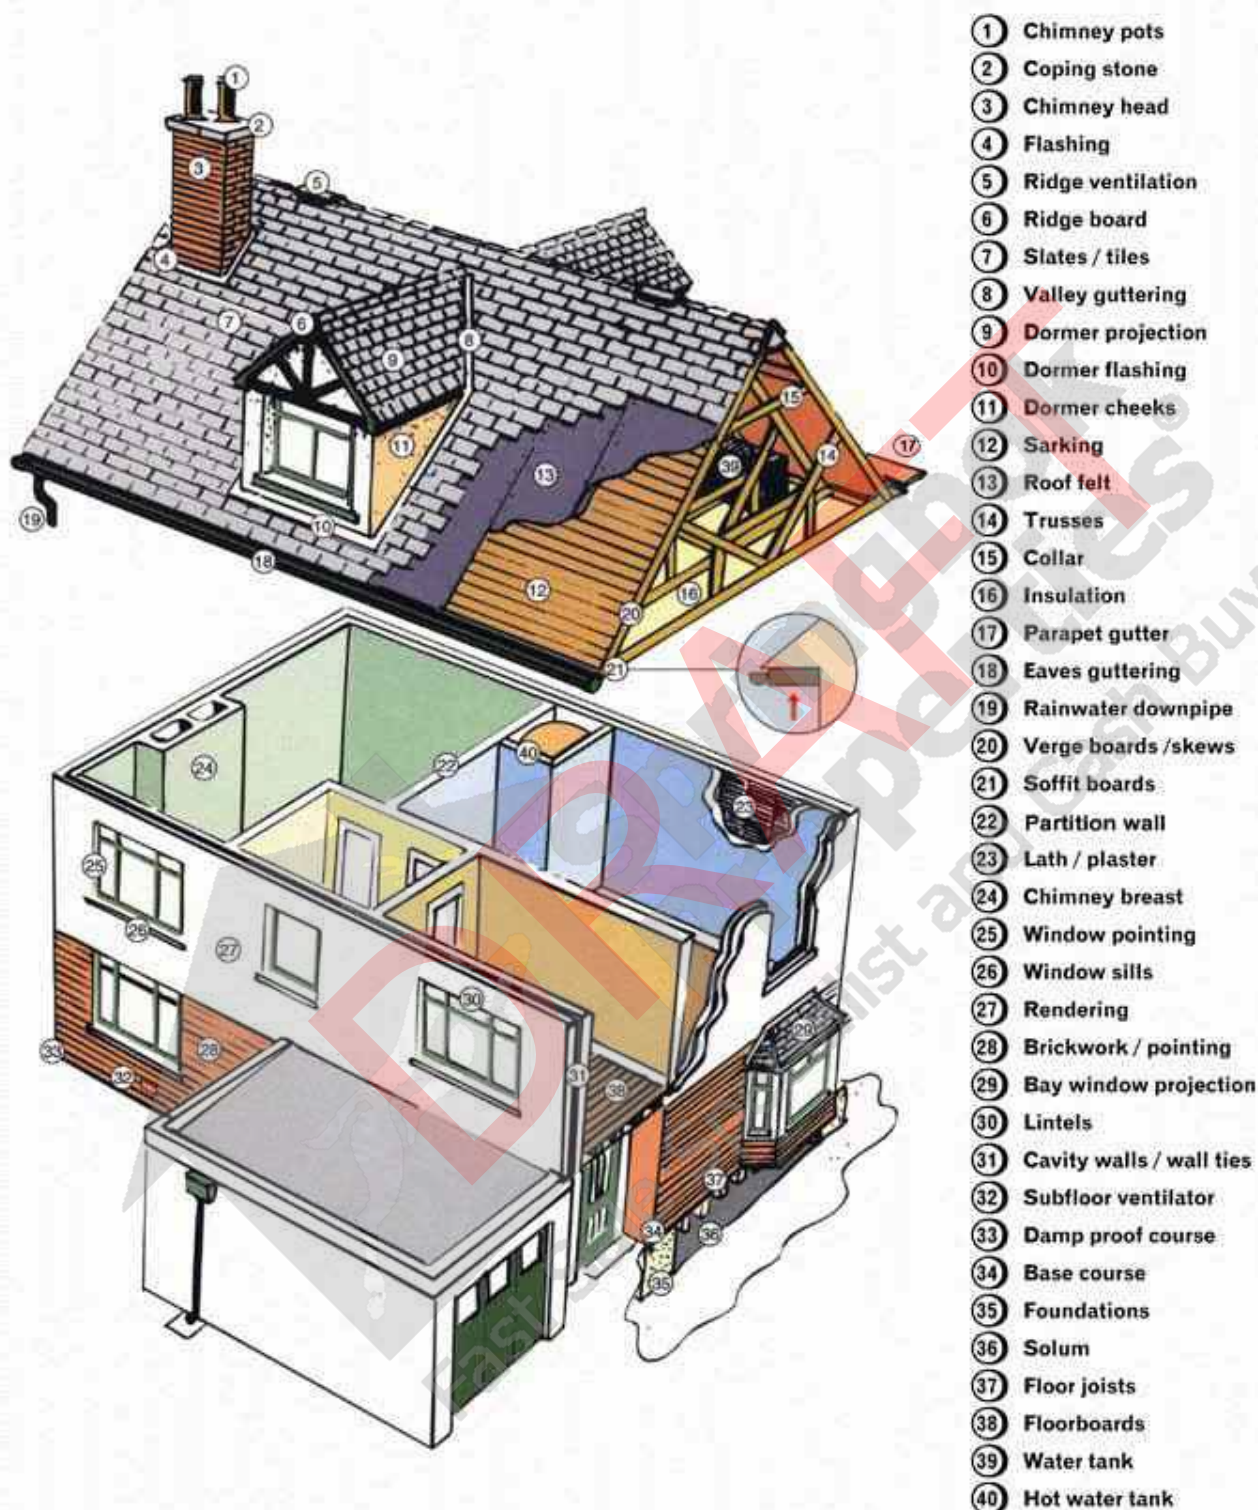
Sectional Diagram showing elements of a typical house

Reference may be made in this report to some or all of the above component parts of the property. This diagram may assist you in locating and understanding these items.
