33 Appian Place,
Motherwell,
Lanarkshire,
ML1 3FT

Home Report

Single Survey

Survey Report on:

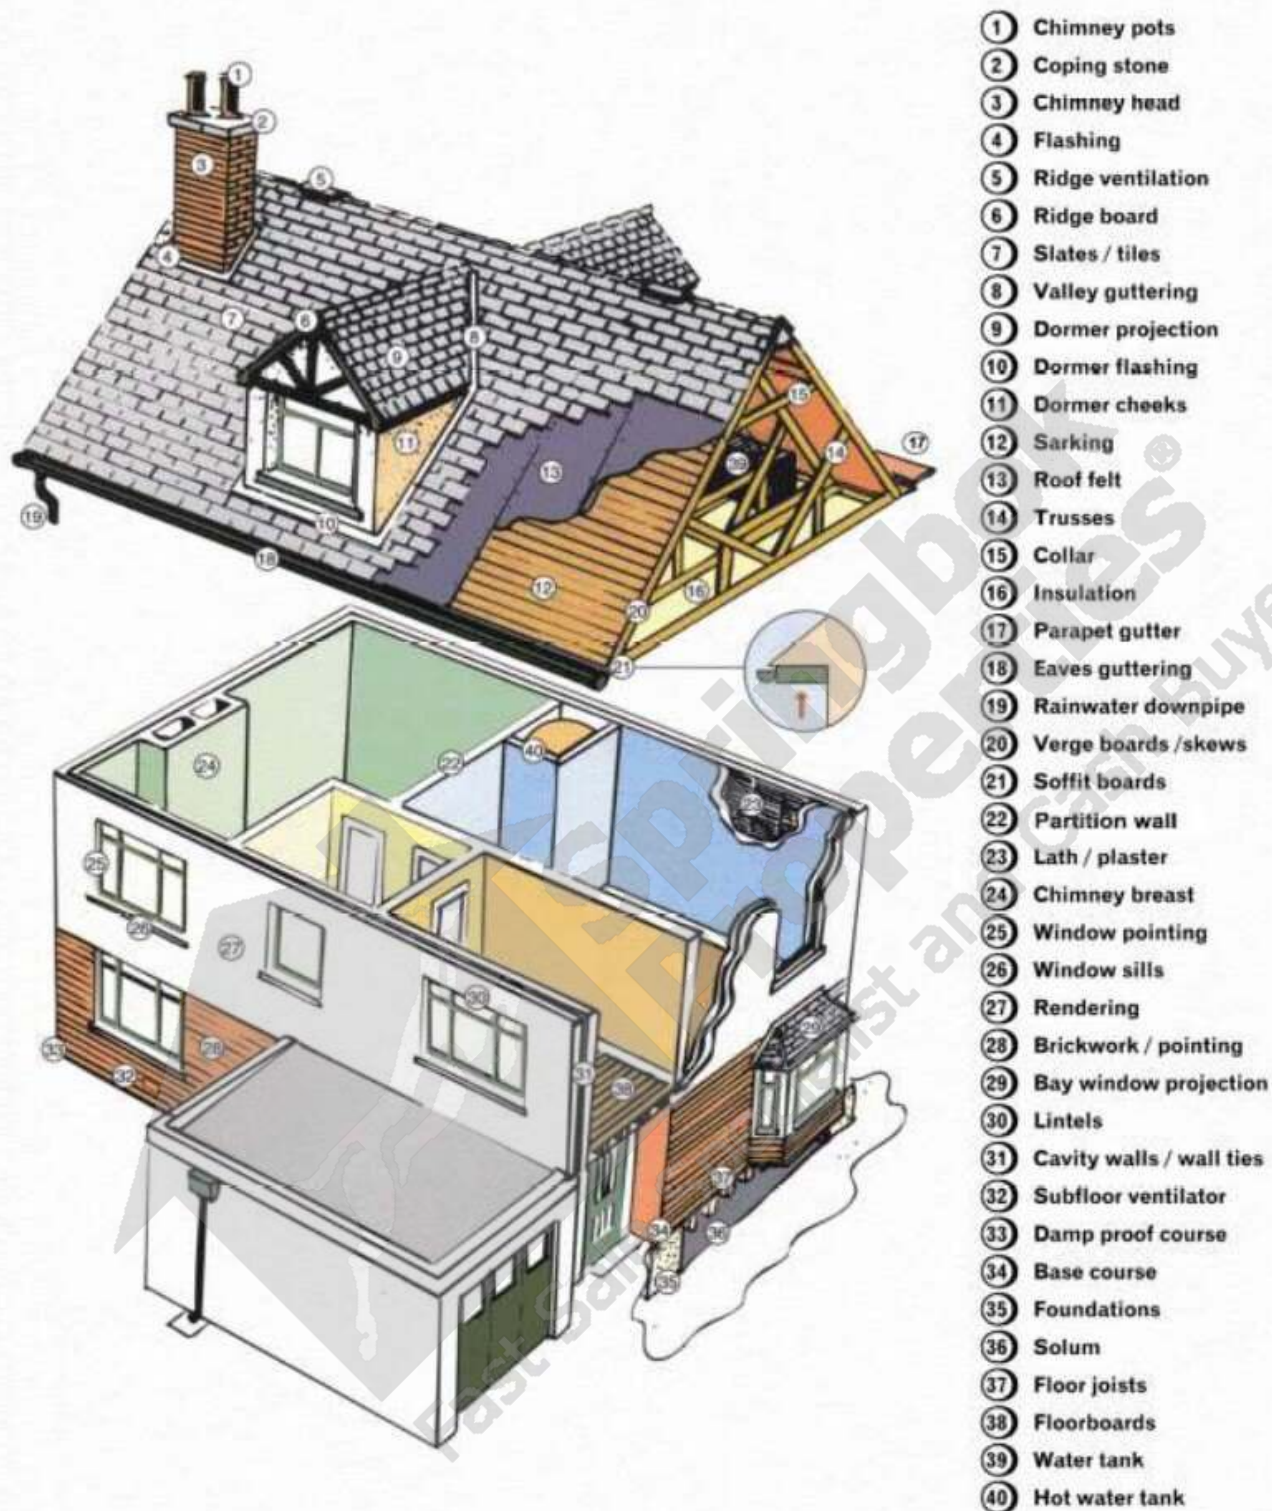
Sectional Diagram showing elements of a typical house

Reference may be made in this report to some or all of the above component parts of the property. This diagram may assist you in locating and understanding these items.
