Home Report

Single Survey

Property Address	The Orchard, Nairn Road, Ardersier, Inverness, IV2 7SE
Reference	1036092
Customer Name	
Date of Inspection	29th April 2025
Surveyor's name, qualifications and office	Colin MacGregor BSc (Hons) MRICS DM Hall LLP Chartered Surveyors Hope House, Cradlehall Business Park, Castlehill Drive Cradlehall Inverness IV2 5GH Tel: 01463 241077 email: invernessresidential@dmhall.co.uk
Prepared By	DM Hall LLP

Description	The property is a detached bungalow.
Accommodation	Ground Floor: Living and Dining room, Dining Kitchen, 2 Bedrooms and Bathroom.
Gross Internal Floor Area (m2)	Approximately 121m ² .
Neighbourhood and Location	The property forms part of an established residential area in the village of Ardersier. The surrounding properties in the immediate vicinity are generally of a differing age and style. A range of typical local amenities can be found in nearby towns and villages.
Age	Built around 1986.
Weather	It was sunny and dry, following generally similar conditions.
Chimney Stacks	Visually inspected with the aid of binoculars where appropriate. There is a chimney stack of concrete block construction. This has a render finish. There is a met

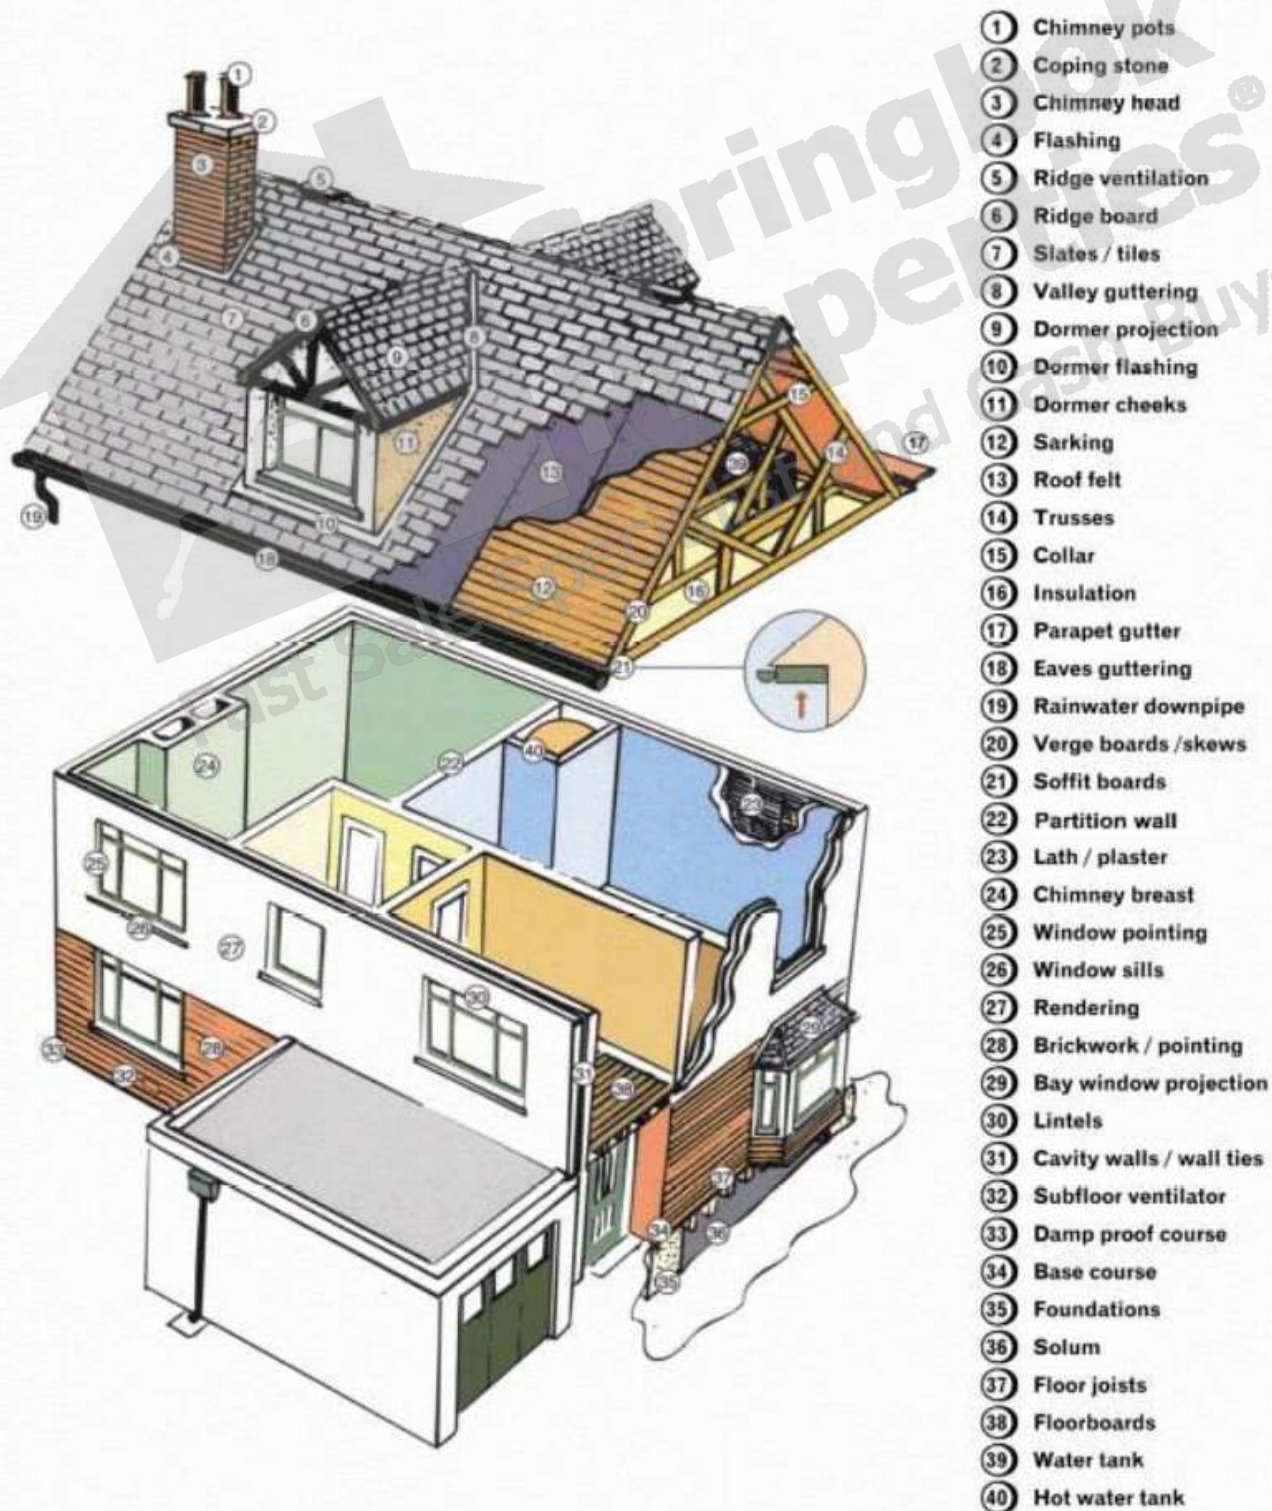
Sectional Diagram showing elements of a typical house

Reference may be made in this report to some or all of the above component parts of the property. This diagram may assist you in locating and understanding these items.

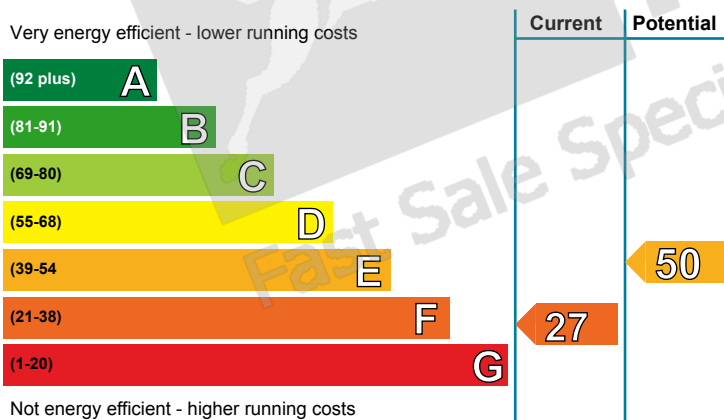
Energy Efficiency Rating

This graph shows the current efficiency of your home, taking into account both energy efficiency and fuel costs. The higher this rating, the lower your fuel bills are likely to be.

The potential rating shows the effect of undertaking all of the improvement measures listed within your recommendations report.
