# Home Report

# Single Survey

| Property address | 1/1<br>26 Kelly Street<br>Greenock<br>PA16 8LA |
| Prepared by | Shepherd Chartered Surveyors |

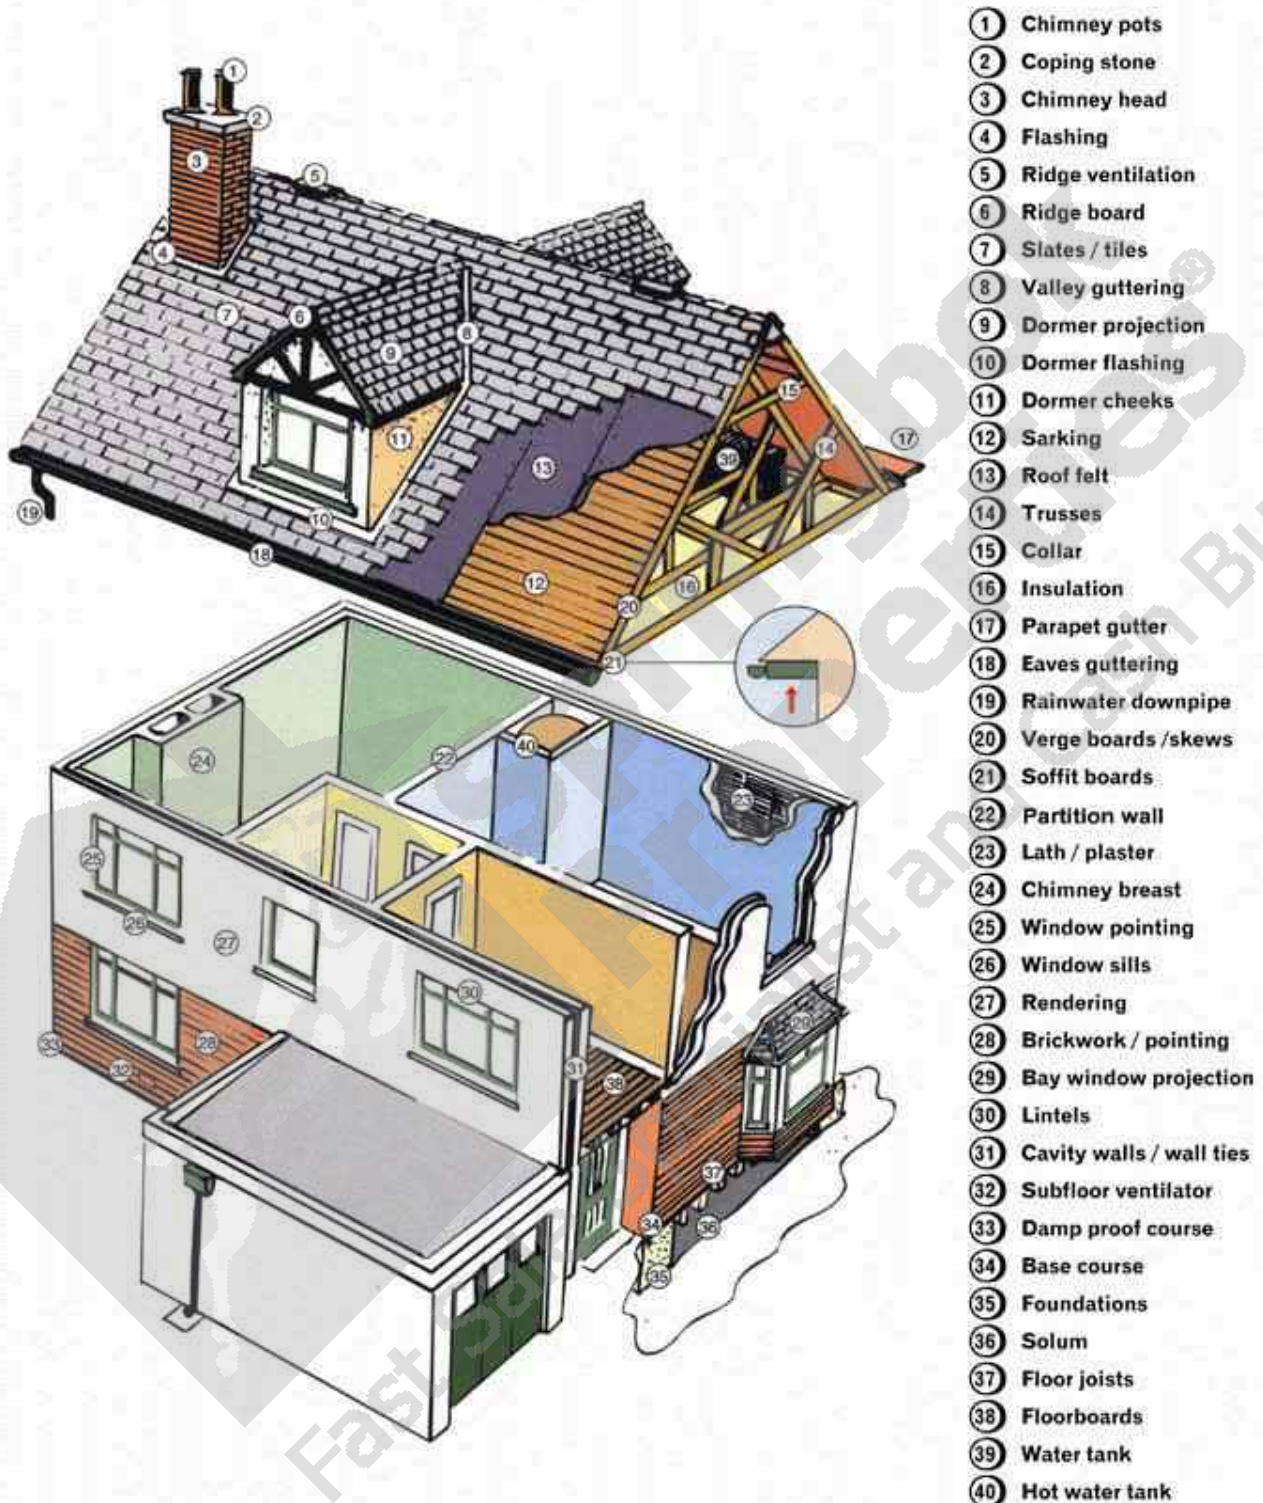
## Sectional Diagram showing elements of a typical house

Reference may be made in this report to some or all of the above component parts of the property. This diagram may assist you in locating and understanding these items.

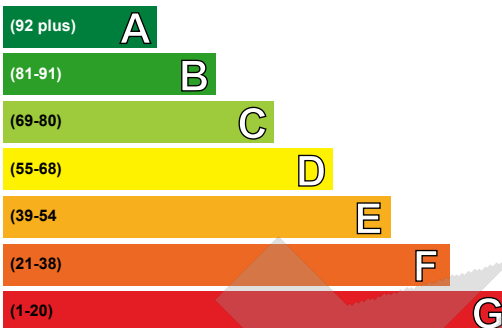
\* based upon the cost of energy for heating, hot water, lighting and ventilation, calculated using standard assumptions

Very energy efficient - lower running costs

Not energy efficient - higher running costs

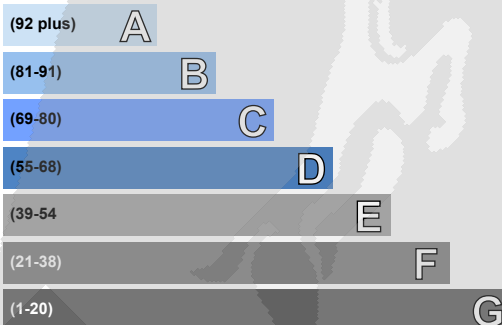
Very environmentally friendly - lower CO<sub>2</sub> emissions

Not environmentally friendly - higher CO<sub>2</sub> emissions
