# Home Report

# Single Survey

| Property address | 62 Urquhart Road<br>Aberdeen<br>AB24 5LX |
| Prepared by | Shepherd Chartered Surveyors |

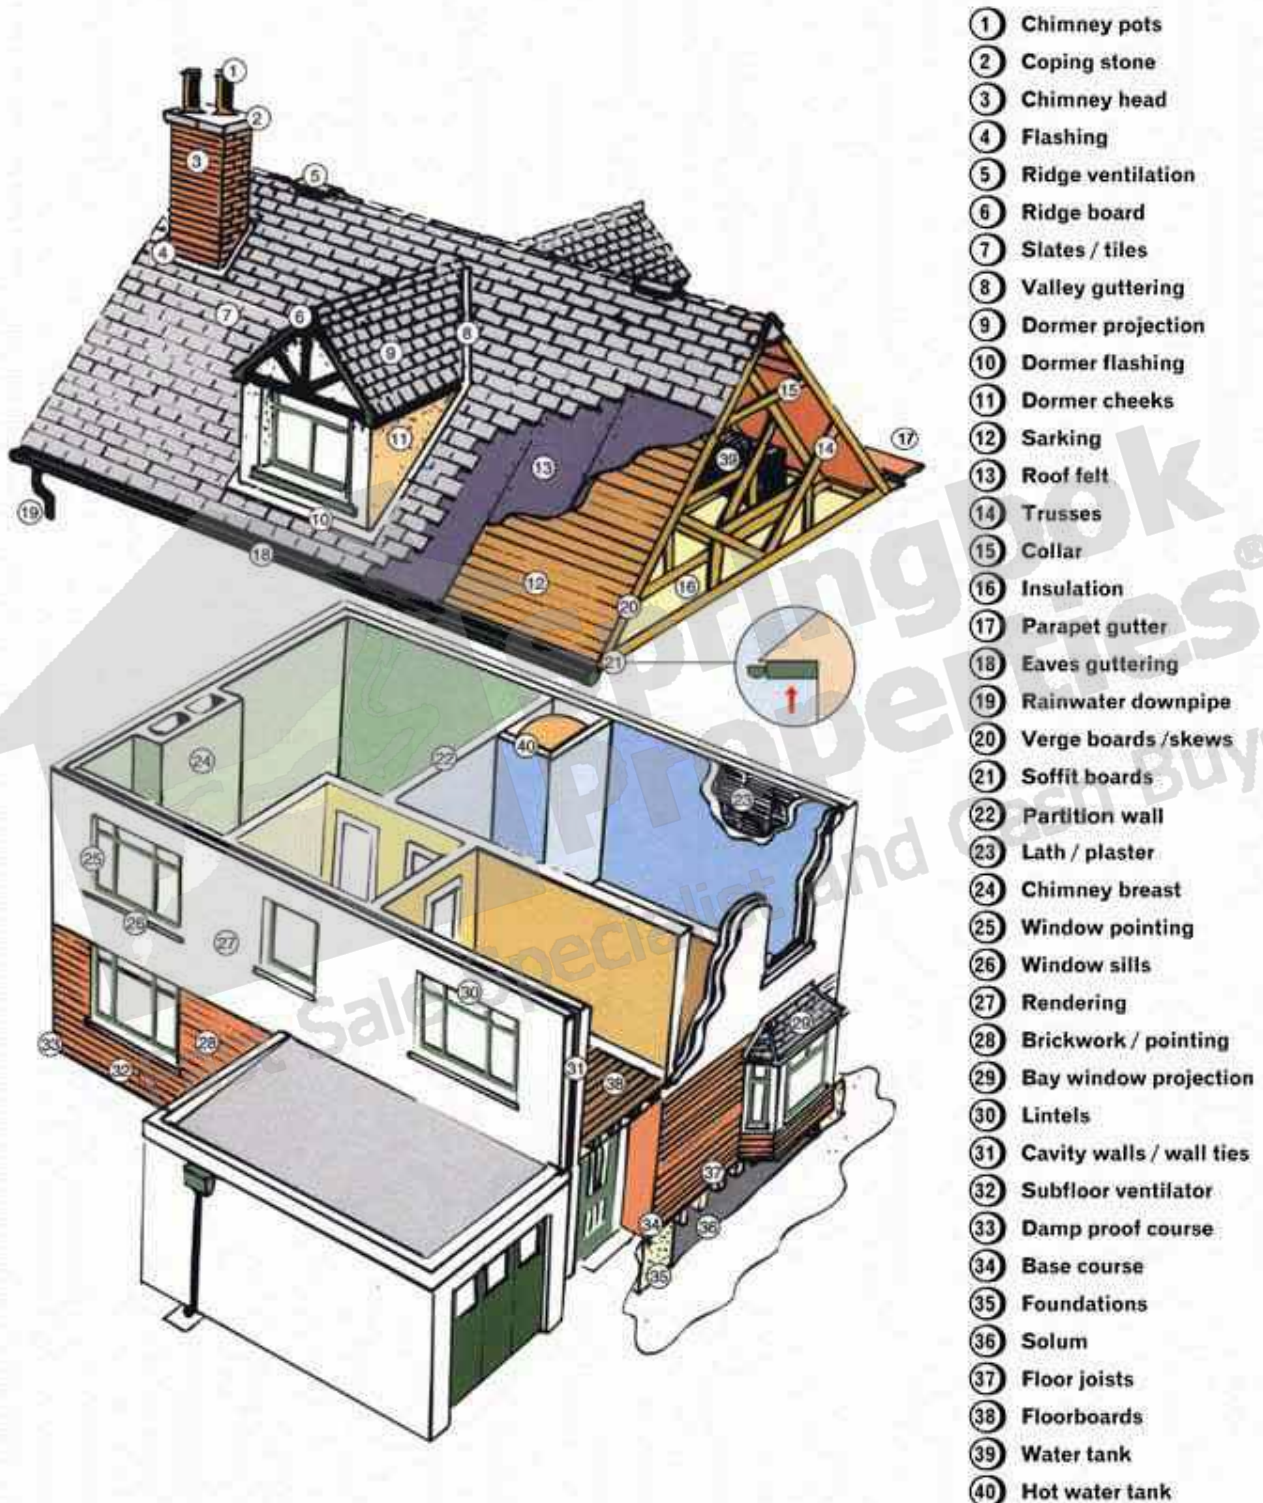
## Sectional Diagram showing elements of a typical house

Reference may be made in this report to some or all of the above component parts of the property. This diagram may assist you in locating and understanding these items.
