# Home Report

# Single Survey

| <b>Property Address</b> | 7 Crimon Place,<br>Aberdeen,<br>Aberdeenshire,<br>AB10 1RX |
| <b>Surveyor's name, qualifications and office</b> | Greg Donald BSc (Hons) MRICS<br>4-5 Union Terrace, Aberdeen AB10 1NJ |

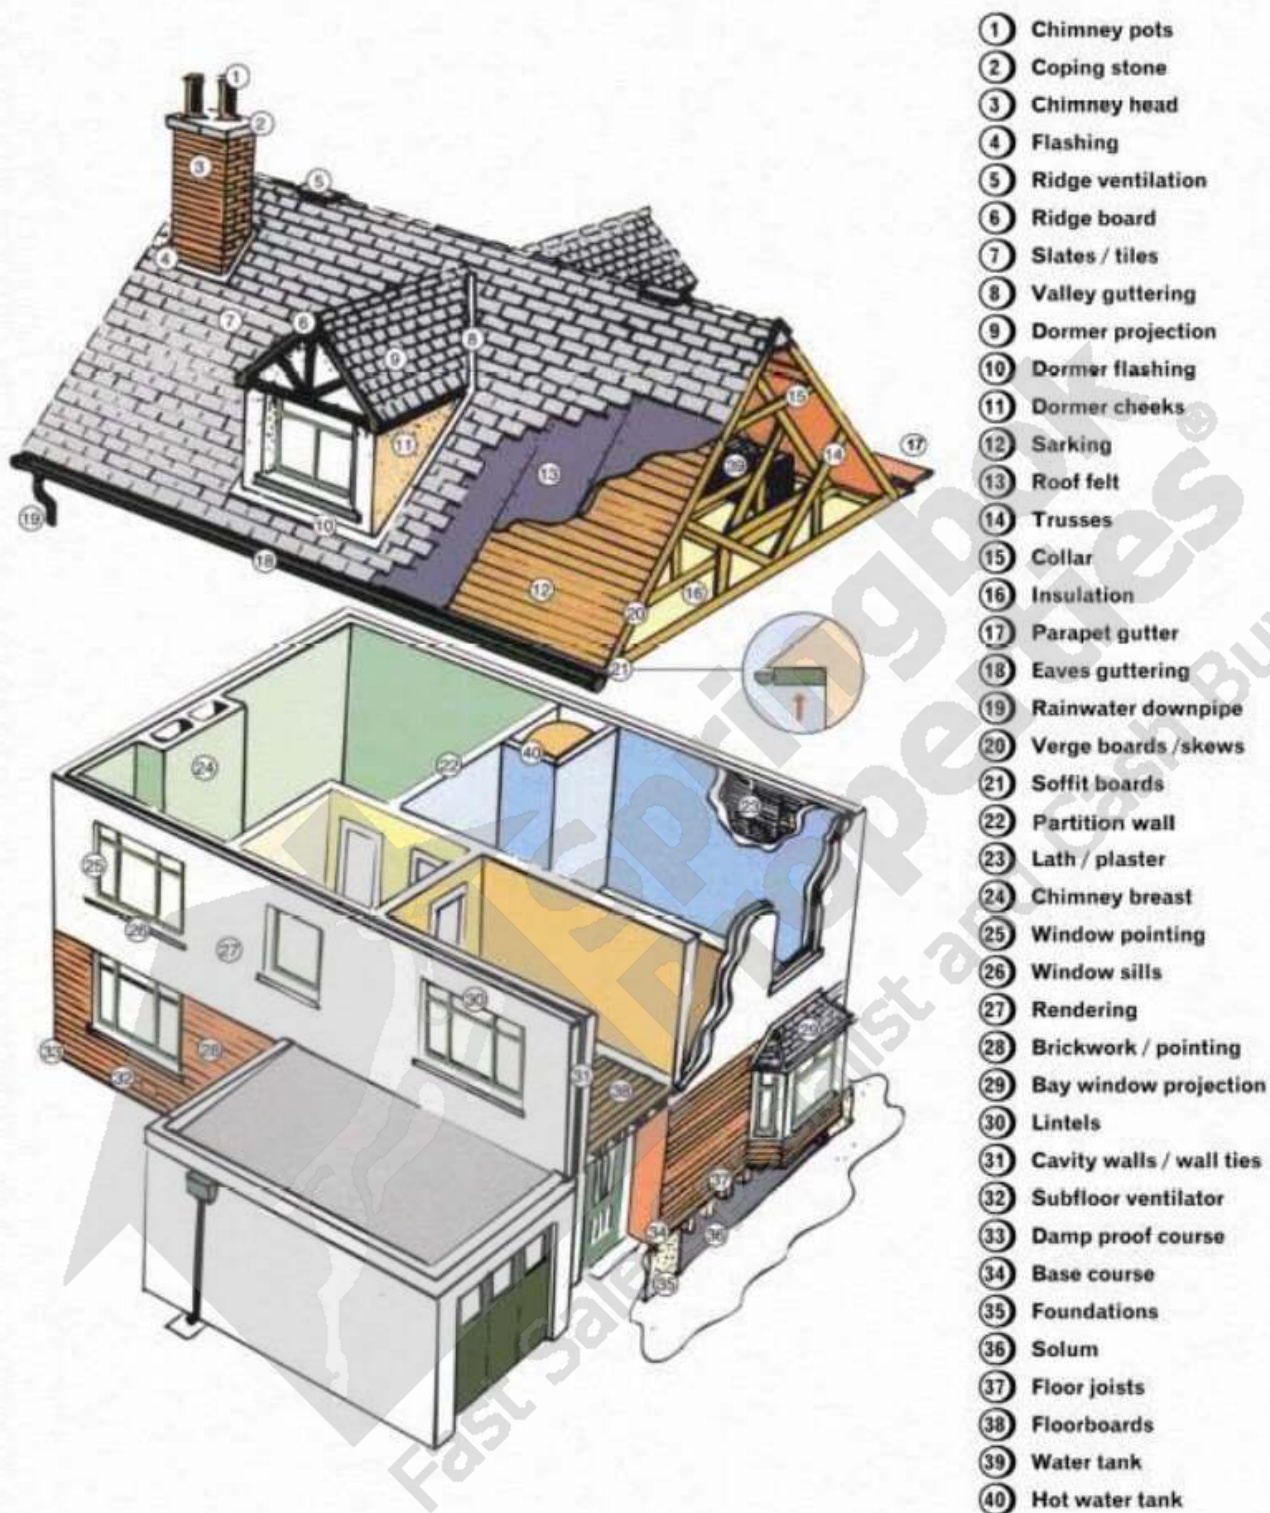
## Sectional Diagram showing elements of a typical house

Reference may be made in this report to some or all of the above component parts of the property. This diagram may assist you in locating and understanding these items.
