# Home Report

6A Mitchell Street  
Crieff PH7 3AG

Date of Valuation: 16/01/2025

# Single Survey

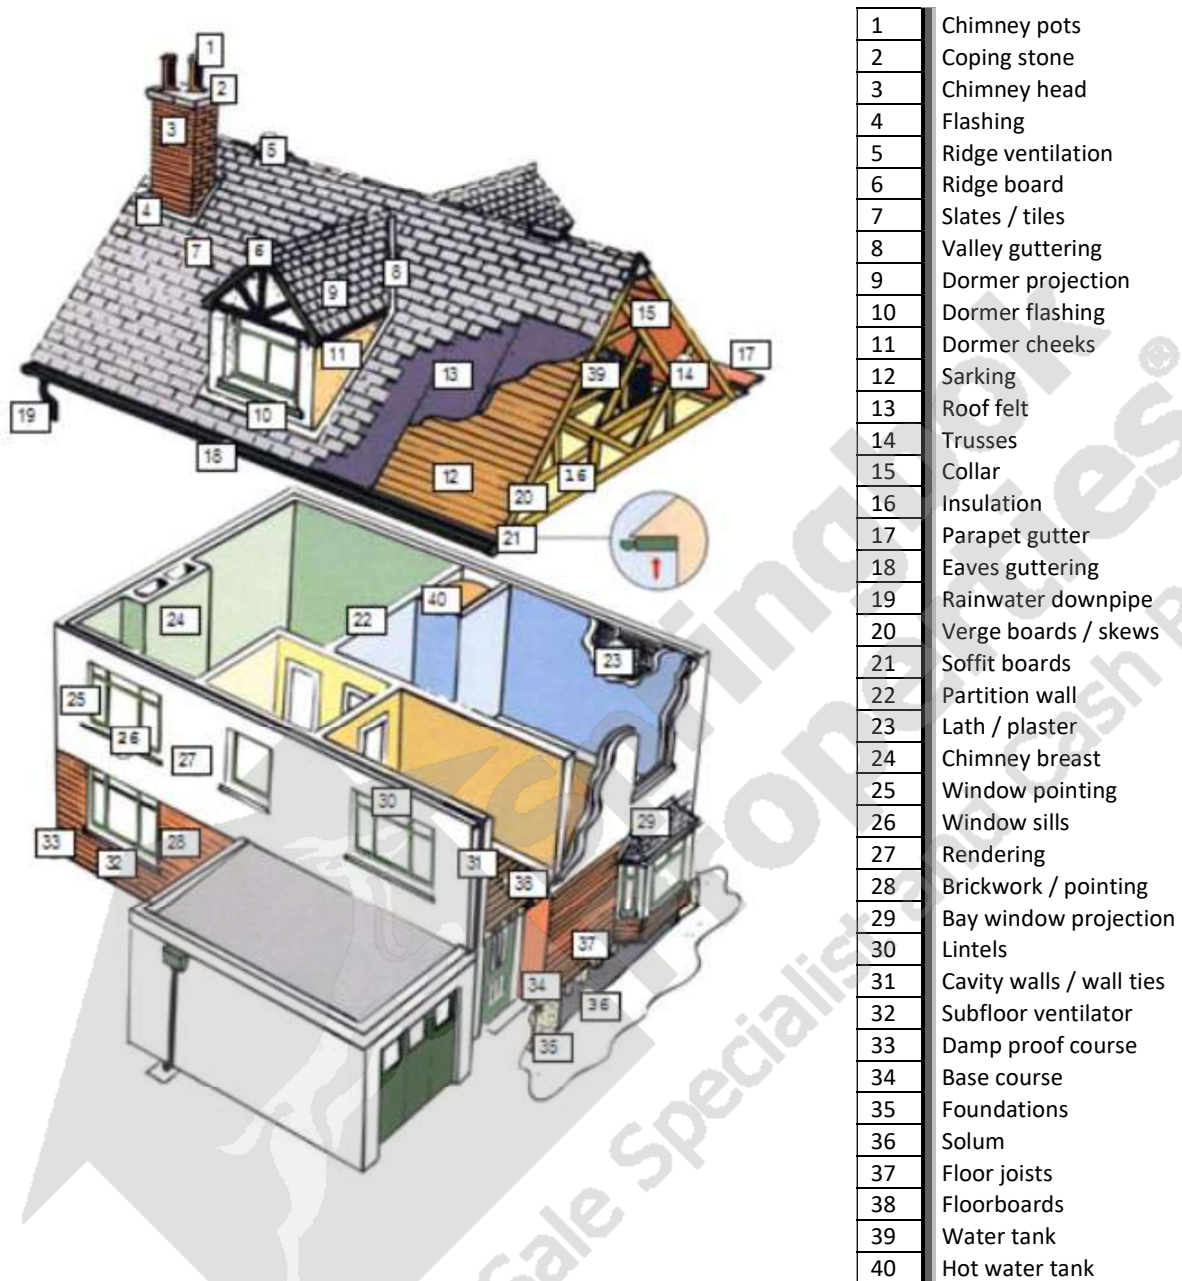
## Sectional diagram showing elements of a typical house

Reference may be made in this report to some or all of the above component parts of the property. This diagram may assist you in locating and understanding these items.

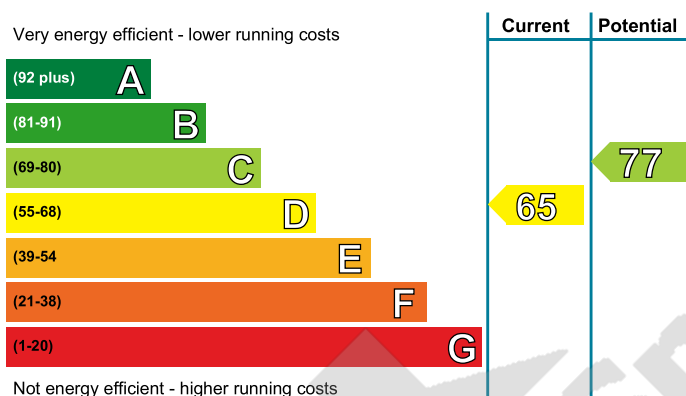
## Energy Efficiency Rating

This graph shows the current efficiency of your home, taking into account both energy efficiency and fuel costs. The higher this rating, the lower your fuel bills are likely to be.

Your current rating is **band D (65)**. The average rating for EPCs in Scotland is **band D (61)**.

The potential rating shows the effect of undertaking all of the improvement measures listed within your recommendations report.

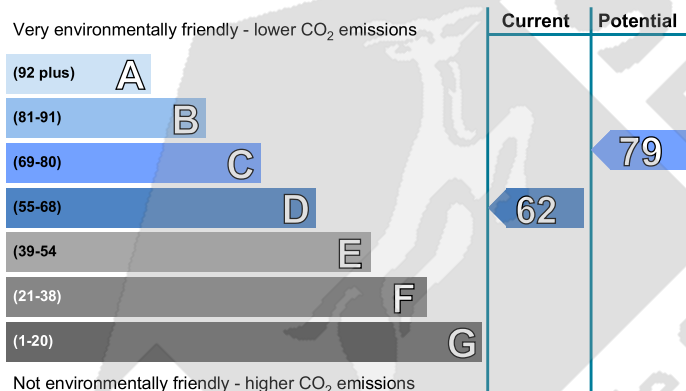
## Environmental Impact (CO<sub>2</sub>) Rating

This graph shows the effect of your home on the environment in terms of carbon dioxide (CO<sub>2</sub>) emissions. The higher the rating, the less impact it has on the environment.
