# Home Report

# Single Survey

| Property address | 2/3<br>5 Causewayside Street<br>Glasgow<br>G32 8LT |
| Prepared by | Shepherd Chartered Surveyors |

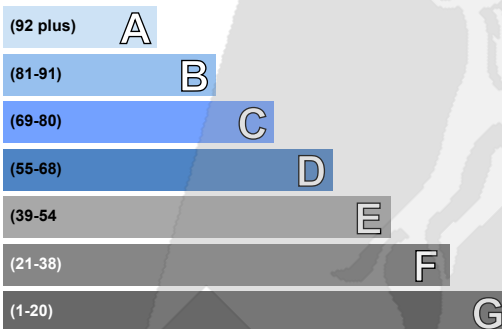
Very environmentally friendly - lower CO<sub>2</sub> emissions

Not environmentally friendly - higher CO<sub>2</sub> emissions
