# Home Report

# Single Survey

| Property address | Murray<br>64 Carfin Street<br>Motherwell<br>ML1 4JL |
| Prepared by | Shepherd Chartered Surveyors |

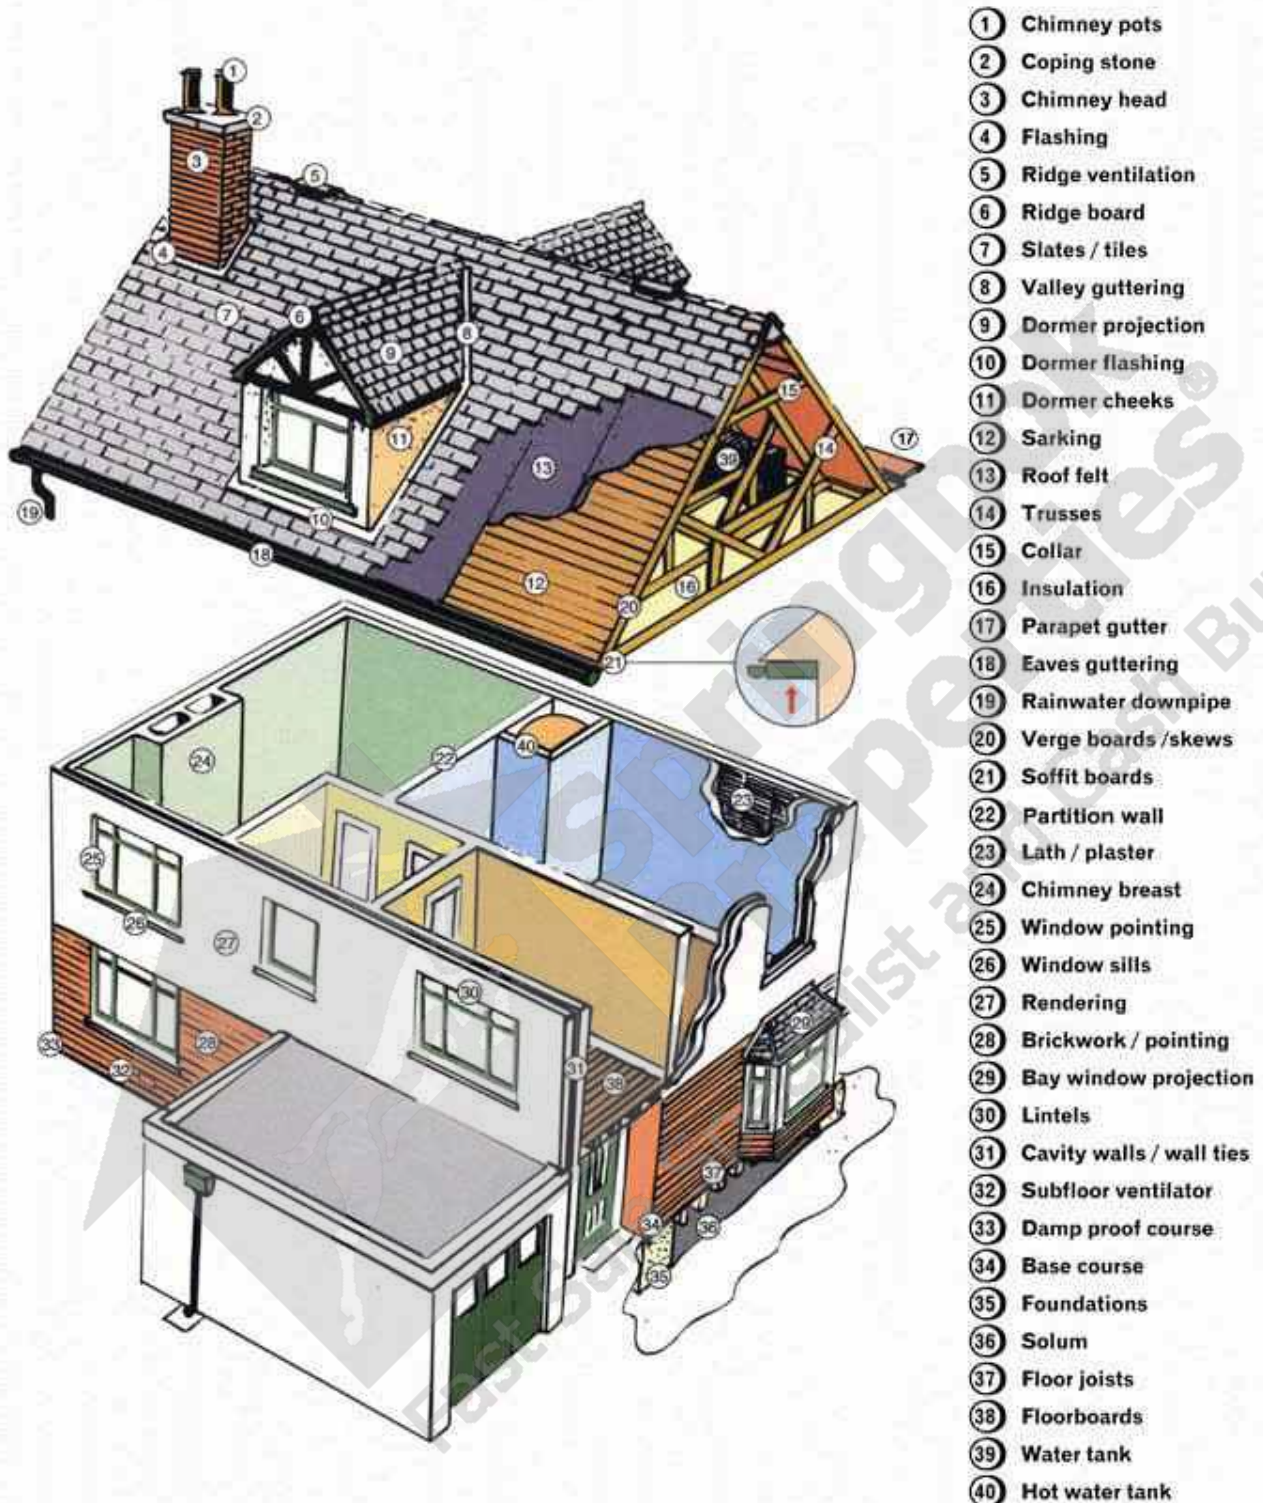
## Sectional Diagram showing elements of a typical house

Reference may be made in this report to some or all of the above component parts of the property. This diagram may assist you in locating and understanding these items.
