# Home Report

# Single Survey

| Property address | 52 Abbotswell Drive<br>Aberdeen<br>AB12 5QN |

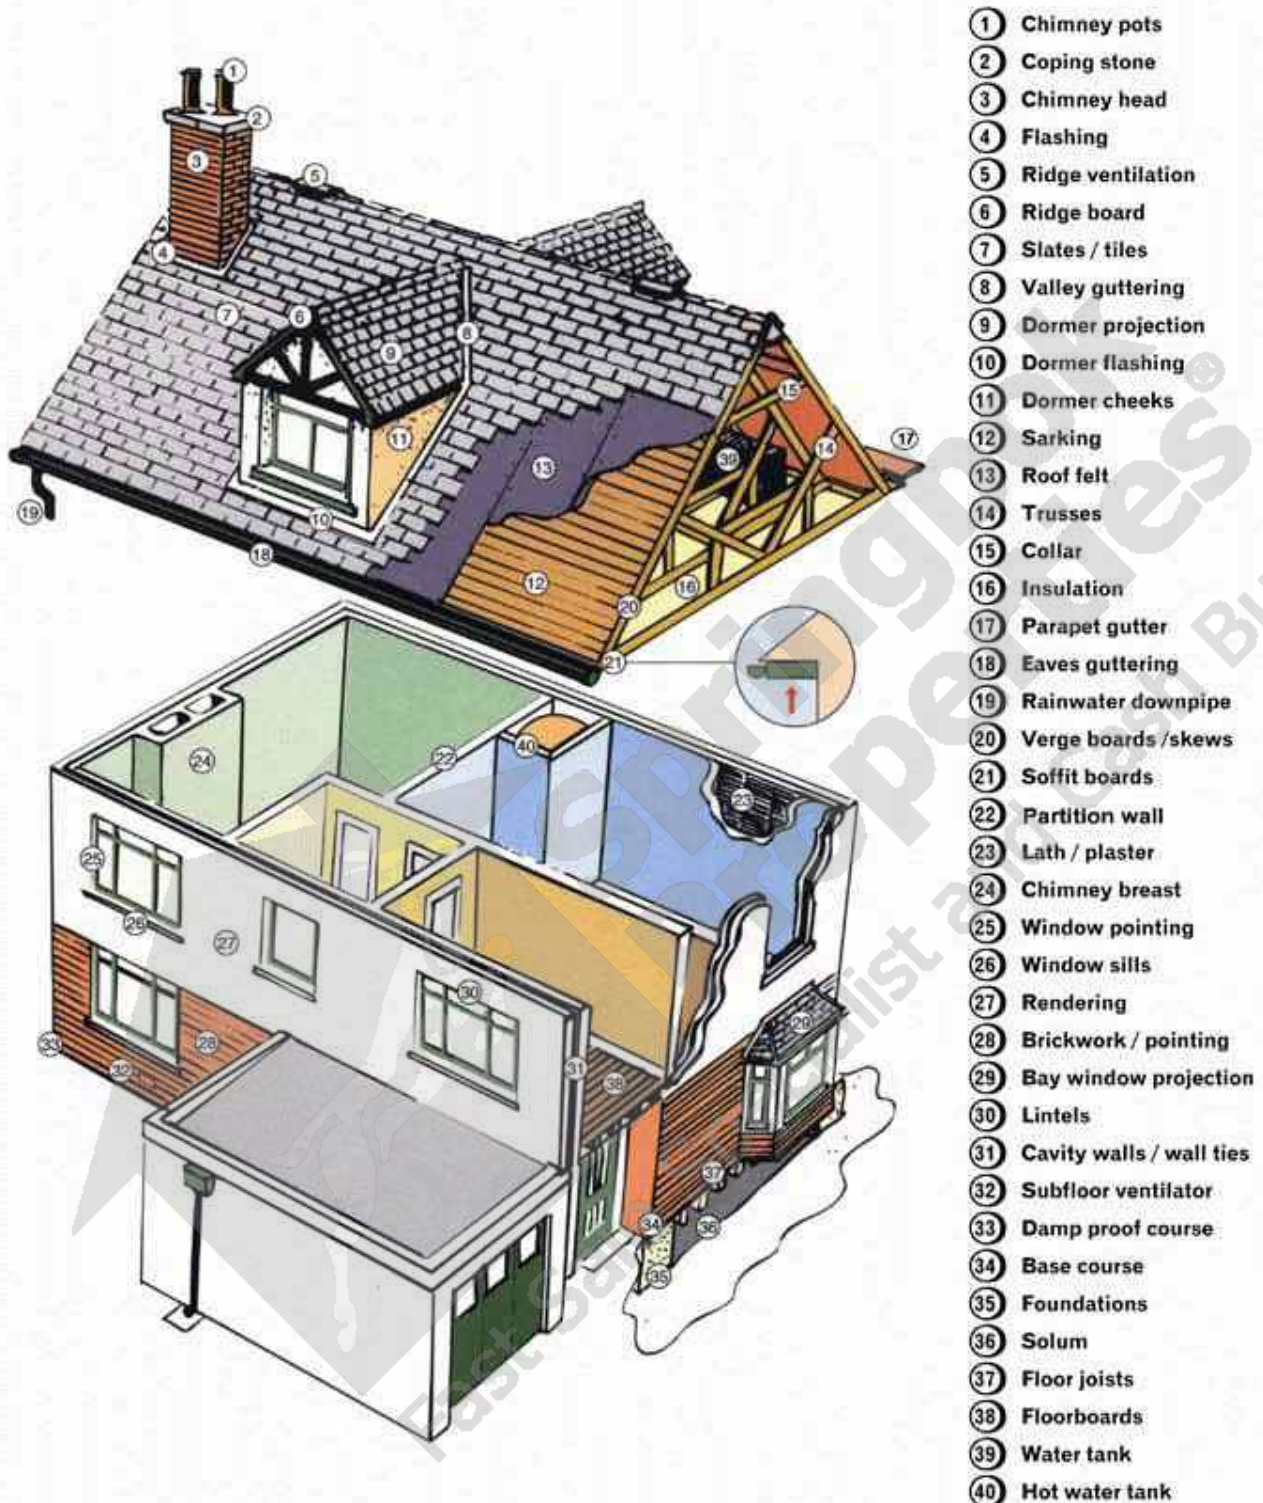
## Sectional Diagram showing elements of a typical house

Reference may be made in this report to some or all of the above component parts of the property. This diagram may assist you in locating and understanding these items.

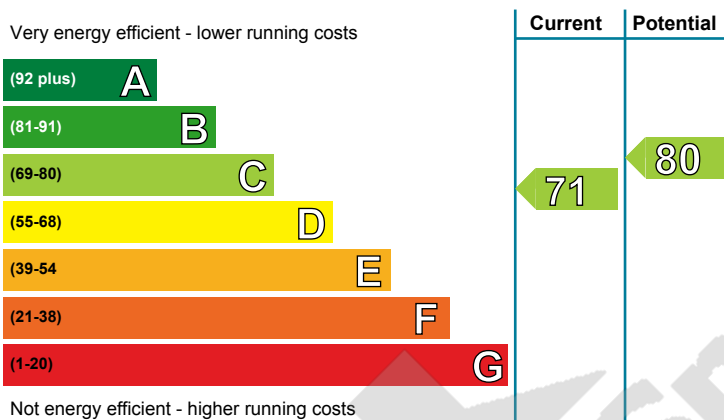
## Energy Efficiency Rating

This graph shows the current efficiency of your home, taking into account both energy efficiency and fuel costs. The higher this rating, the lower your fuel bills are likely to be.

The potential rating shows the effect of undertaking all of the improvement measures listed within your recommendations report.

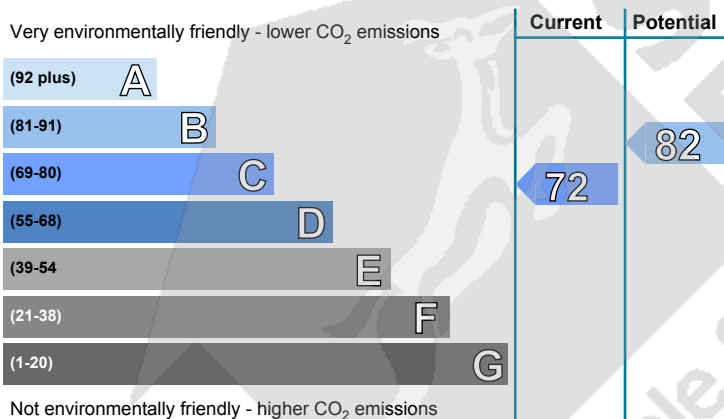
## Environmental Impact (CO<sub>2</sub>) Rating

This graph shows the effect of your home on the environment in terms of carbon dioxide (CO<sub>2</sub>) emissions. The higher the rating, the less impact it has on the environment.
