# Home Report

# Single Survey

| Property address | Flat 2<br>16 Templehill<br>Troon<br>KA10 6BE |
| Prepared by | Shepherd Chartered Surveyors |

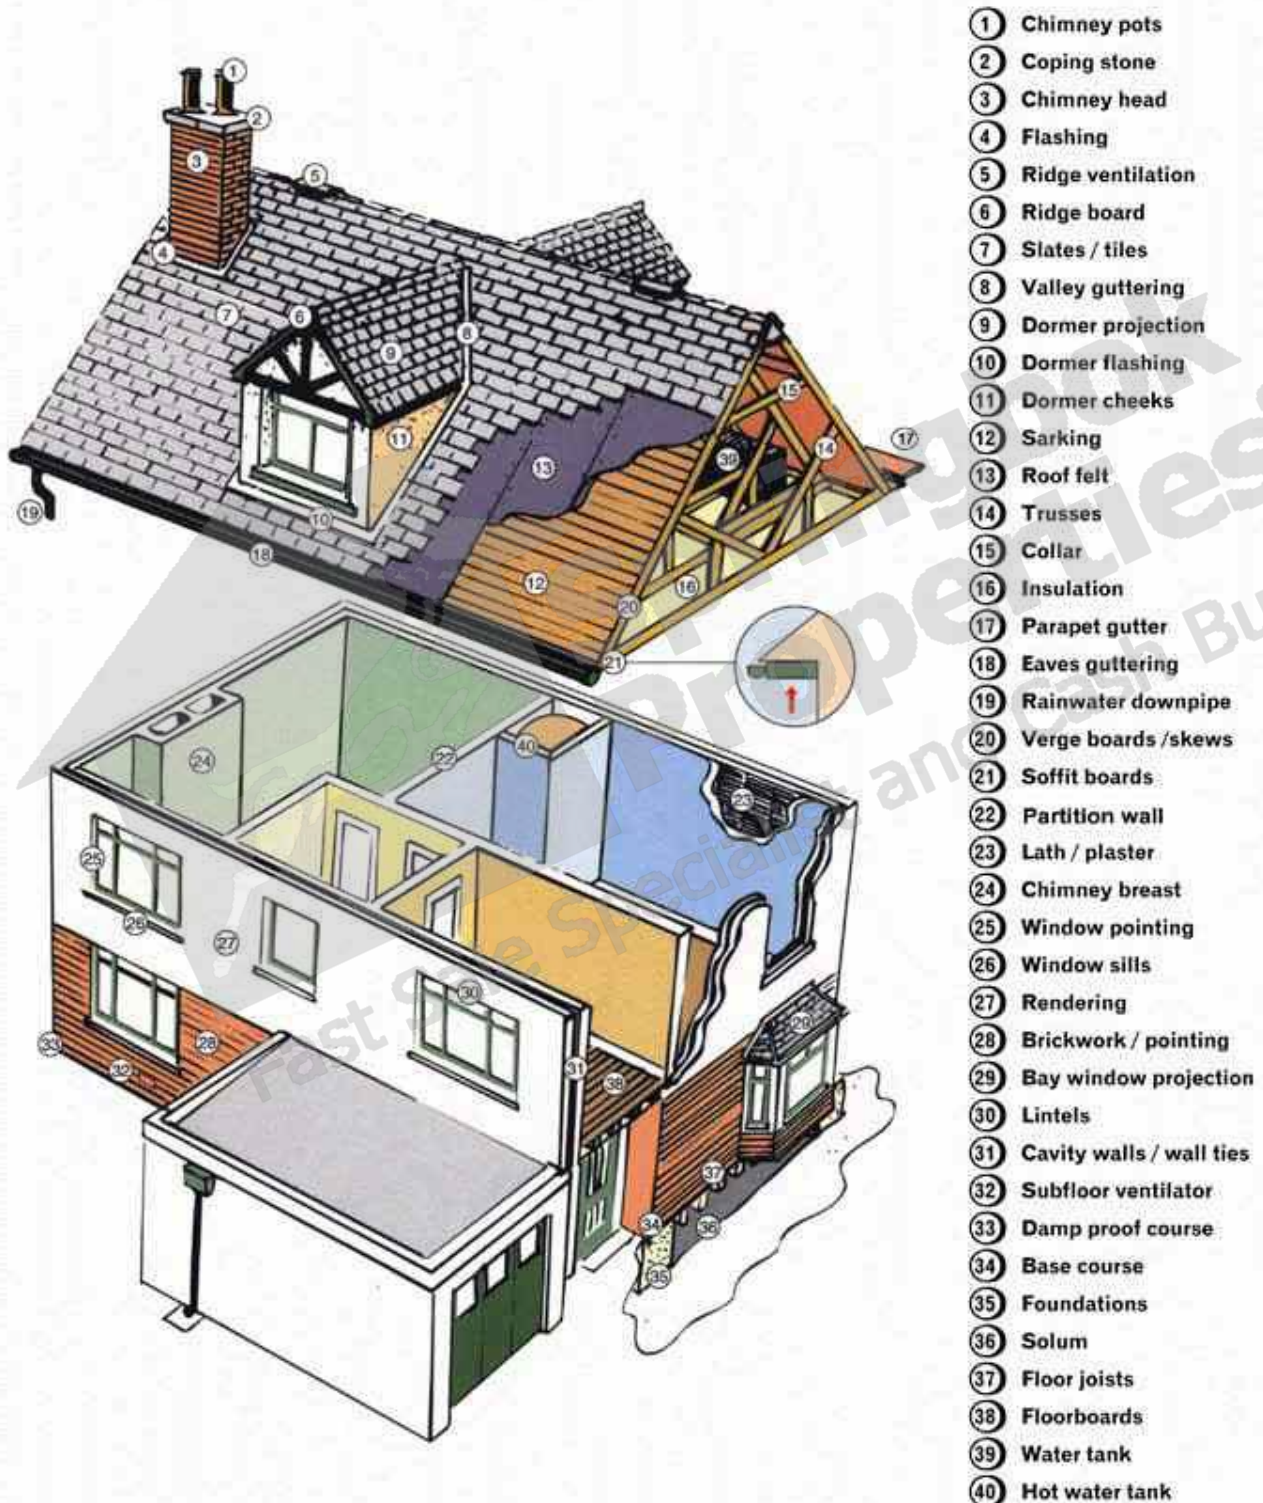
## Sectional Diagram showing elements of a typical house

Reference may be made in this report to some or all of the above component parts of the property. This diagram may assist you in locating and understanding these items.
