# Home Report

# Single Survey

| Property address | 22 Martinside<br>East Kilbride<br>Glasgow<br>G75 0BW |
| Prepared by | Shepherd Chartered Surveyors |

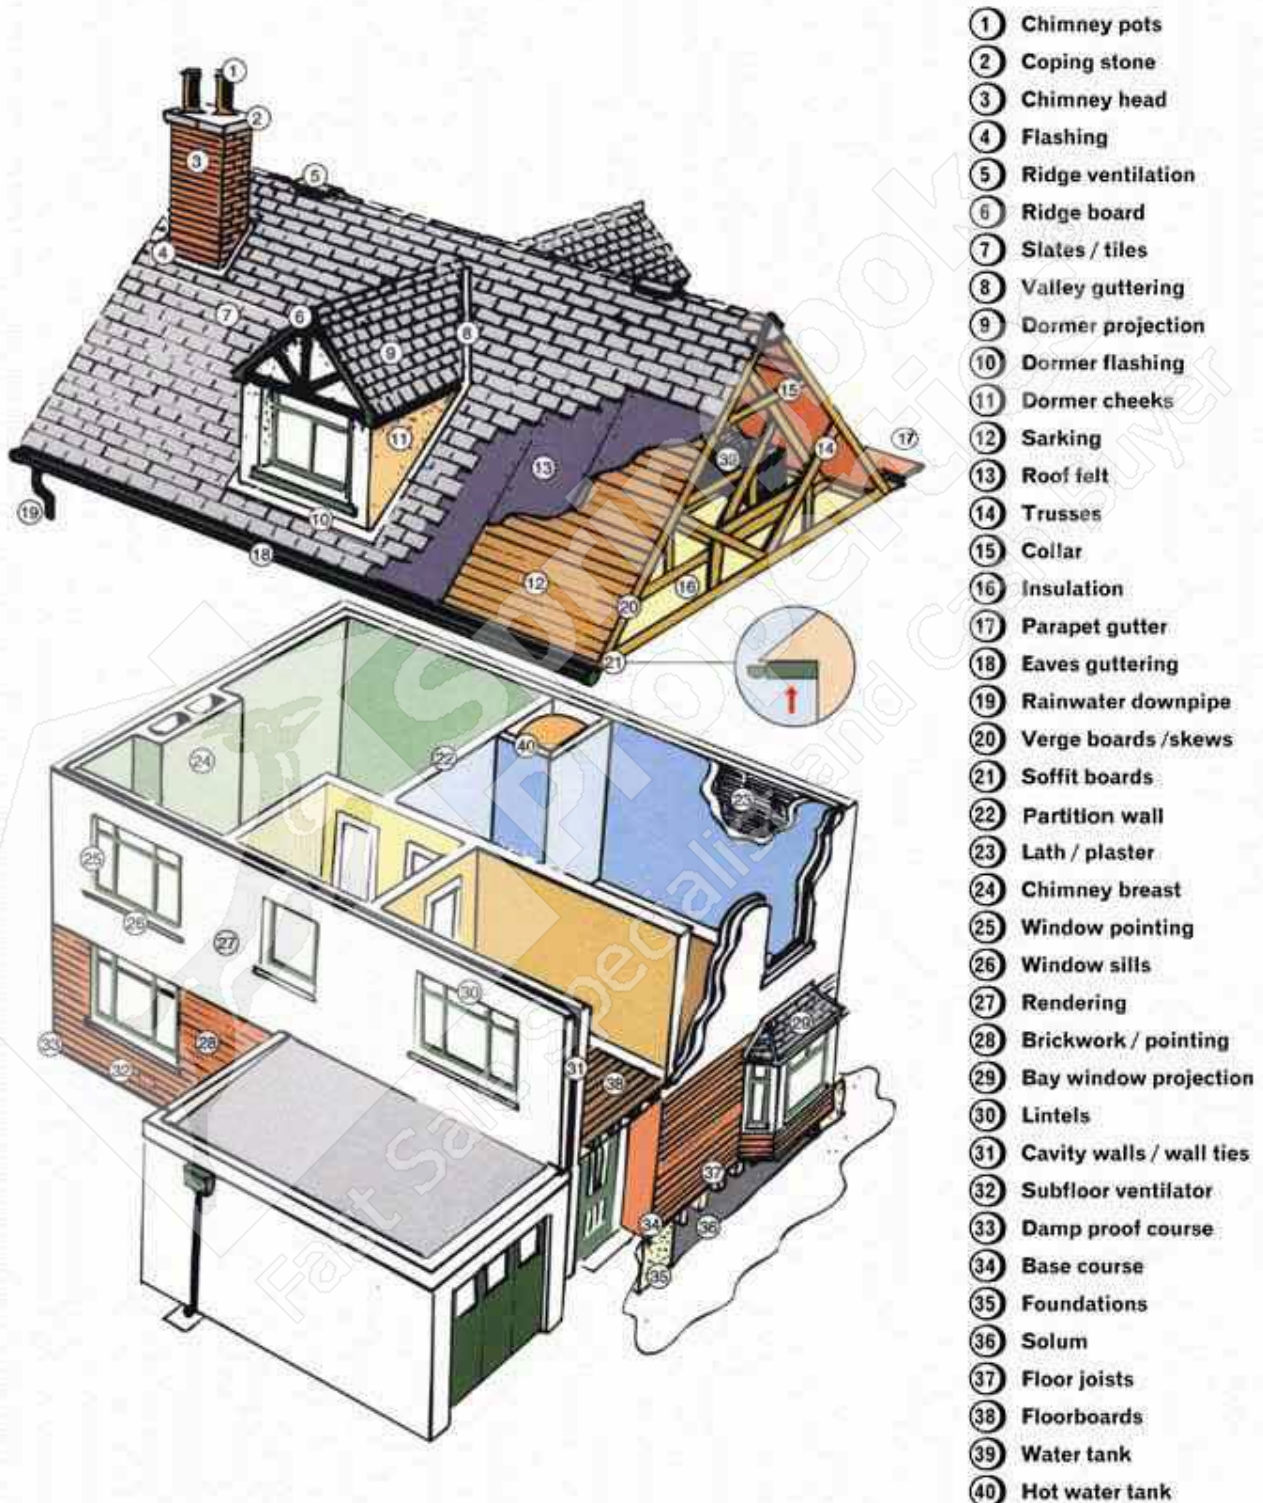
## Sectional Diagram showing elements of a typical house

Reference may be made in this report to some or all of the above component parts of the property. This diagram may assist you in locating and understanding these items.
