# Home Report

# Single Survey

| Property address | 8 Afton Grove<br>Dunfermline<br>KY11 4LE |
| Prepared by | Shepherd Chartered Surveyors |

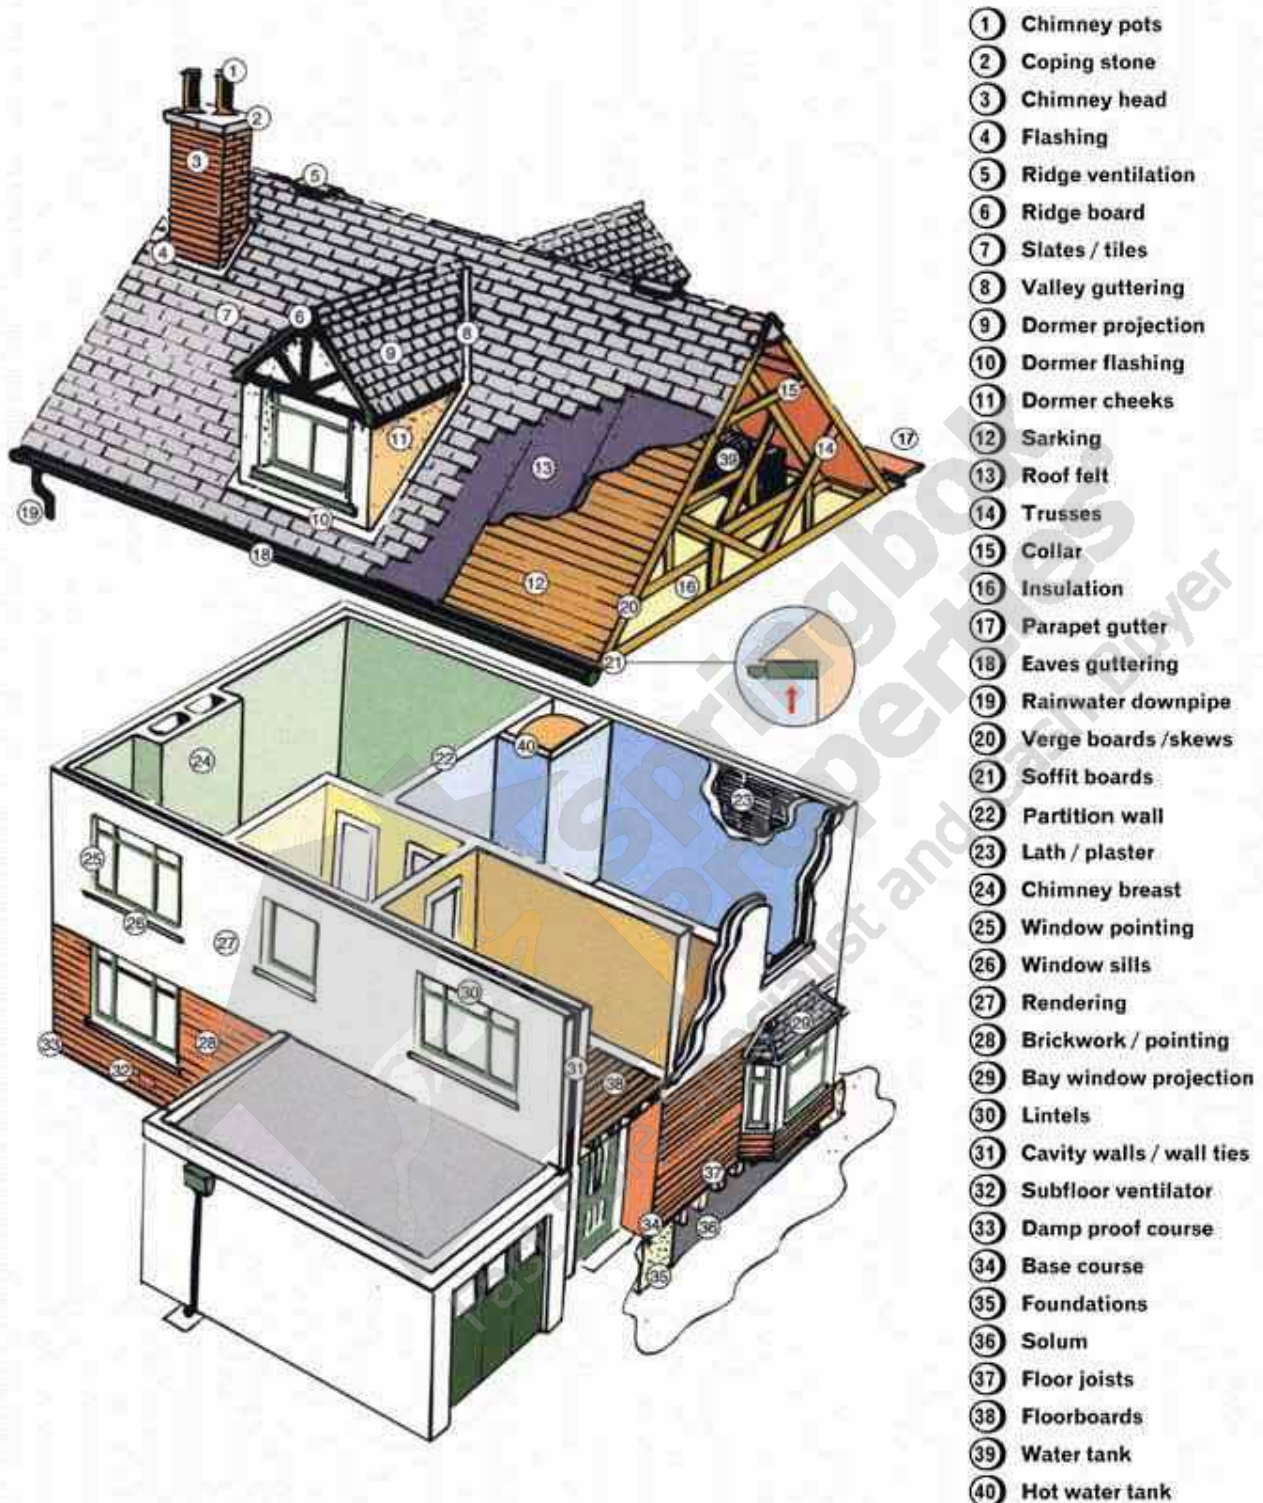
## Sectional Diagram showing elements of a typical house

Reference may be made in this report to some or all of the above component parts of the property. This diagram may assist you in locating and understanding these items.
