# HOME REPORT

73 RANDOLPH STREET  
BUCKHAVEN  
LEVEN  
KY8 1AT

**DM HALL**  
CHARTERED SURVEYORS

# ENERGY PERFORMANCE CERTIFICATE

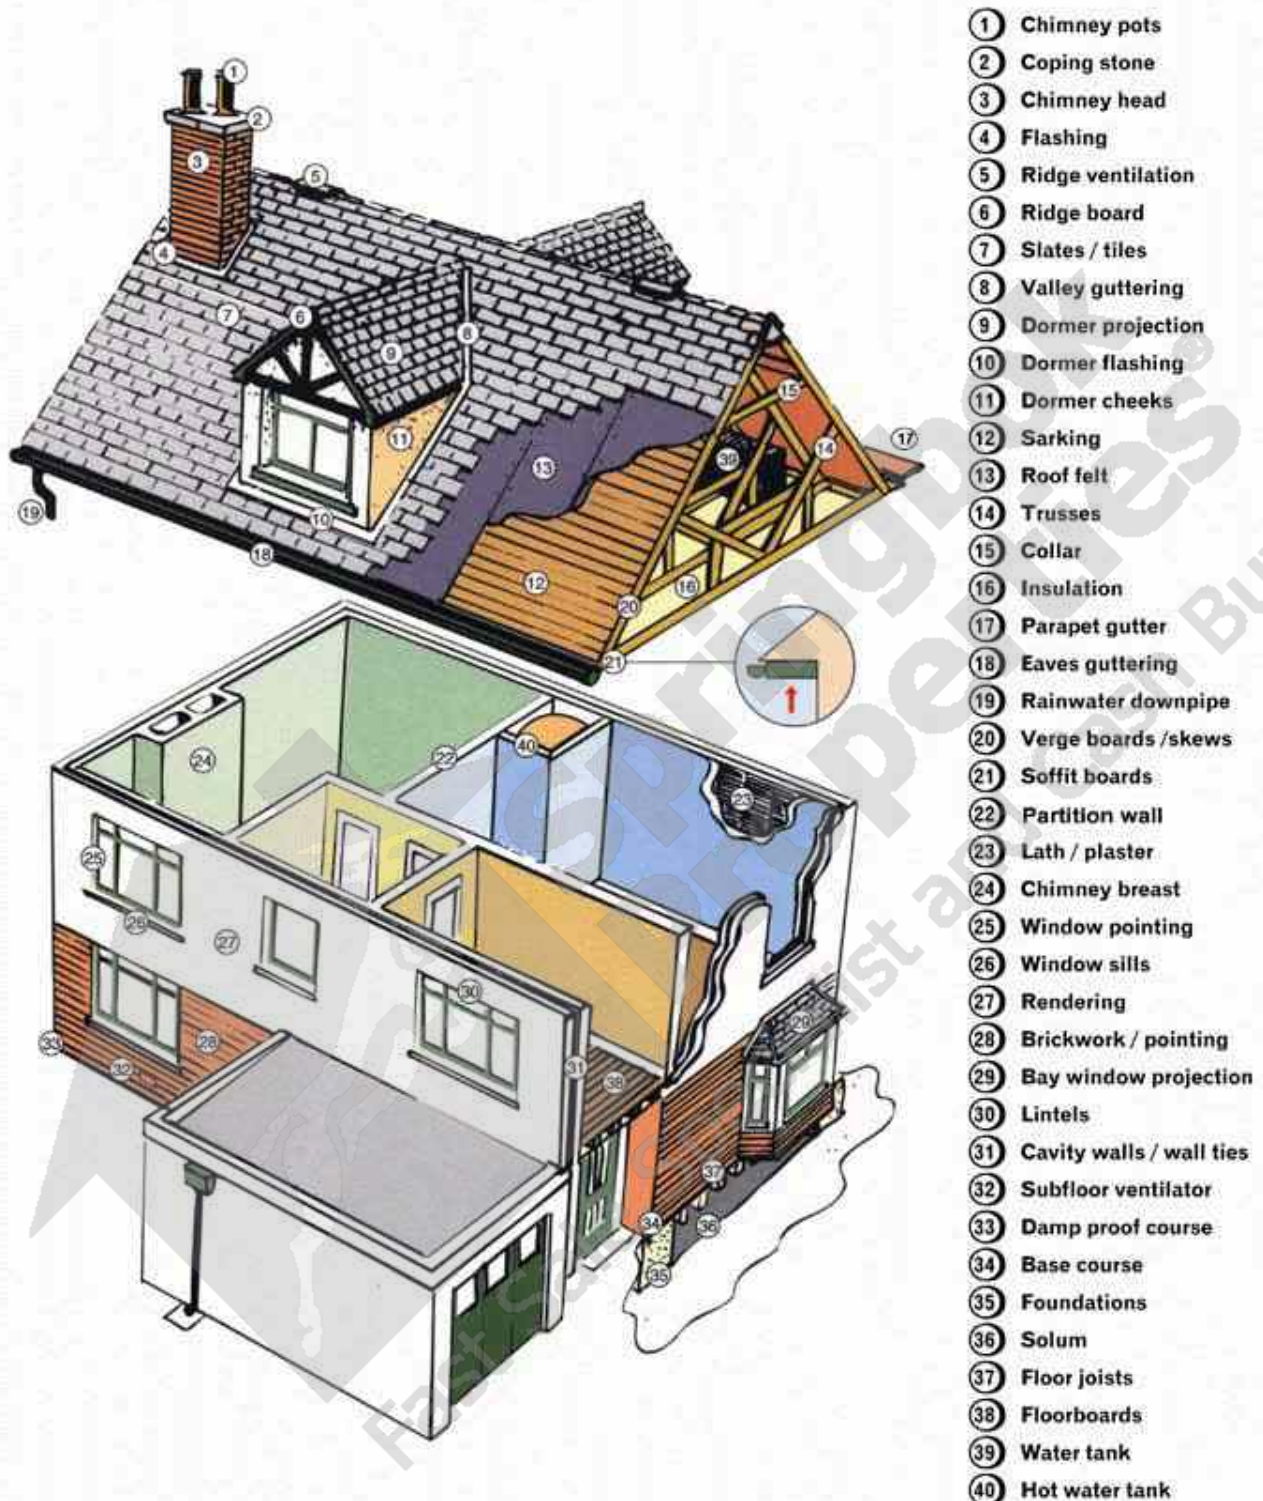
## Sectional Diagram showing elements of a typical house

Reference may be made in this report to some or all of the above component parts of the property. This diagram may assist you in locating and understanding these items.
