# YOUR ONESURVEY HOME REPORT

206 Piersfield Terrace  
Edinburgh  
EH8 7BN

# SINGLE SURVEY

A report on the condition of the property, with categories being rated from 1 to 3.

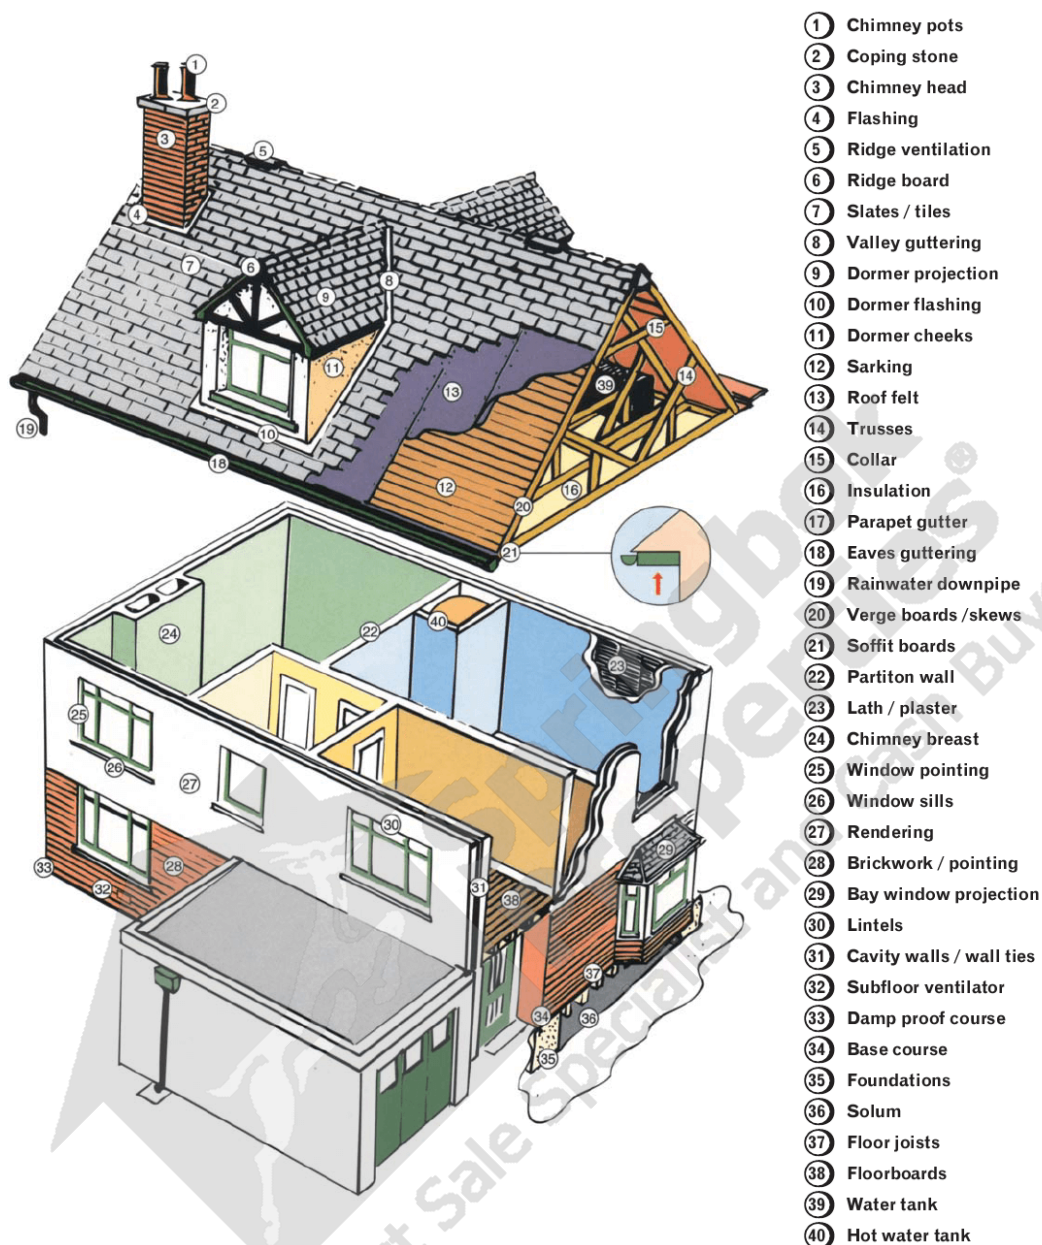
## Sectional Diagram showing elements of a typical house

Reference may be made in this report to some or all of the above component parts of the property. This diagram may assist you in locating and understanding these items.

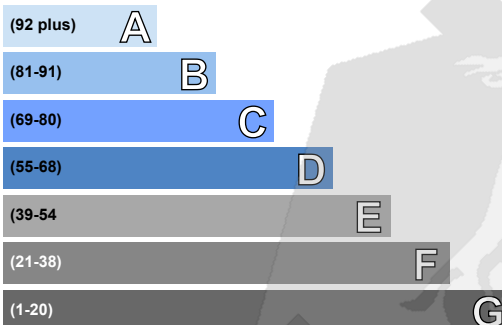
Very environmentally friendly - lower CO<sub>2</sub> emissions

Not environmentally friendly - higher CO<sub>2</sub> emissions
