YOUR ONESURVEY HOME REPORT

Hilton Mains
Station Road
Langbank, Port Glasgow
PA14 6YA

SINGLE SURVEY

Single Survey

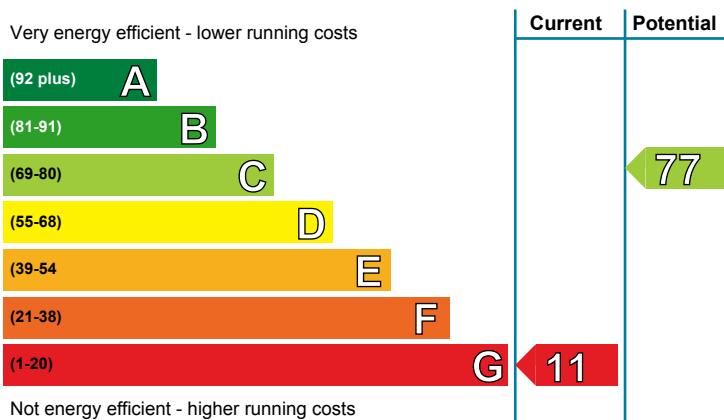
Energy Efficiency Rating

This graph shows the current efficiency of your home, taking into account both energy efficiency and fuel costs. The higher this rating, the lower your fuel bills are likely to be.

The potential rating shows the effect of undertaking all of the improvement measures listed within your recommendations report.

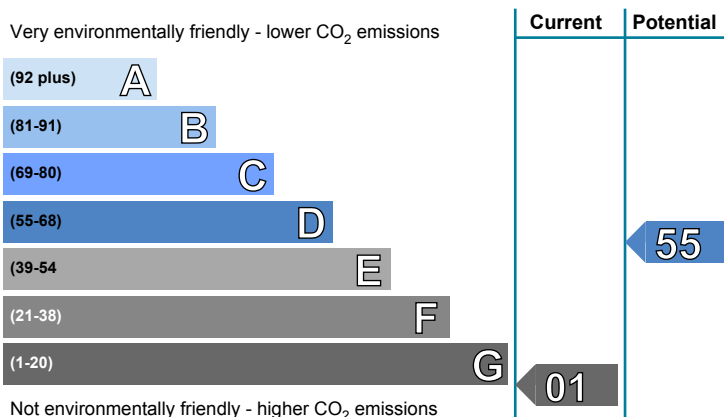
Environmental Impact (CO₂) Rating

This graph shows the effect of your home on the environment in terms of carbon dioxide (CO₂) emissions. The higher the rating, the less impact it has on the environment.
