YOUR ONE SURVEY  
**HOME REPORT**

Flat 2/2  
12 Richmond Park Terrace  
Glasgow  
G5 0LX

# SINGLE SURVEY

# Single Survey

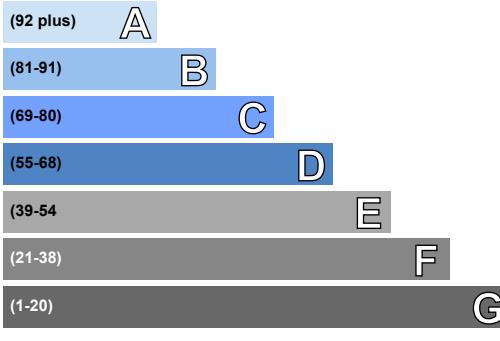
## Environmental Impact (CO<sub>2</sub>) Rating

Very environmentally friendly - lower CO<sub>2</sub> emissions

Current	Potential
	89	89
