YOUR ONE SURVEY  
**HOME REPORT**

Flat 14  
Broomcliff  
30 Castleton Drive  
Newton Mearns, Glasgow, G77 5LG

# SINGLE SURVEY

A report on the condition of the property, with categories  
being rated from 1 to 3.

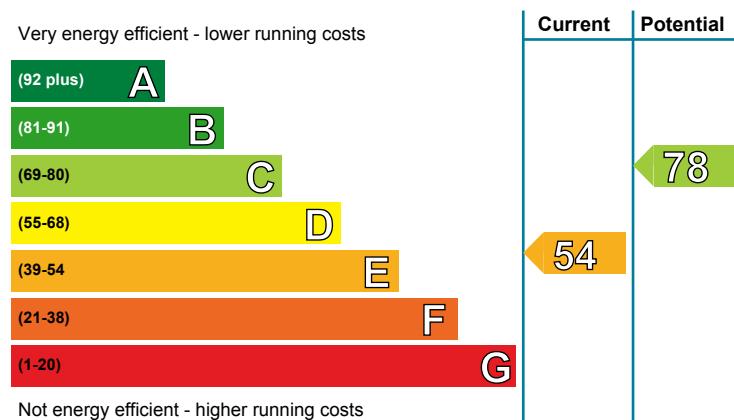
## Energy Efficiency Rating

This graph shows the current efficiency of your home, taking into account both energy efficiency and fuel costs. The higher this rating, the lower your fuel bills are likely to be.

Your current rating is **band E (54)**. The average rating for EPCs in Scotland is **band D (61)**.

The potential rating shows the effect of undertaking all of the improvement measures listed within your recommendations report.

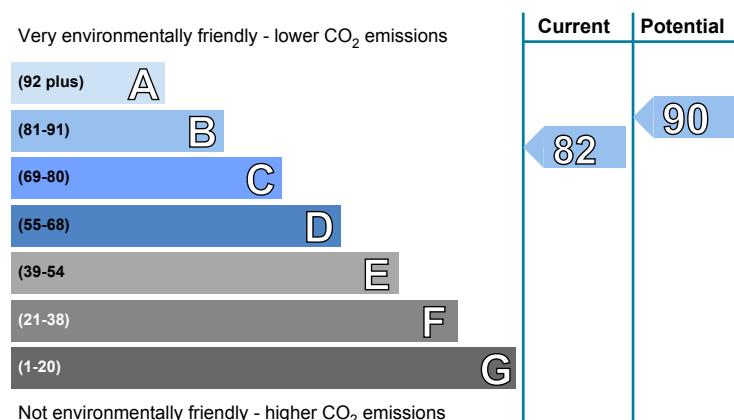
## Environmental Impact (CO<sub>2</sub>) Rating

This graph shows the effect of your home on the environment in terms of carbon dioxide (CO<sub>2</sub>) emissions. The higher the rating, the less impact it has on the environment.
