# Home Report

# Scottish Single Survey

<b>Property address</b>	Apartment 6 Venlaw Castle Edinburgh Road Peebles EH45 8RD
-------------------------	---

<b>Prepared by</b>	Shepherd Chartered Surveyors
--------------------	------------------------------

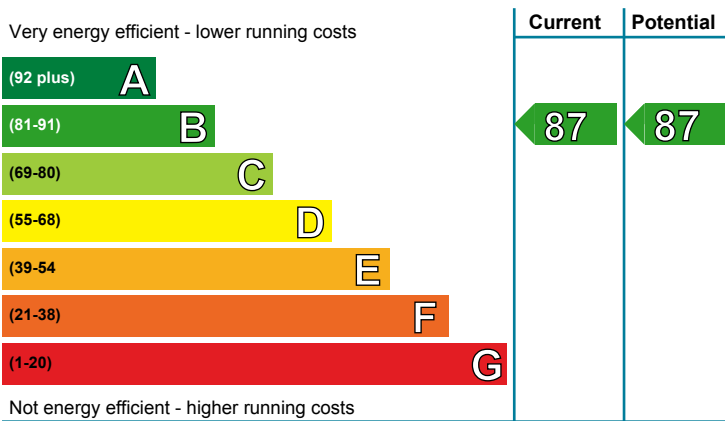
## Energy Efficiency Rating

This graph shows the current efficiency of your home, taking into account both energy efficiency and fuel costs. The higher this rating, the lower your fuel bills are likely to be.

Your current rating is **band B (87)**. The average rating for EPCs in Scotland is **band D (61)**.

The potential rating shows the effect of undertaking all of the improvement measures listed within your recommendations report.
