HOME REPORT

48 ROSS PLACE
UPPER ACHINTORE
FORT WILLIAM
PH33 6JZ

Single Survey

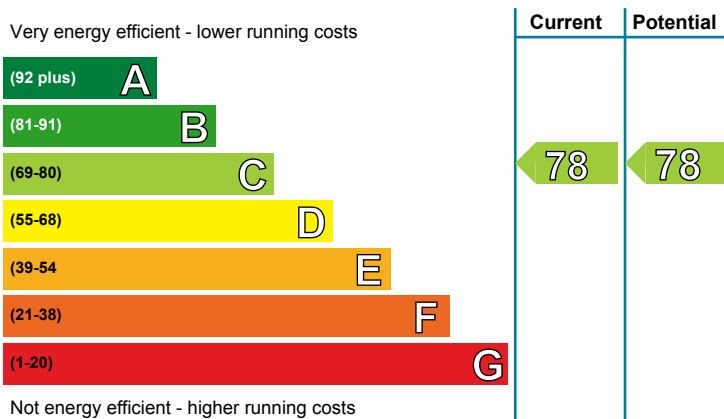
Energy Efficiency Rating

This graph shows the current efficiency of your home, taking into account both energy efficiency and fuel costs. The higher this rating, the lower your fuel bills are likely to be.

Your current rating is **band C (78)**. The average rating for EPCs in Scotland is **band D (61)**.

The potential rating shows the effect of undertaking all of the improvement measures listed within your recommendations report.

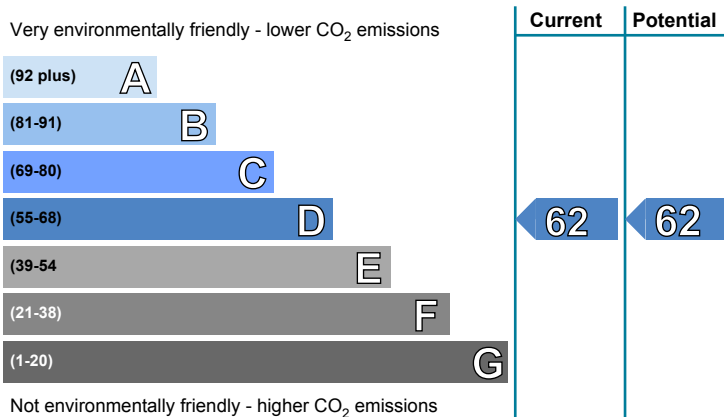
Environmental Impact (CO₂) Rating

This graph shows the effect of your home on the environment in terms of carbon dioxide (CO₂) emissions. The higher the rating, the less impact it has on the environment.

Your current rating is **band D (62)**. The average rating for EPCs in Scotland is **band D (59)**.

The potential rating shows the effect of undertaking all of the improvement measures listed within your recommendations report.
