Home Report

**13 Farrow Drive
Corpach
Fort William
PH33 7JW**

Inspected on: 14th August 2024

Prepared by:
Samuel & Partners
First Surveyors Scotland
First Floor
20 High Street
FORT WILLIAM
PH33 6AT

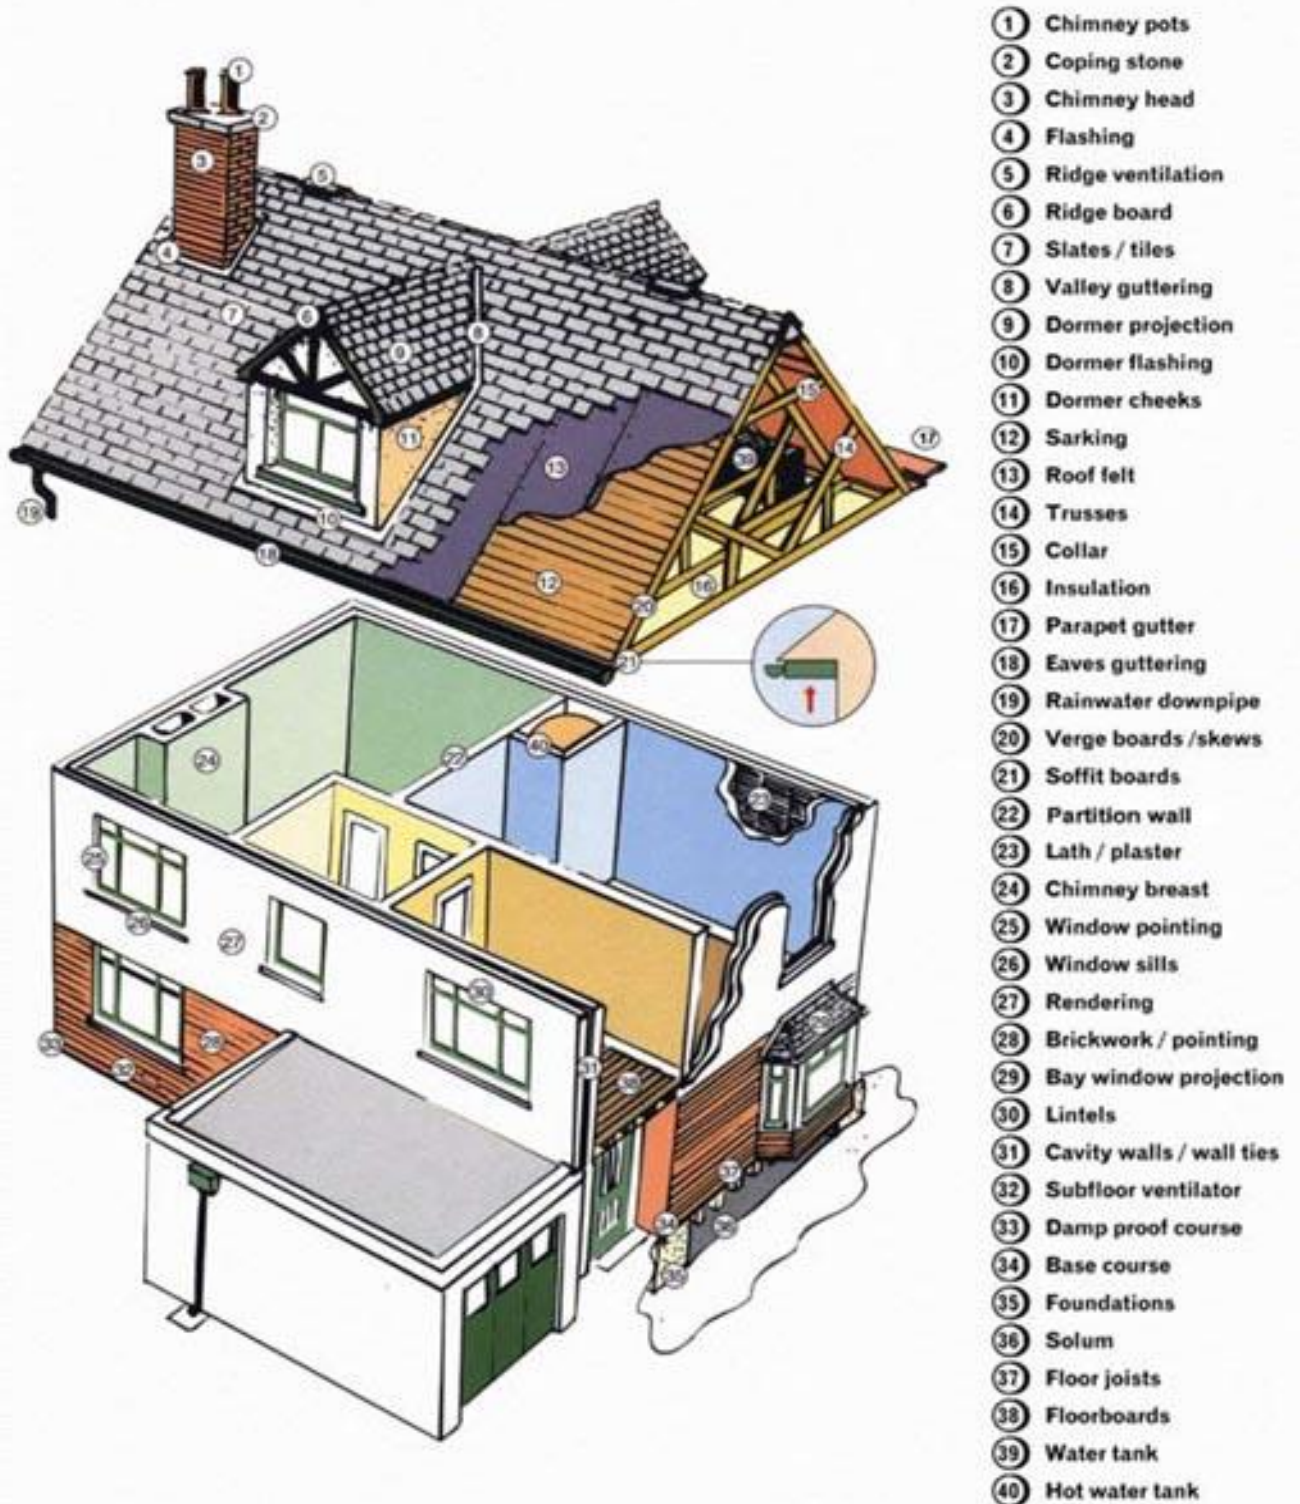
Sectional Diagram showing elements of a typical house

Reference may be made in this report to some or all of the above component parts of the property. This diagram may assist you in locating and understanding these items.

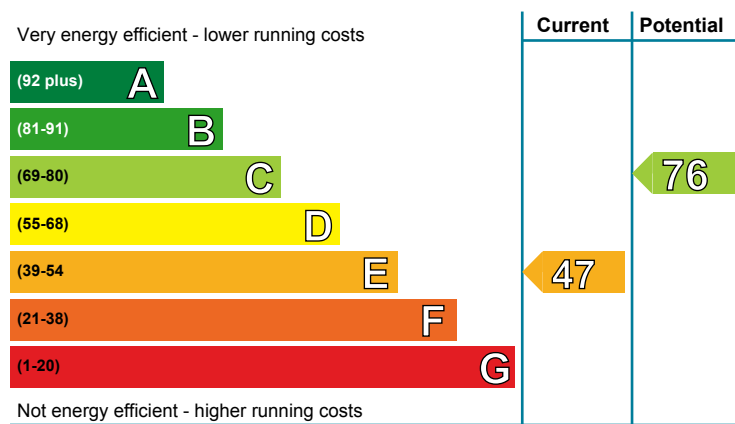
Energy Efficiency Rating

This graph shows the current efficiency of your home, taking into account both energy efficiency and fuel costs. The higher this rating, the lower your fuel bills are likely to be.

Your current rating is **band E (47)**. The average rating for EPCs in Scotland is **band D (61)**.

The potential rating shows the effect of undertaking all of the improvement measures listed within your recommendations report.

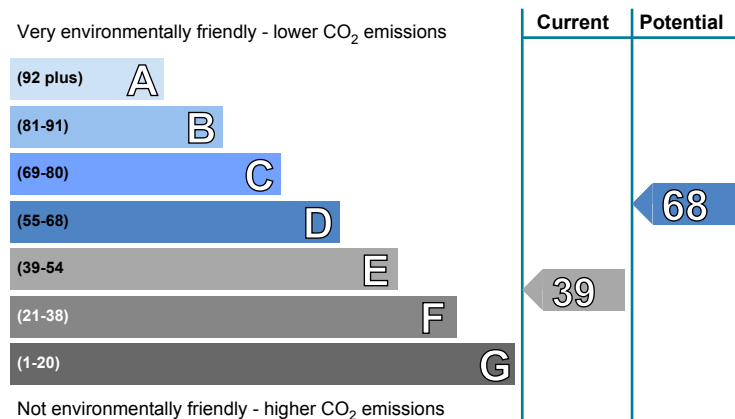
Environmental Impact (CO₂) Rating

This graph shows the effect of your home on the environment in terms of carbon dioxide (CO₂) emissions. The higher the rating, the less impact it has on the environment.
