7 Old Ground Invergarry PH35 4HH

Inspected on: 8th August 2024

Prepared by:
Samuel & Partners
First Surveyors Scotland
First Floor
20 High Street
FORT WILLIAM
PH33 6AT

H o m e R e p o r t - i n d e x

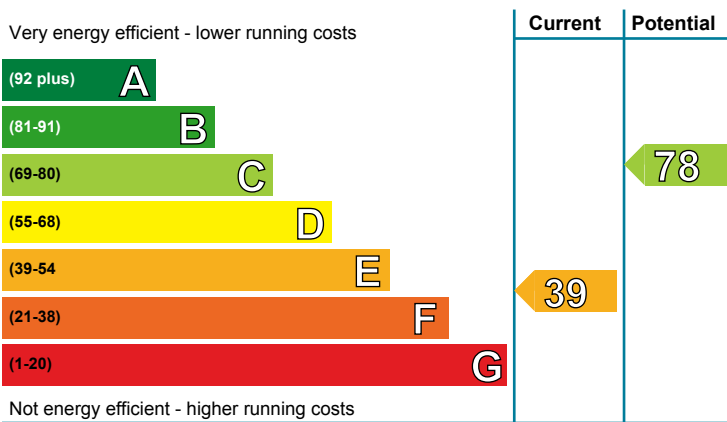
Energy Efficiency Rating

This graph shows the current efficiency of your home, taking into account both energy efficiency and fuel costs. The higher this rating, the lower your fuel bills are likely to be.

Your current rating is **band E (39)**. The average rating for EPCs in Scotland is **band D (61)**.

The potential rating shows the effect of undertaking all of the improvement measures listed within your recommendations report.
