**15 Caledonian Road
Corpach
Fort William
PH33 7LF**

Inspected on: 1st August 2024

Prepared by:
Samuel & Partners
First Surveyors Scotland
First Floor
20 High Street
FORT WILLIAM
PH33 6AT

H o m e R e p o r t - i n d e x

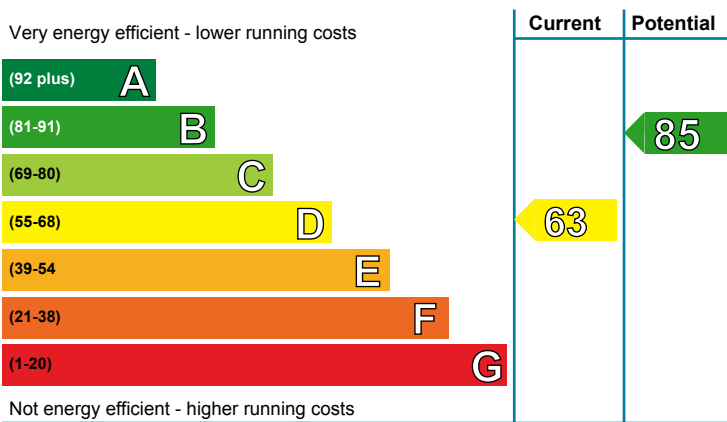
Energy Efficiency Rating

This graph shows the current efficiency of your home, taking into account both energy efficiency and fuel costs. The higher this rating, the lower your fuel bills are likely to be.

Your current rating is **band D (63)**. The average rating for EPCs in Scotland is **band D (61)**.

The potential rating shows the effect of undertaking all of the improvement measures listed within your recommendations report.

Estimated energy costs for your home for 3 years*	£4,548	See your recommendations report for more information
Over 3 years you could save*	£1,146

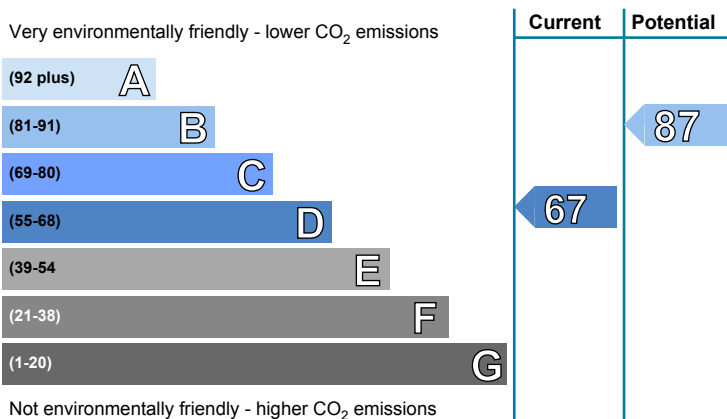
Environmental Impact (CO₂) Rating

This graph shows the effect of your home on the environment in terms of carbon dioxide (CO₂) emissions. The higher the rating, the less impact it has on the environment.
