R
e
p
o
r
t

**Merchiston
Badabrie
Banavie
Fort William
PH33 7LX**

Inspected on: 12th February 2024

Prepared by:
Samuel & Partners
First Surveyors Scotland
First Floor
20 High Street
FORT WILLIAM
PH33 6AT

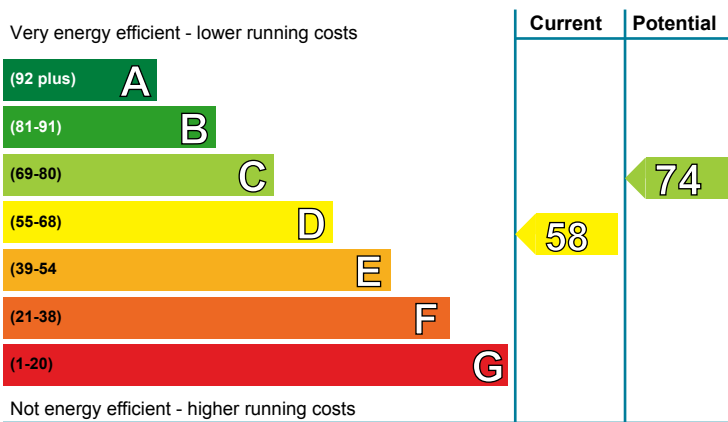
Energy Efficiency Rating

This graph shows the current efficiency of your home, taking into account both energy efficiency and fuel costs. The higher this rating, the lower your fuel bills are likely to be.

Your current rating is **band D (58)**. The average rating for EPCs in Scotland is **band D (61)**.

The potential rating shows the effect of undertaking all of the improvement measures listed within your recommendations report.

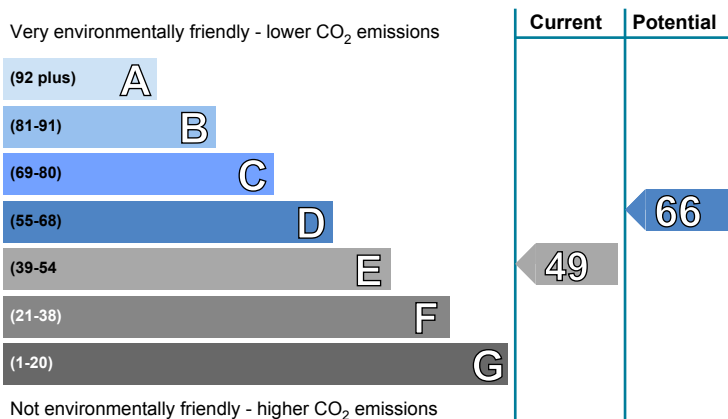
Environmental Impact (CO₂) Rating

This graph shows the effect of your home on the environment in terms of carbon dioxide (CO₂) emissions. The higher the rating, the less impact it has on the environment.
