**Far View Cottage  
Kilchoan  
Acharacle  
PH36 4LH**

Inspected on: 7<sup>th</sup> March 2025

**Prepared by:**  
Samuel & Partners  
First Surveyors Scotland  
First Floor  
20 High Street  
FORT WILLIAM  
PH33 6AT

1. Property Questionnaire
2. Single Survey
3. Mortgage Valuation
4. Energy Report

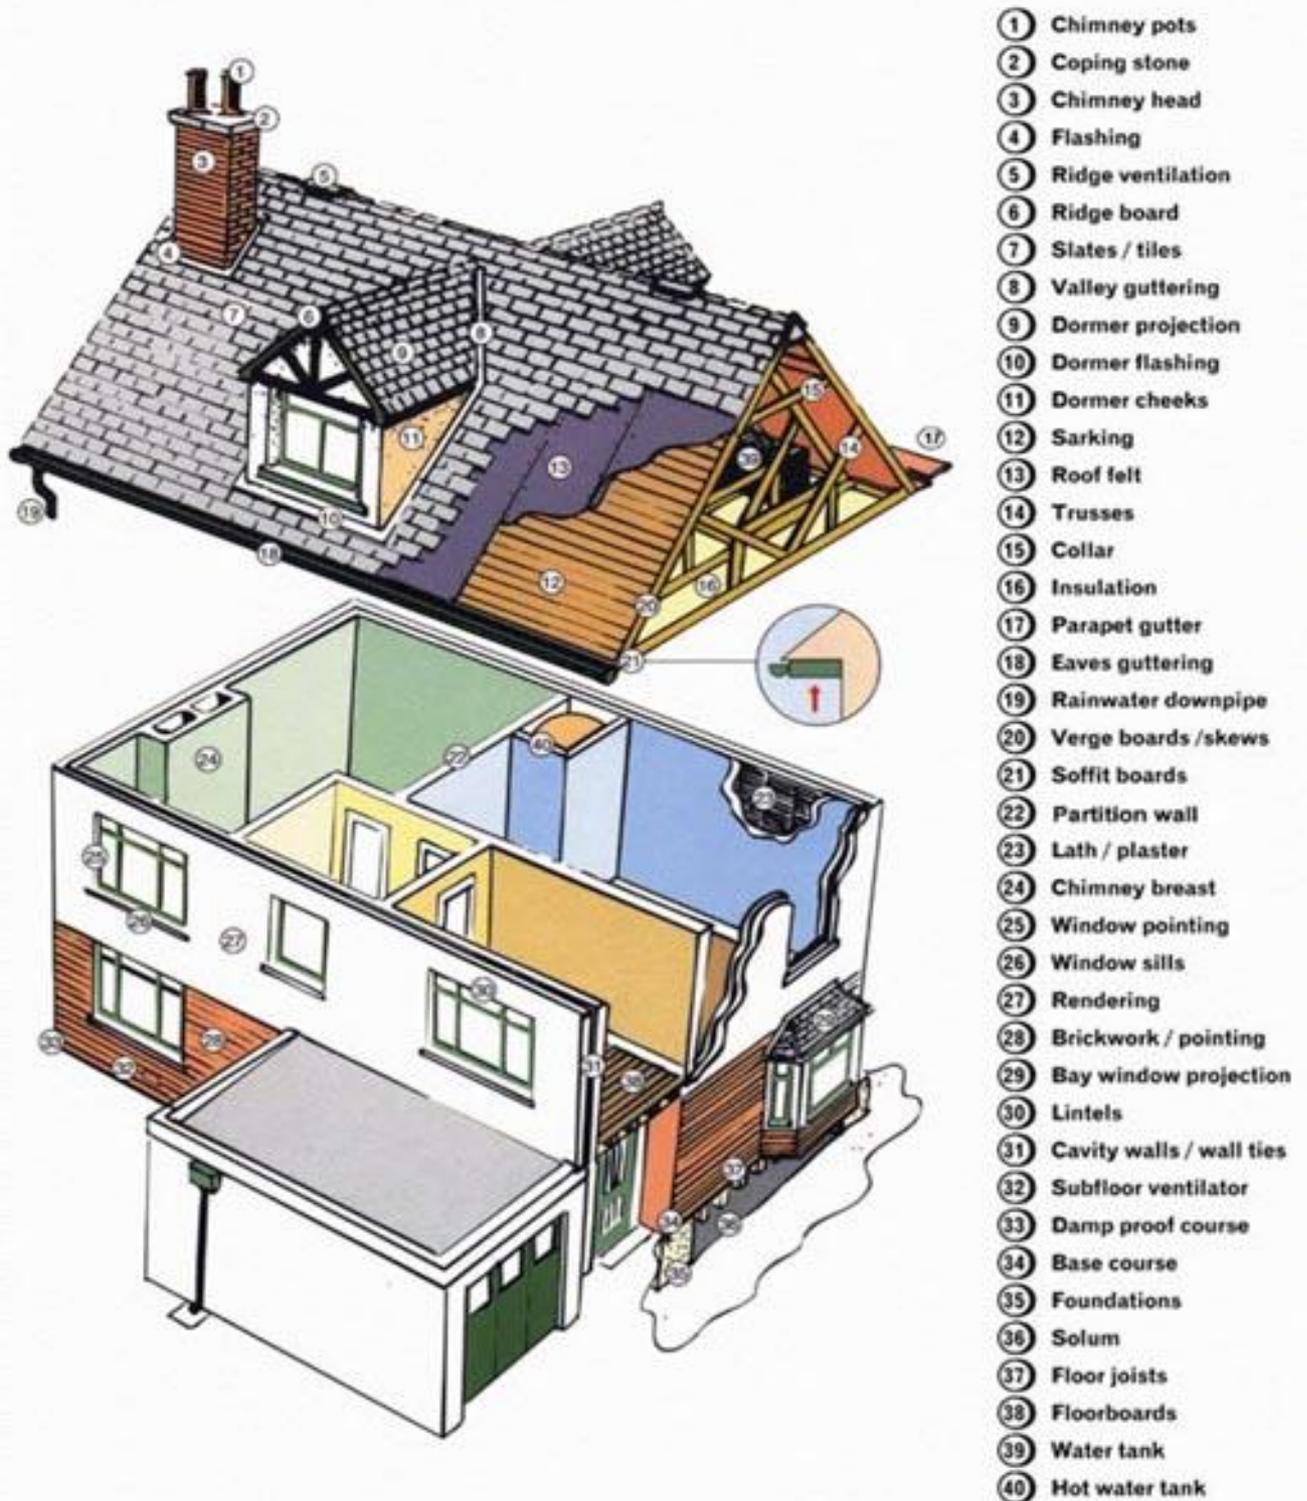
## Sectional Diagram showing elements of a typical house

Reference may be made in this report to some or all of the above component parts of the property. This diagram may assist you in locating and understanding these items.

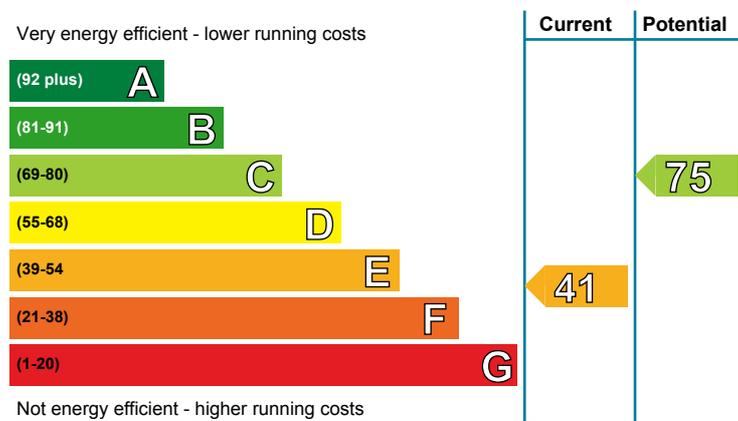
## Energy Efficiency Rating

This graph shows the current efficiency of your home, taking into account both energy efficiency and fuel costs. The higher this rating, the lower your fuel bills are likely to be.

Your current rating is **band E (41)**. The average rating for EPCs in Scotland is **band D (61)**.

The potential rating shows the effect of undertaking all of the improvement measures listed within your recommendations report.

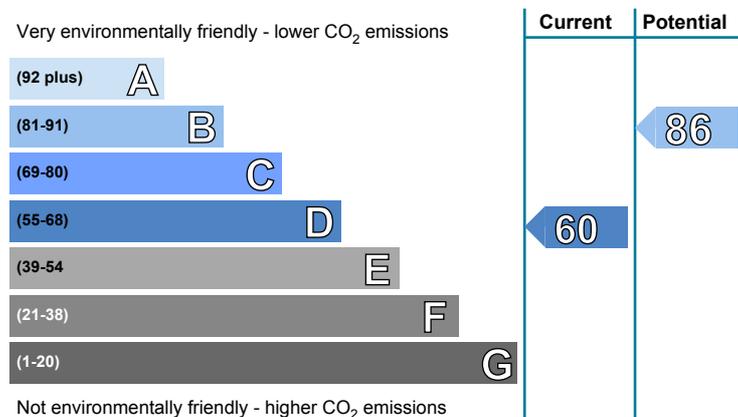
## Environmental Impact (CO<sub>2</sub>) Rating

This graph shows the effect of your home on the environment in terms of carbon dioxide (CO<sub>2</sub>) emissions. The higher the rating, the less impact it has on the environment.
