# **HOME REPORT**

#### **GLENDEVIN RIGH CRESCENT**

**ONICH FORT WILLIAM**

# SINGLE SURVEY

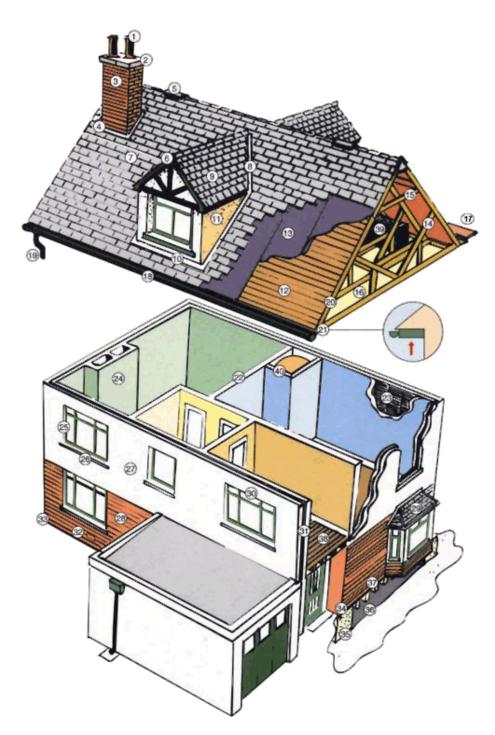
#### Sectional Diagram showing elements of a typical house

Reference may be made in this report to some or all of the above component parts of the property. This diagram may assist you in locating and understanding these items.

- 1) Chimney pots
- 2) Coping stone
- 3) Chimney head
- 4 Flashing
- 5) Ridge ventilation
- 6 Ridge board
- 7) Slates / tiles
- 8 Valley guttering
- 9 Dormer projection
- 10) Dormer flashing
- 11) Dormer cheeks
- 12) Sarking
- 13) Roof felt
- 14) Trusses
- 15) Collar
- (16) Insulation
- (17) Parapet gutter
- (18) Eaves guttering
- Rainwater downpipe
- 20) Verge boards/skews
- 21) Soffit boards
- 22) Partition wall
- 23) Lath / plaster
- 24) Chimney breast
- 25) Window pointing
- 6) Window sills
- 27) Rendering
- (28) Brickwork / pointing
- 29) Bay window projection
- 30 Lintels
- (31) Cavity walls / wall ties
- 32) Subfloor ventilator
- 33 Damp proof course
- 34) Base course
- 35) Foundations
- 36) Solum
- 37) Floor joists
- 38) Floorboards
- 39) Water tank
- 40 Hot water tank
