# Home Report

## 3 Millhouse Flats North Road Fort William PH33 6LR

# Home Report Index

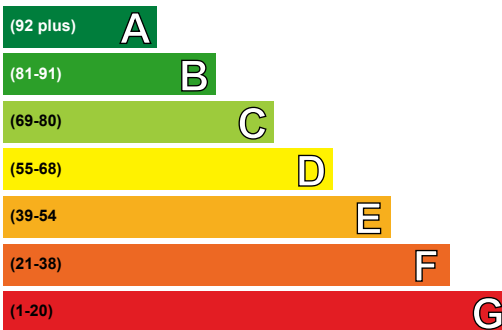
Very energy efficient - lower running costs

Not energy efficient - higher running costs

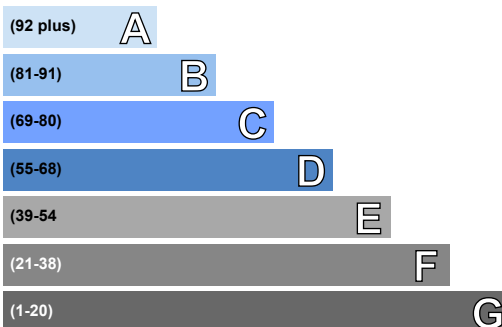
Very environmentally friendly - lower CO<sub>2</sub> emissions

Not environmentally friendly - higher CO<sub>2</sub> emissions
