Home Report

Scottish
Single Survey

Property address	4 Bryson Place Mid Street Bathgate EH48 1PT
Customer	Melissa O'Reilly
Customer address	4 Bryson Place Mid Street Bathgate EH48 1PT
Prepared by	Shepherd Chartered Surveyors
Date of inspection	30/04/2025

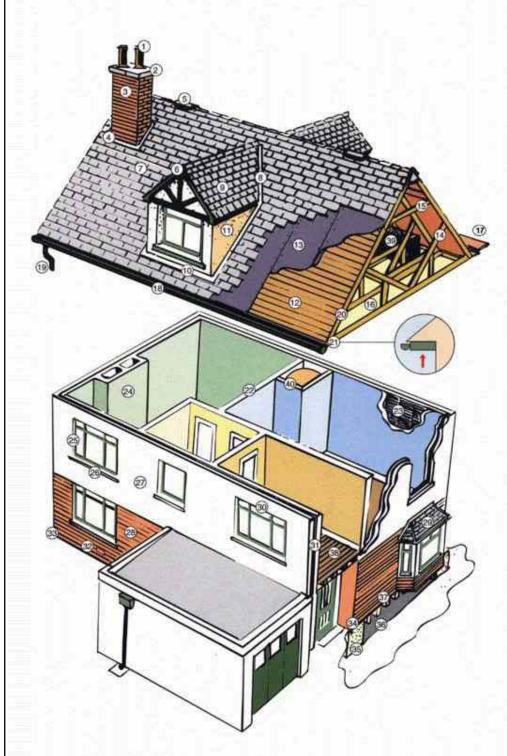
Sectional Diagram showing elements of a typical house

Reference may be made in this report to some or all of the above component parts of the property. This diagram may assist you in locating and understanding these items.

- 1) Chimney pots
- 2) Coping stone
- 3) Chimney head
- (4) Flashing
- 5) Ridge ventilation
- (6) Ridge board
- (7) Slates / tiles
- 8 Valley guttering
- Dormer projection
- 10 Dormer flashing
- 11) Dormer cheeks
- (12) Sarking
- (13) Roof felt
- (14) Trusses
- (15) Collar
- (16) Insulation
- 17) Parapet gutter
- 18) Eaves guttering
- (19) Rainwater downpipe
- 20) Verge boards /skews
- 21) Soffit boards
- 22) Partition wall
- 23) Lath / plaster
- 24) Chimney breast
- 25) Window pointing
- 26) Window sills
- 27) Rendering
- (28) Brickwork / pointing
- (29) Bay window projection
- (30) Lintels
- (31) Cavity walls / wall ties
- 32) Subfloor ventilator
- (33) Damp proof course
- 34) Base course
- 35) Foundations
- 36) Solum
- 7) Floor joists
- 38) Floorboards
- 39) Water tank
- 40) Hot water tank
