Home Report

Scottish Single Survey

Property address	6 Main Street Dalry KA24 5DH
------------------	------------------------------------

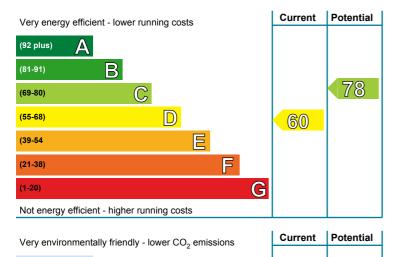
Energy Efficiency Rating

This graph shows the current efficiency of your home, taking into account both energy efficiency and fuel costs. The higher this rating, the lower your fuel bills are likely to be.
